GEOTECHNICAL INVESTIGATION AND DESIGN REPORT KASHWAKAMAK LAKE DAM REPLACEMENT, TOWNSHIP OF NORTH FRONTENAC, ONTARIO

Project No.: CCO-23-3603

Mississippi Valley Conservation Authority
10970 Highway 7
Carleton Place, ON K7C 3P1

Revision 1 - January 2023

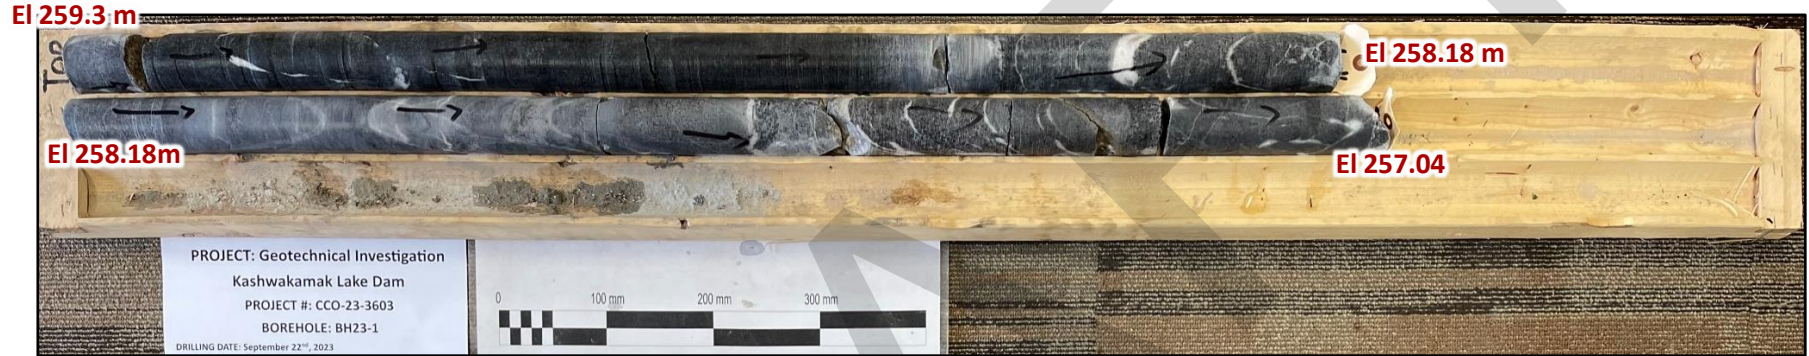
(BH23-1)

RC 1 – 259.3 to 258.18 m
(RQD = 93%)

RC 2 – 258.18 to 257.04 m
(RQD = 89%)

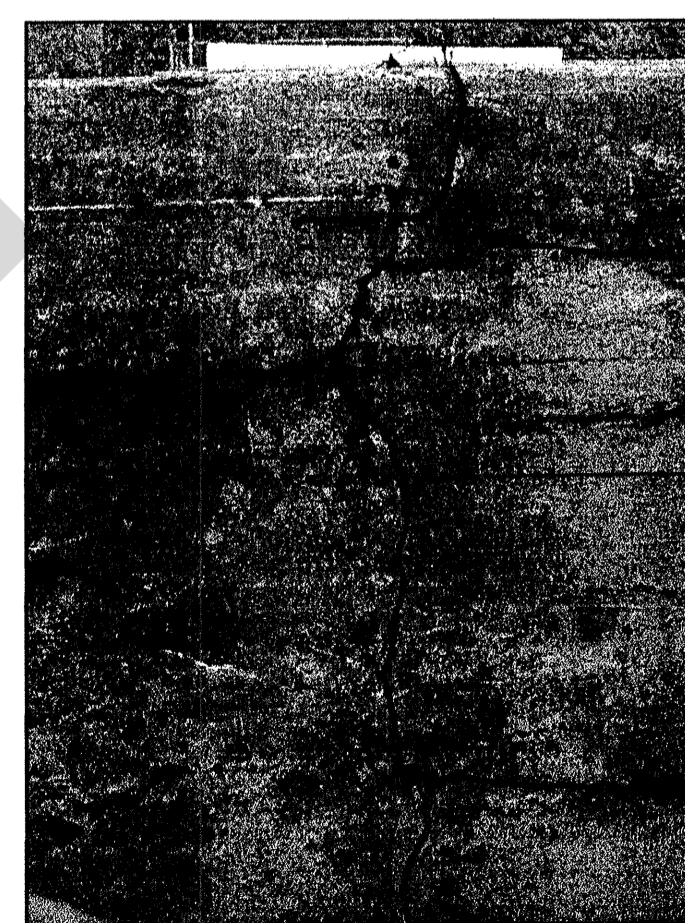
PHOTO #4

SEVERE STRUCTURAL CRACK

COLD JOINT DETERIORATION

- LAYOUT & CONFIRM ALL CRACKS AND JOINTS TO BE REPAIRED.
- PRESSURE WASH.
- REMOVE LOOSE DELETERIOUS MATERIALS.
- SUFFICIENTLY GROUT CRACKS TO BE ABLE TO PRESSURE INJECT HILTI RM700 EP REPAIR MORTAR.
- CLEAN CONCRETE FACE OF SURPLUS REPAIR MATERIALS.

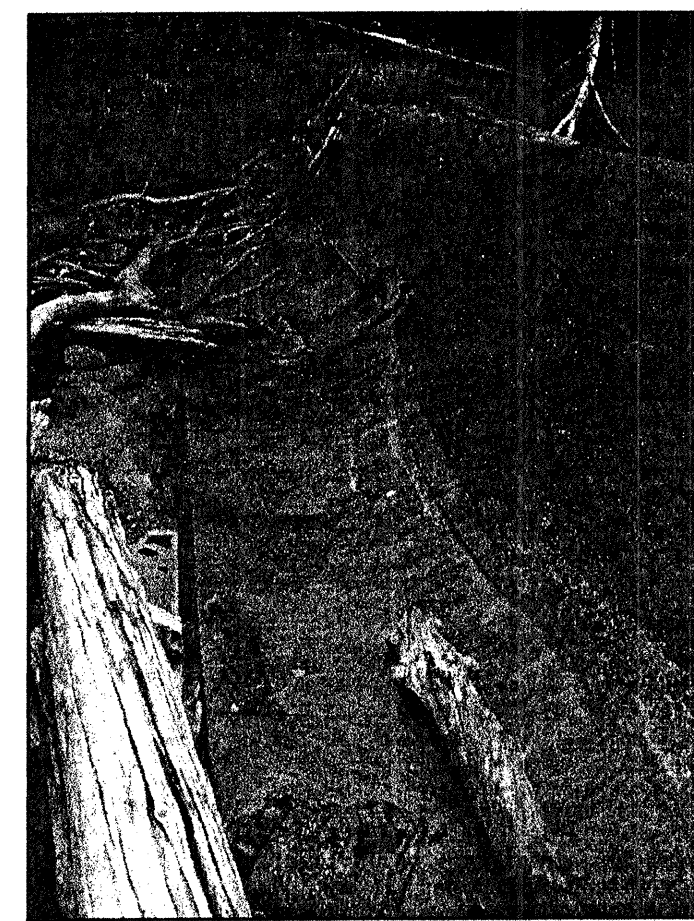
PHOTO #7

SEVERE
STRUCTURAL
CRACK

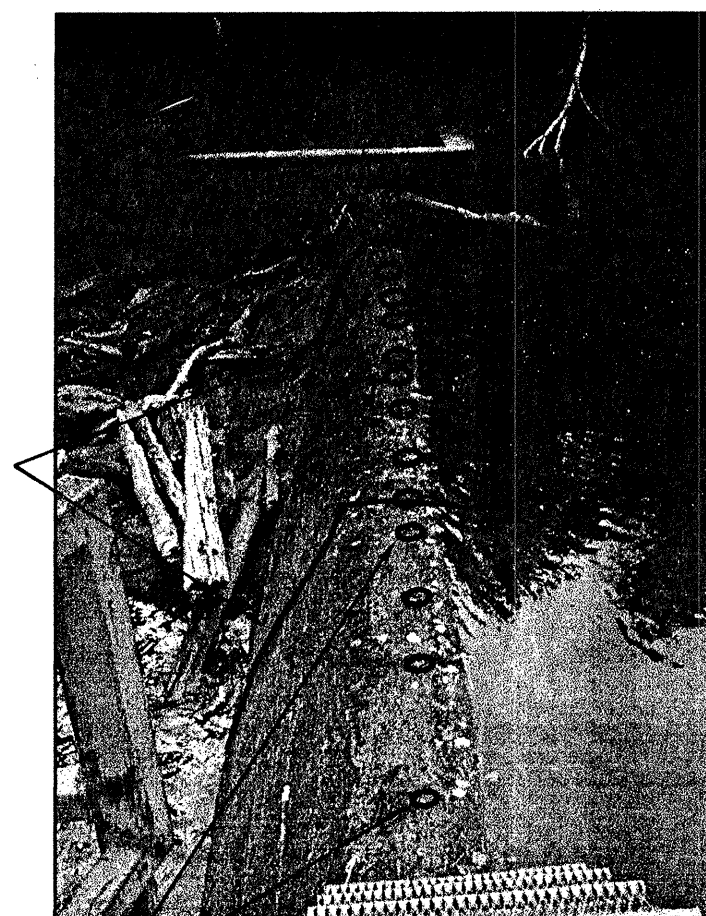
PHOTO #10

ABANDONED
POST HOLES FOR
FLASHBOARDS

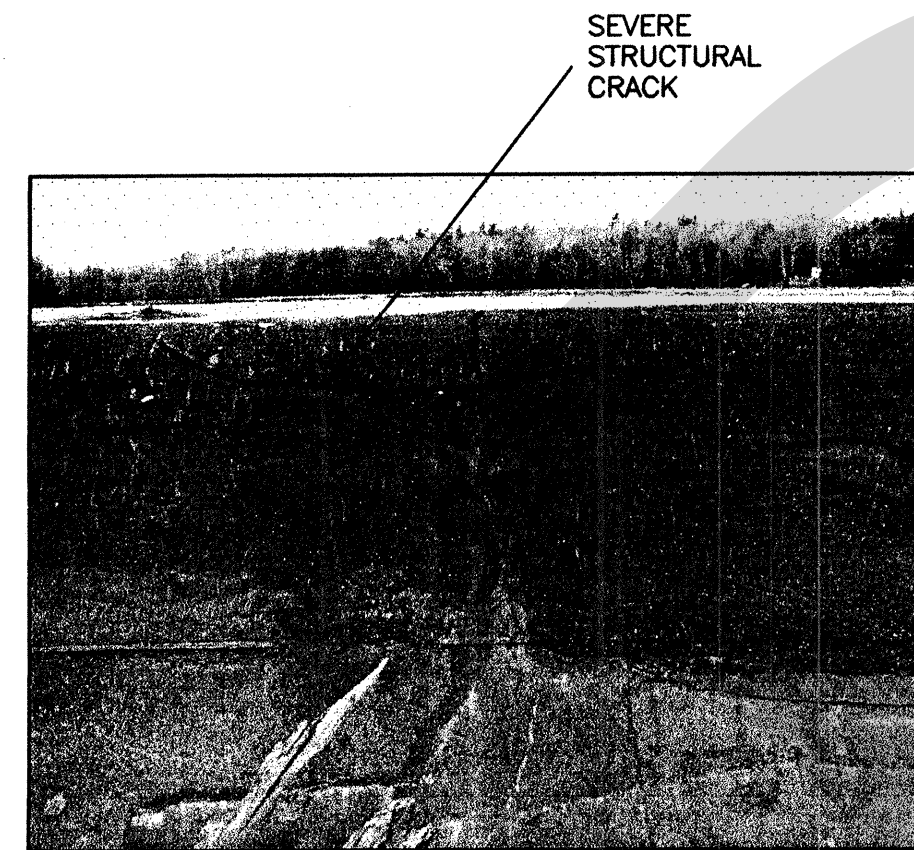
PHOTO #8

SEVERE
STRUCTURAL
CRACK

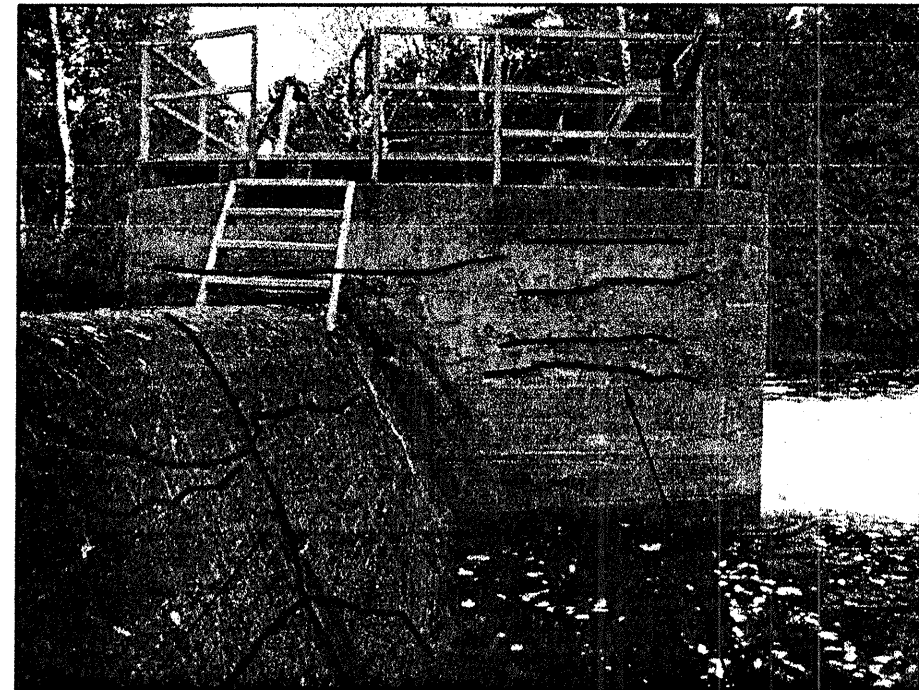
PHOTO #11
SEVERE STRUCTURAL CRACKS
COLD JOINT DETERIORATION

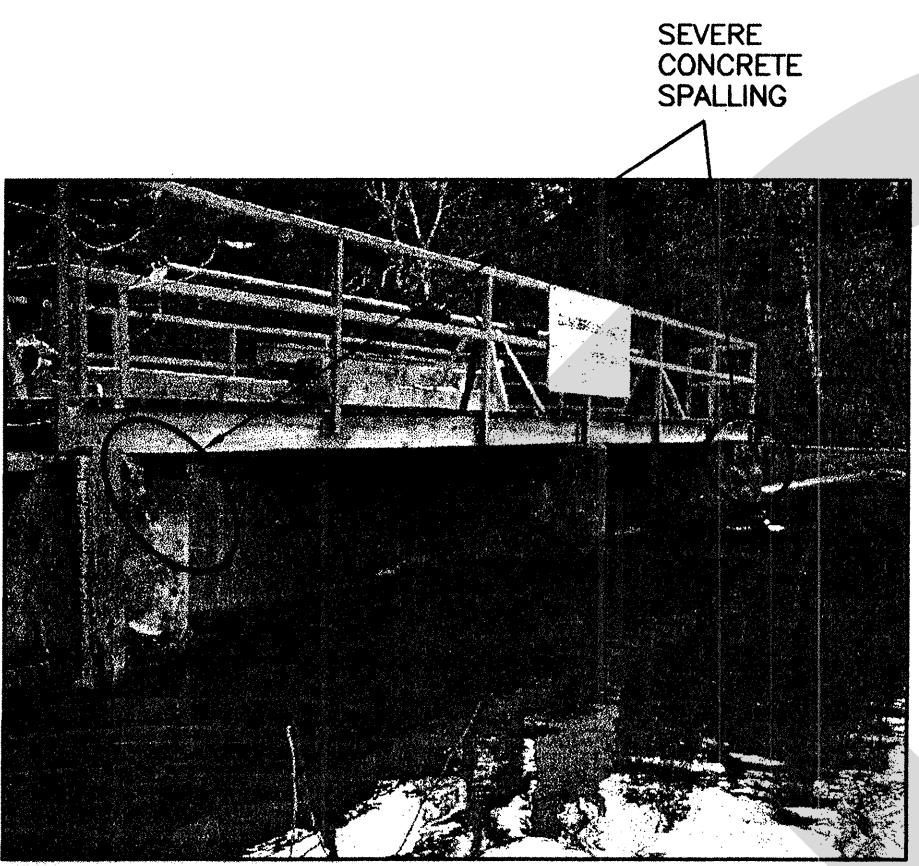
PHOTO #13
SEVERE CONCRETE SPALLING

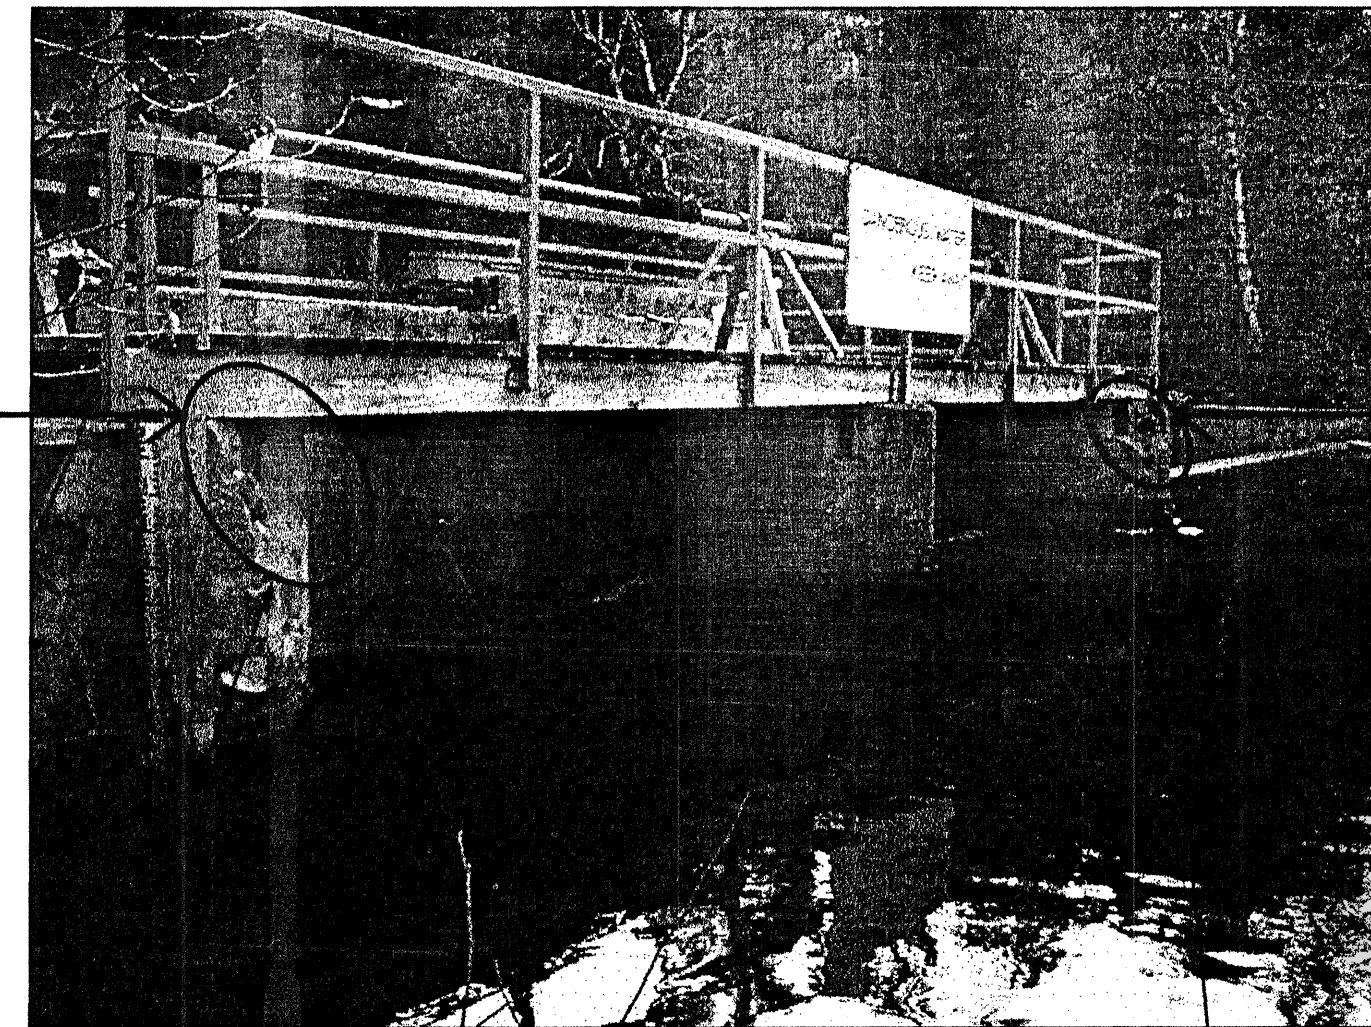
UPSTREAM NORTH PIER SEVERE CONCRETE SPALLING

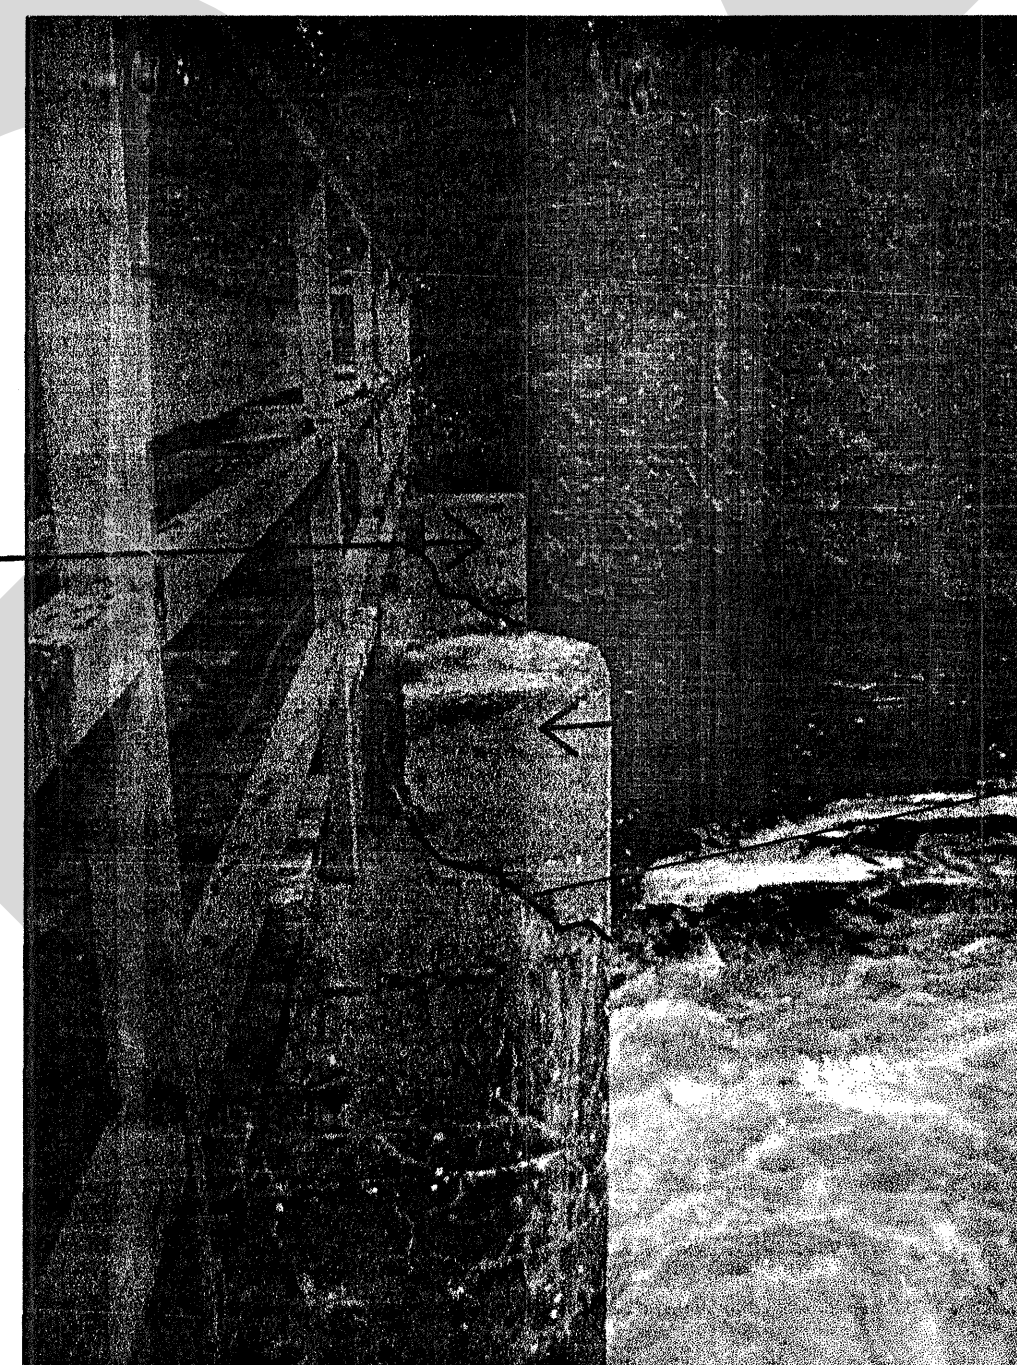
DOWNSTREAM NORTH PIER SEVERE STRUCTURAL CRACK

DOWNSTREAM CENTRE PIER SEVERE STRUCTURAL CRACK
