# GEOTECHNICAL INVESTIGATION AND DESIGN REPORT KASHWAKAMAK LAKE DAM REPLACEMENT, TOWNSHIP OF NORTH FRONTENAC, ONTARIO

Project No.: CCO-23-3603

Revision 2 – June 2024

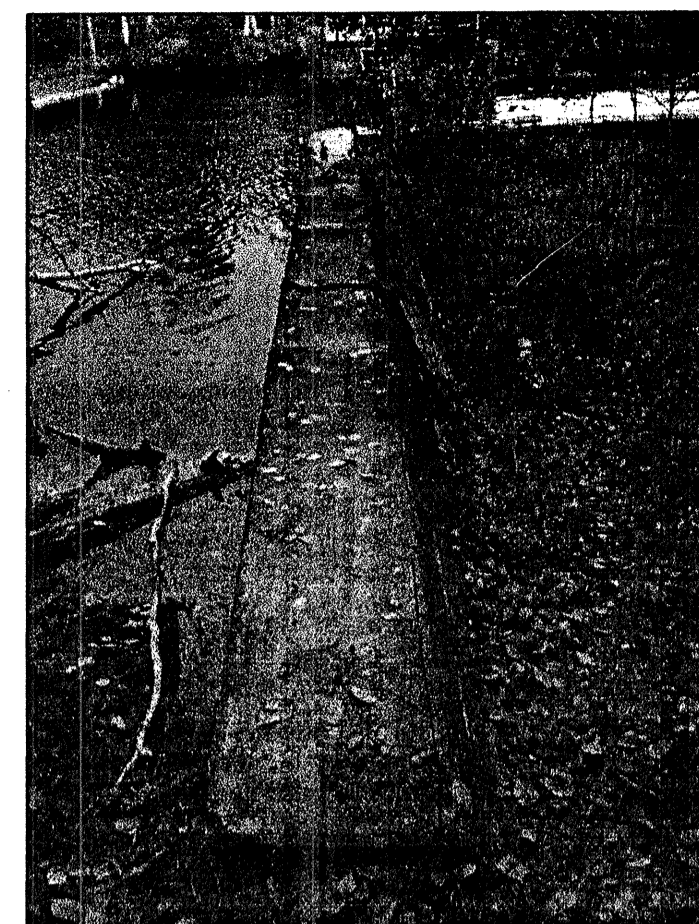
PHOTO #1

SEVERE STRUCTURAL CRACK

- LAYOUT & CONFIRM ALL CRACKS AND JOINTS TO BE REPAIRED.
- PRESSURE WASH.
- REMOVE LOOSE DELETERIOUS MATERIALS.
- SUFFICIENTLY GROUT CRACKS TO BE ABLE TO PRESSURE INJECT HILTI RM700 EP REPAIR MORTAR.
- CLEAN CONCRETE FACE OF SURPLUS REPAIR MATERIALS.

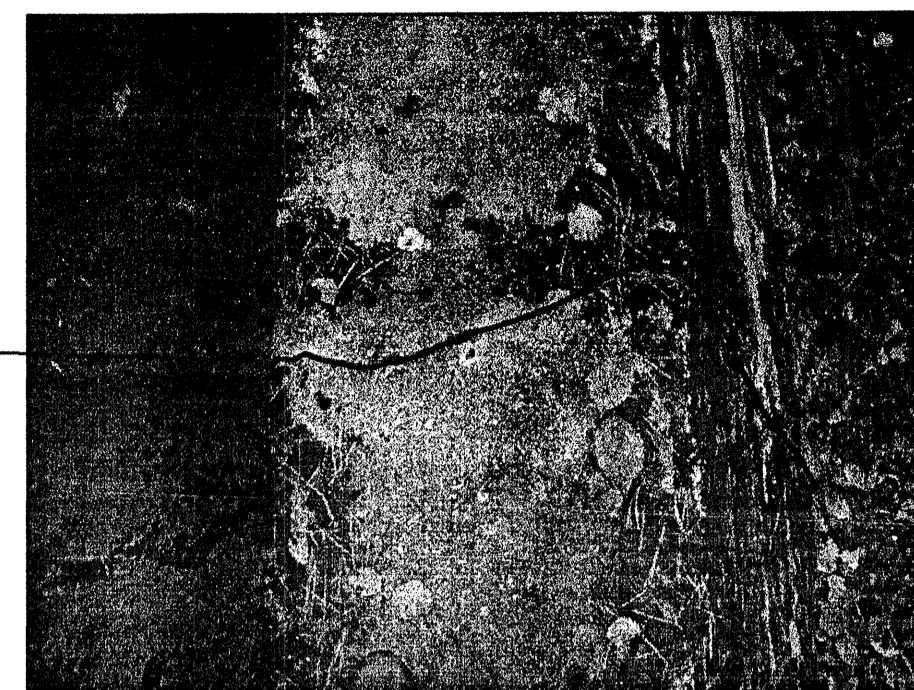
PHOTO #2

SEVERE STRUCTURAL CRACK

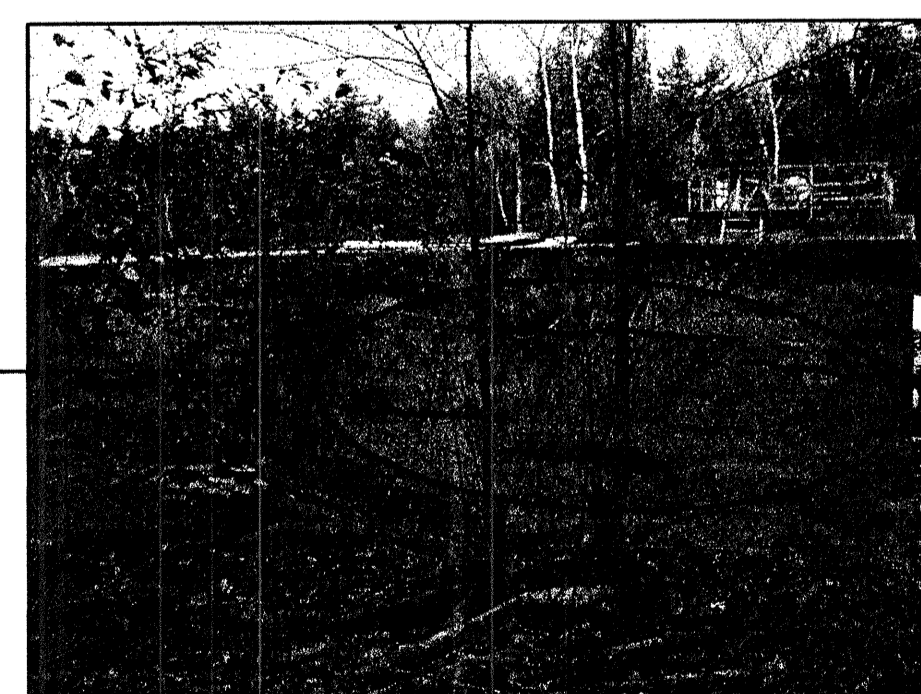
PHOTO #4

SEVERE STRUCTURAL CRACK

COLD JOINT DETERIORATION

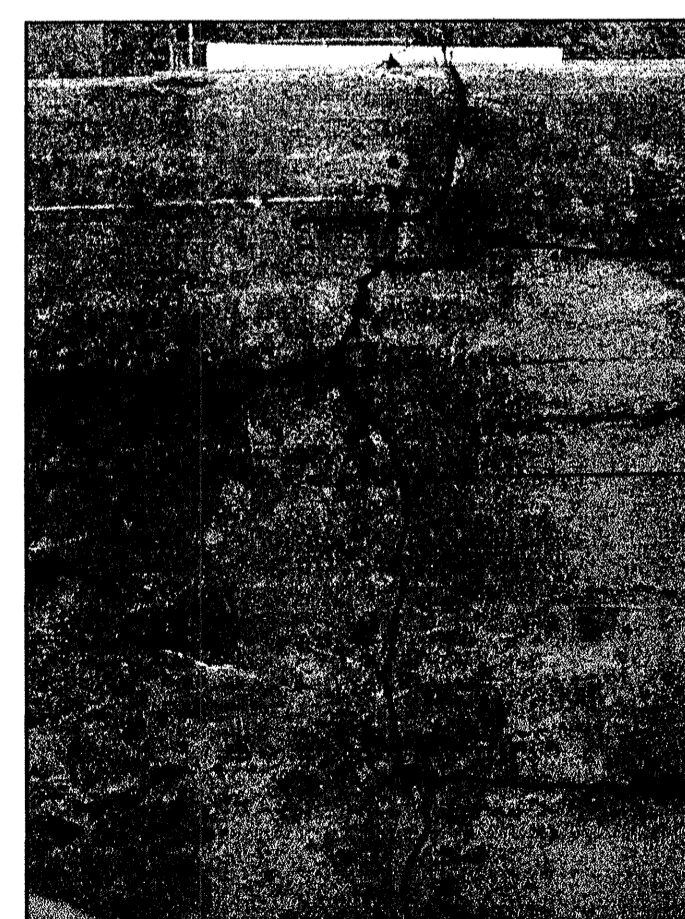
PHOTO #5

SEVERE STRUCTURAL CRACK

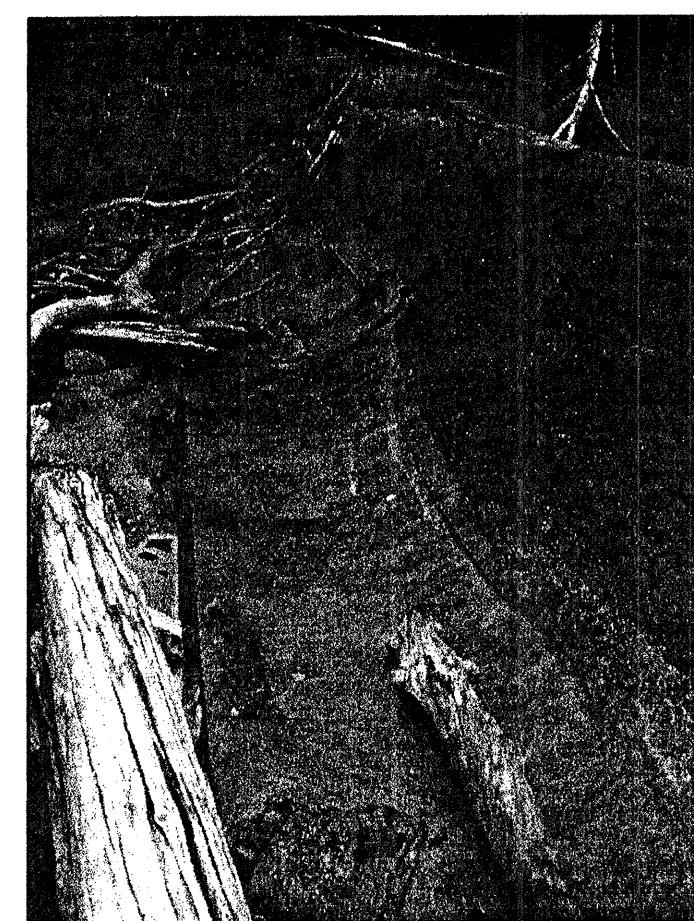
PHOTO #7

SEVERE STRUCTURAL CRACK

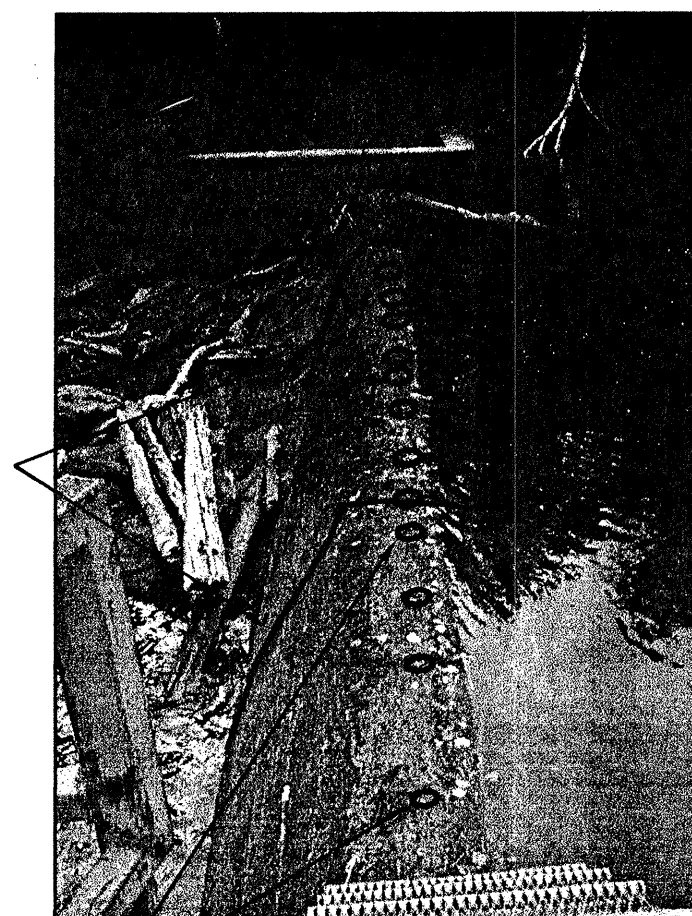
PHOTO #10

ABANDONED POST HOLES FOR FLASHBOARDS

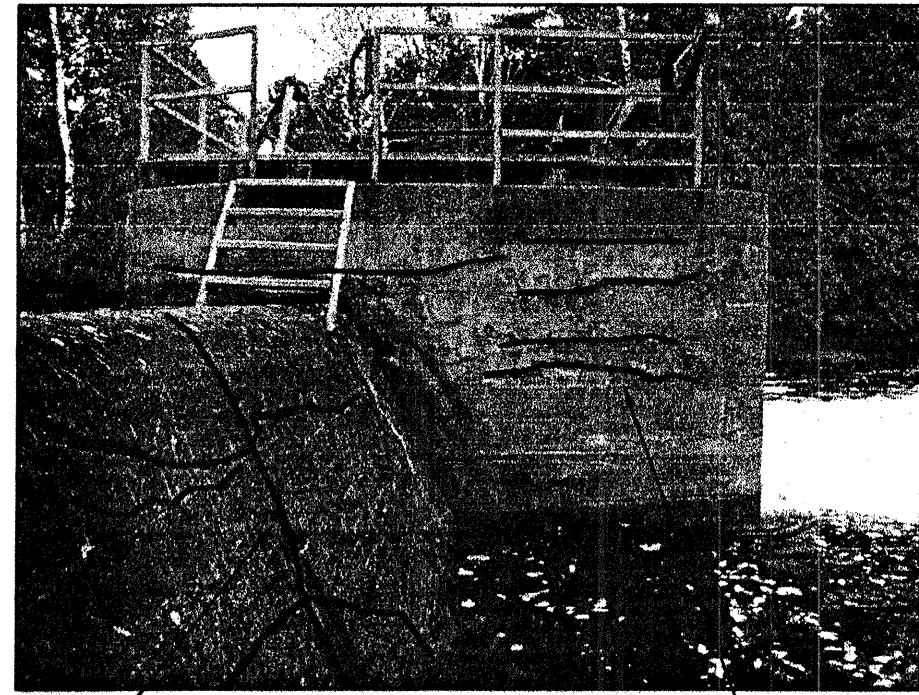
PHOTO #11  
SEVERE STRUCTURAL CRACKS  
COLD JOINT DETERIORATION

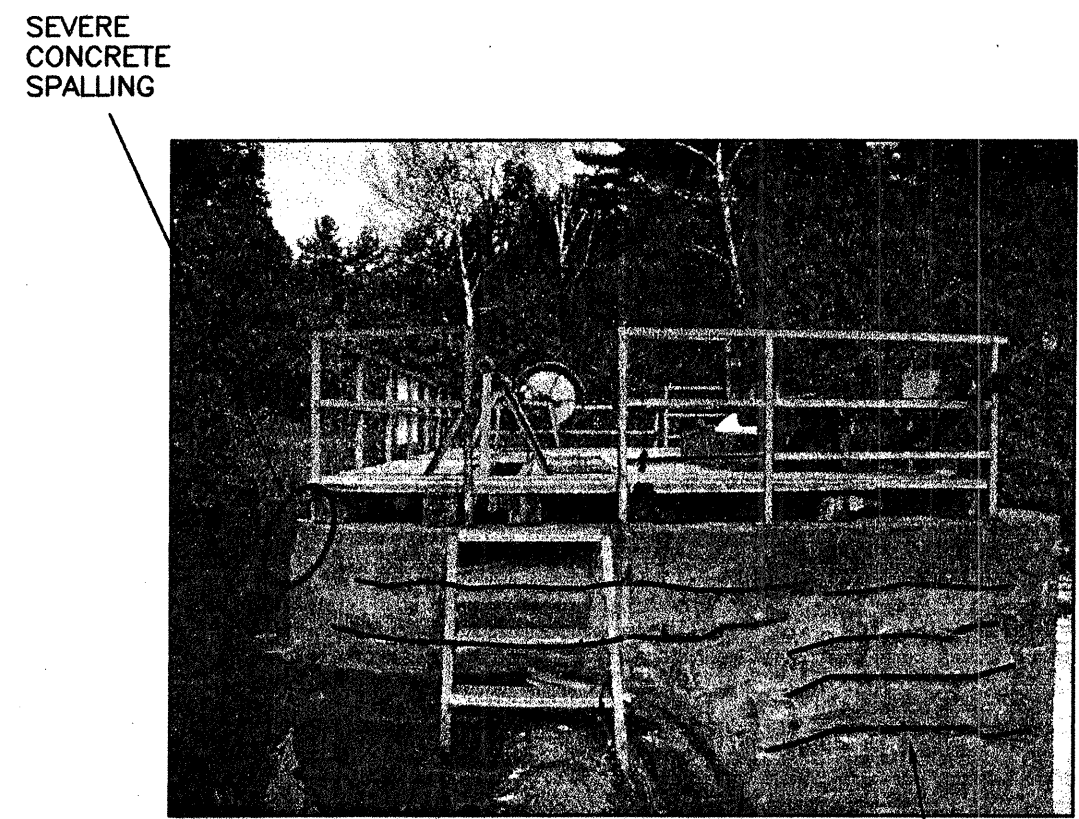
PHOTO #12  
SEVERE CONCRETE SPALLING  
COLD JOINT DETERIORATION

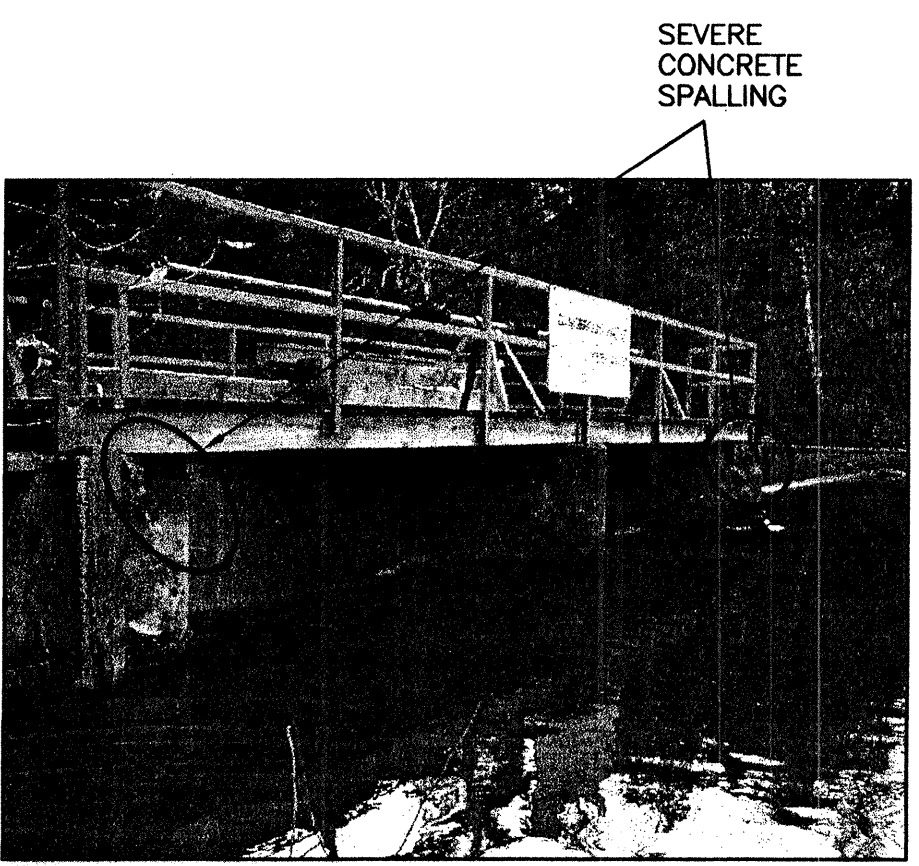
PHOTO #13  
SEVERE CONCRETE SPALLING

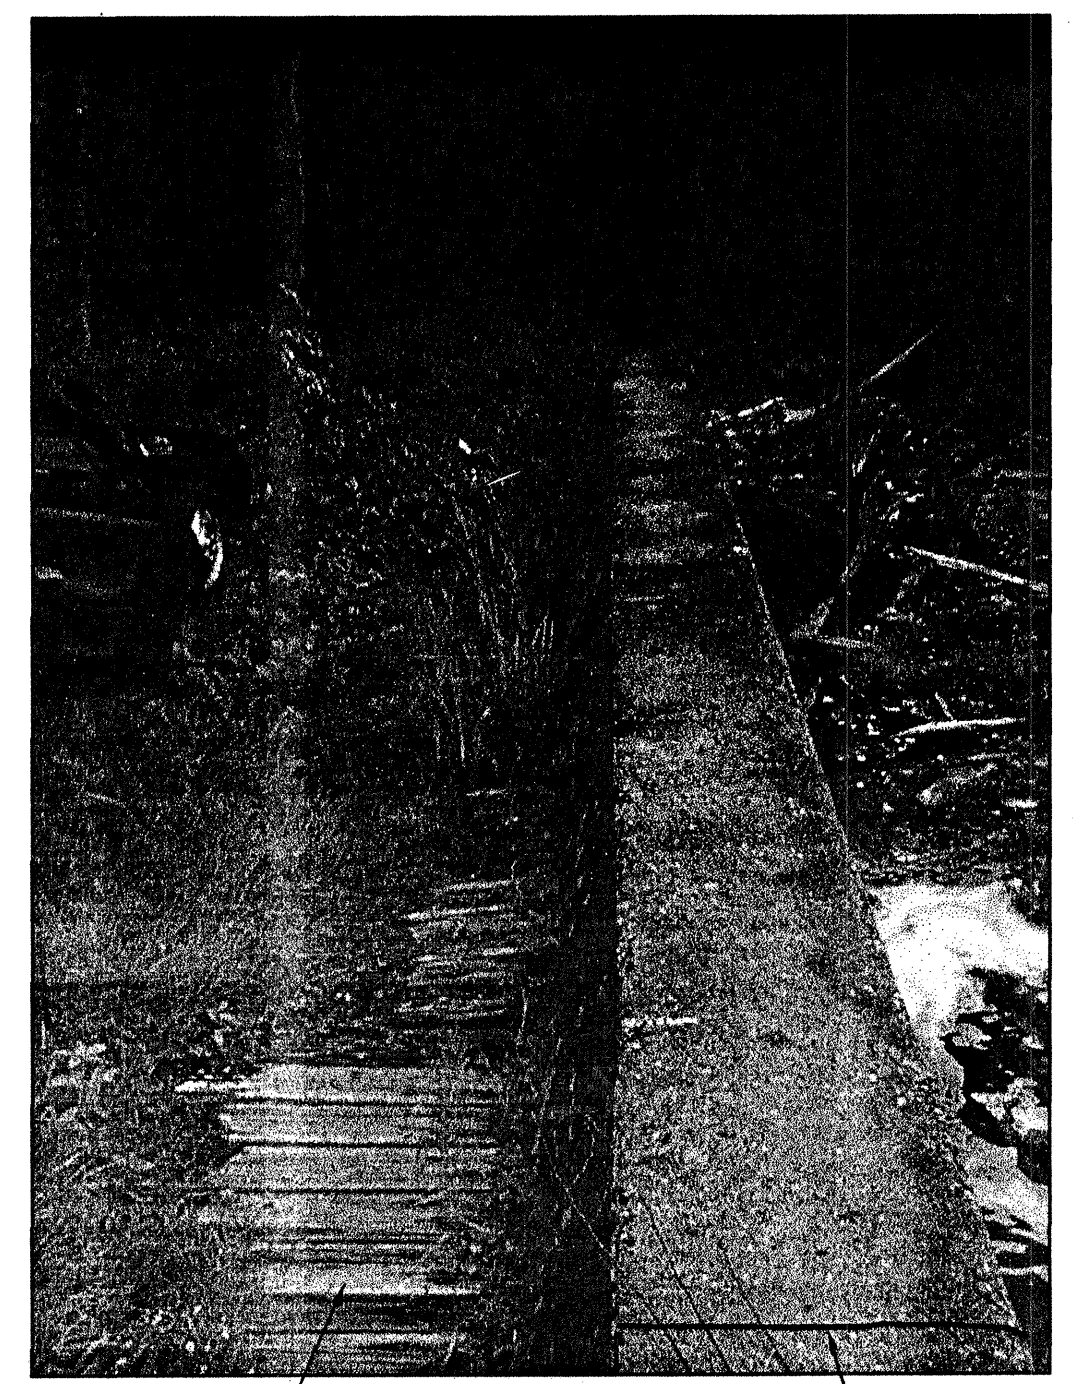
PHOTO #19  
WOOD PLANK WALKWAY OVER ROCK FILL/BEDROCK SEVERE STRUCTURAL CRACK

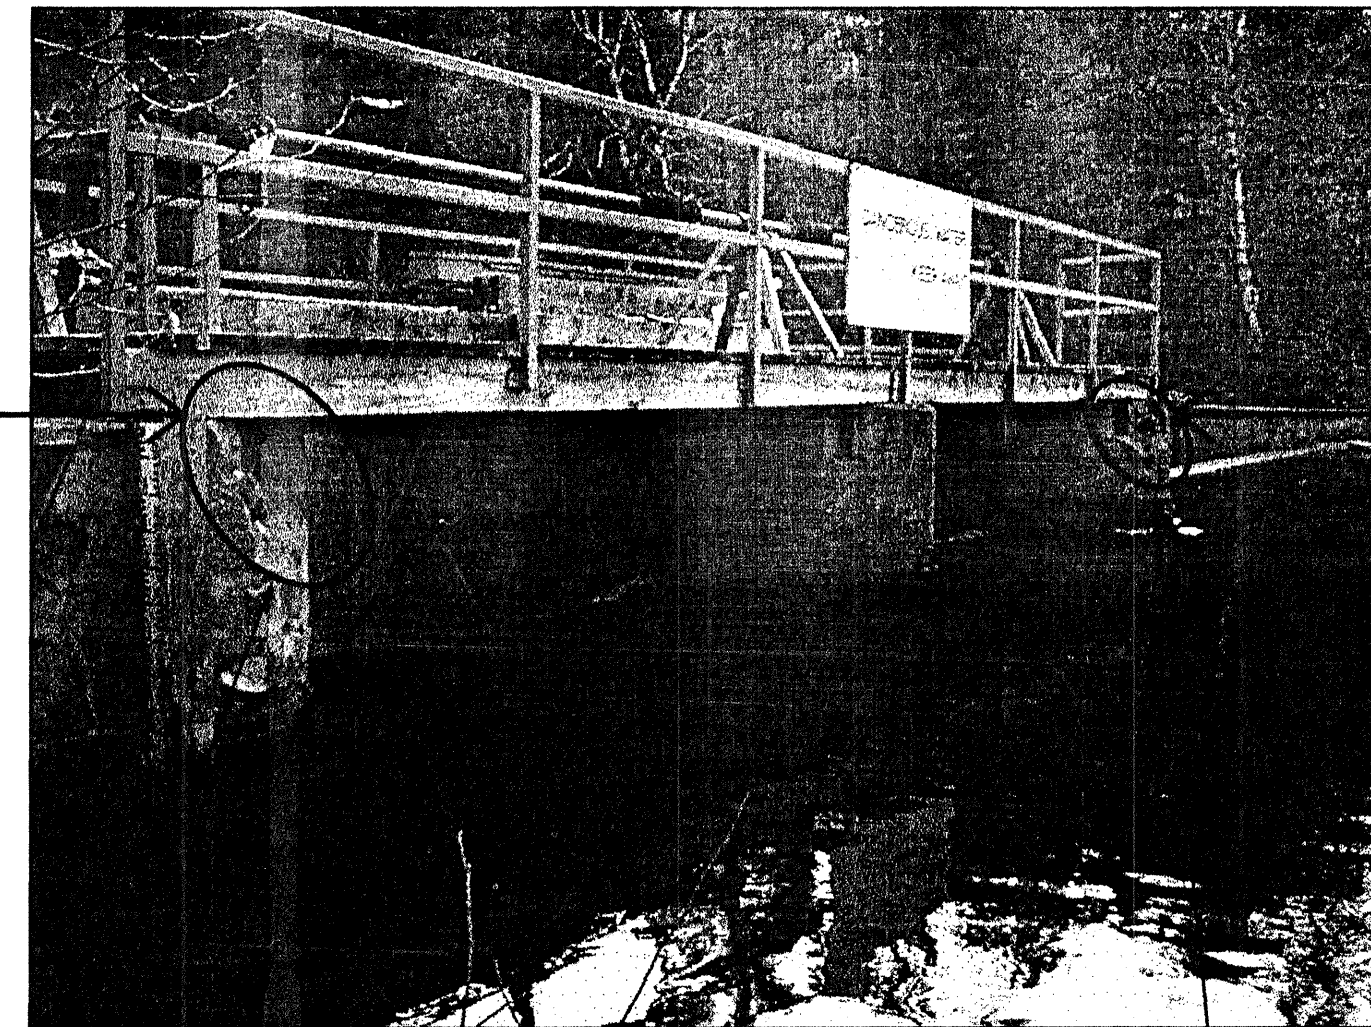
UPSTREAM NORTH PIER SEVERE CONCRETE SPALLING

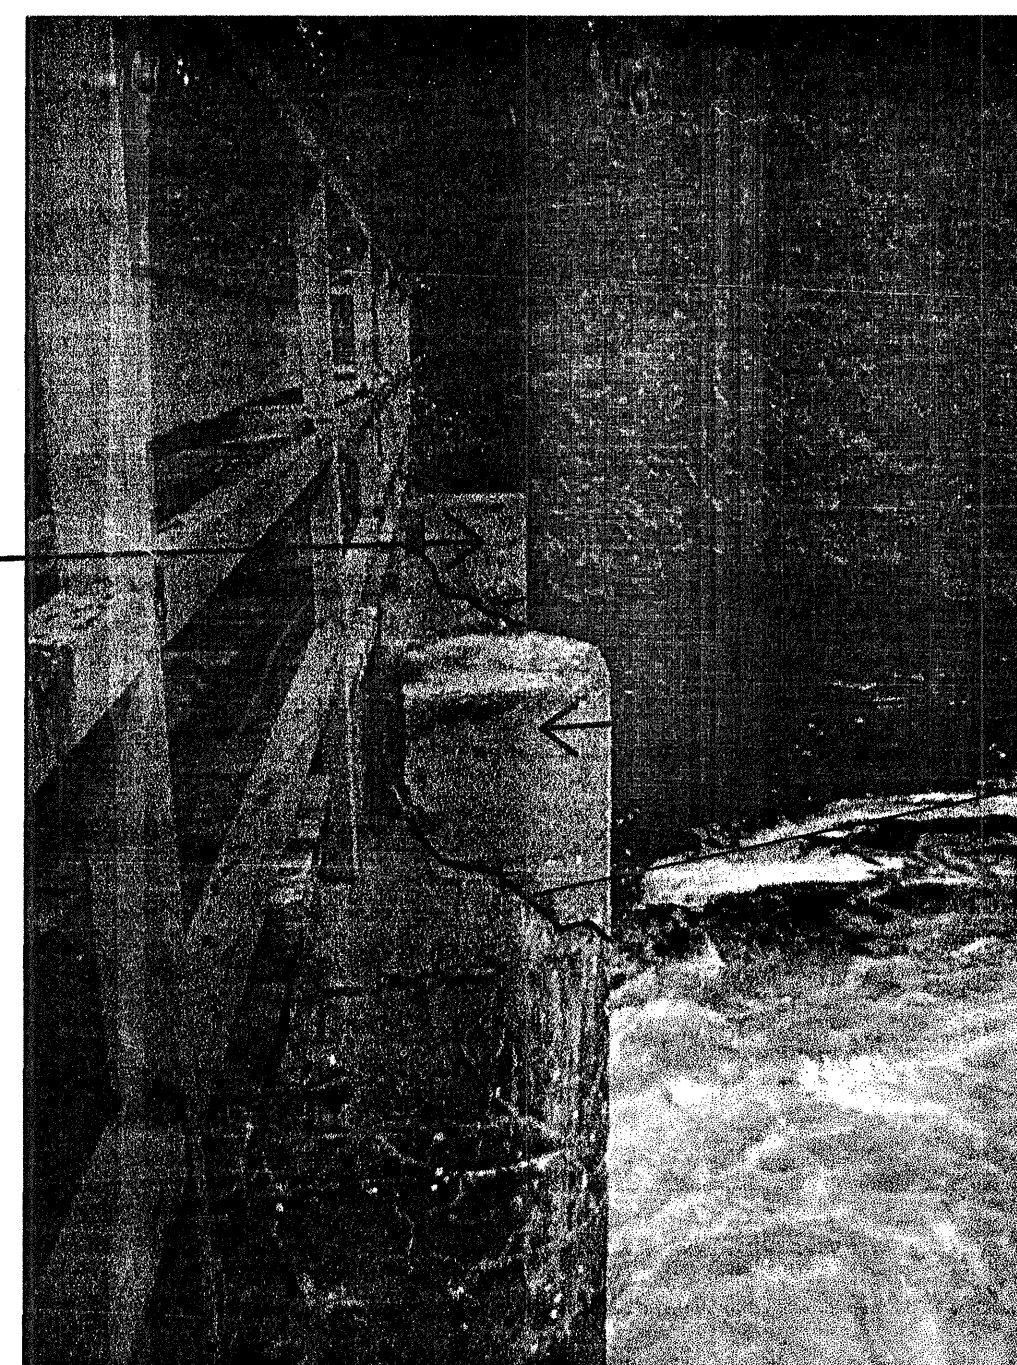
DOWNSTREAM NORTH PIER SEVERE STRUCTURAL CRACK
