# Corkery Creek 2015 Summary Report

## Monitoring Activity in the City of Ottawa

## Corkery Creek

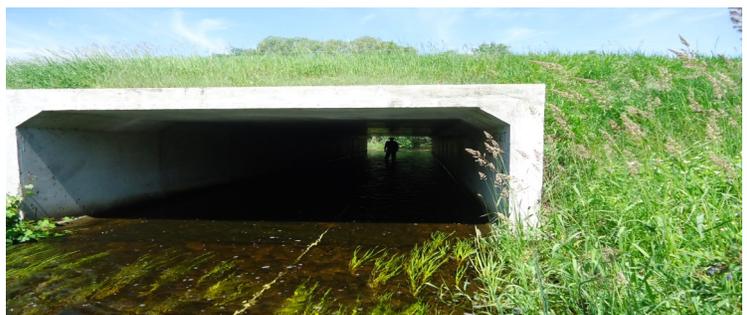
*A large culvert where Corkery Creek crosses Vaughn Side Rd.*

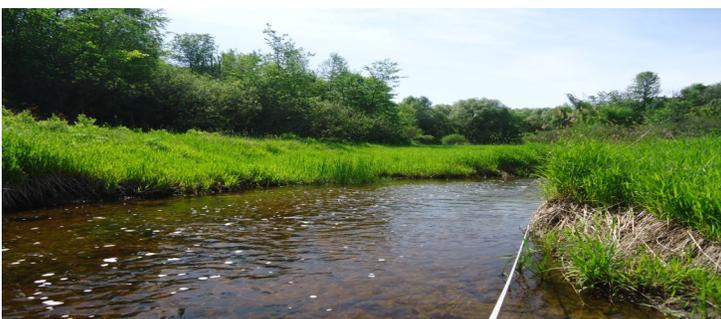
**Figure 9(a) and (b):** Overhanging trees and branches along Corkery Creek.

Changes in the amount of overhanging branches and trees along Corkery Creek can be seen in Figures 9(a) and (b). Overall, Corkery Creek has a measurable lack of overhanging trees and branches. In some areas this reflects the surrounding natural vegetation community, where the creek passes through sections of open wetland, and in some areas it reflects over-clearing of the vegetation too close to the creek. Those are the areas that would greatly benefit from planting.

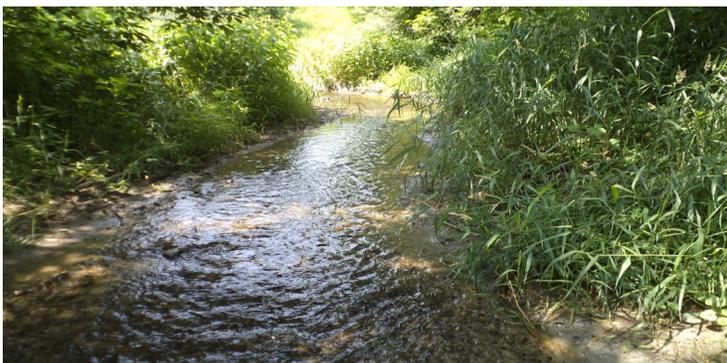
**Figure 11(a) and (b): Stream shading along Corkery Creek.**

Figure 11(a) and (b) show the variability in the amount of stream shading along different sections of Corkery Creek. There are pockets of well shaded areas near Diamondview Road and on either side of Vaughan Side Road. There are also large sections of the creek, namely south of Highway 417, that have little to no shading. This section represents an area where the creek passes through open wadeable wetland dominated by low growth vegetation that doesn't offer shade but offers other beneficial features.

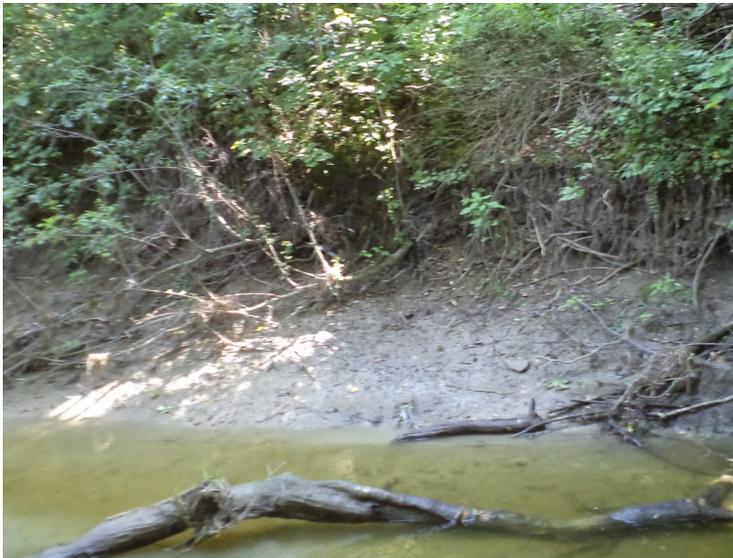
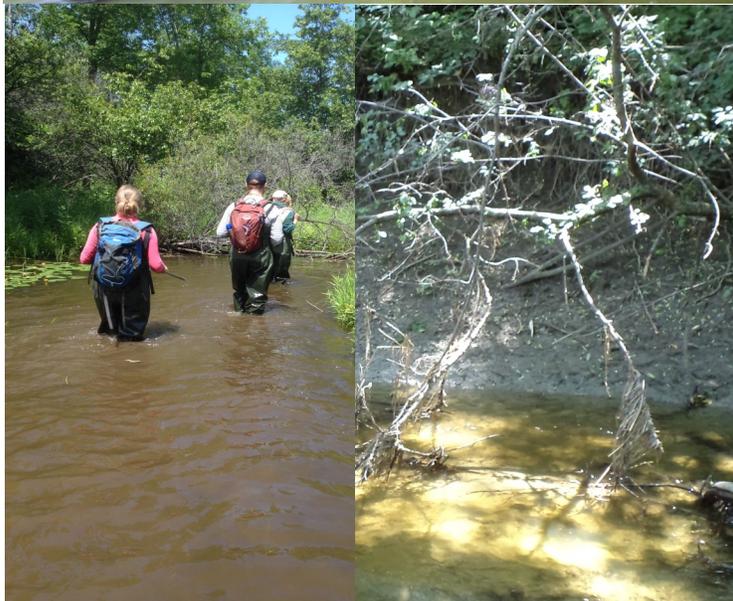
**Figure 20(a) and (b):** Potential areas for riparian restoration projects.

Naturally vegetated shorelines help reduce erosion, filter pollutants from entering the watercourse, assist in flood control and provide food and habitat for a diversity of wild-life. Figure 20(a) and (b) depict the locations identified by MVCA staff and volunteers, as areas for potential riparian restoration activities. We found intermittent areas that could be improved through riparian planting, erosion control, cattle access restriction and invasive species removal.

The next steps will be to approach the landowners and work with them on a voluntary basis to enhance their shorelines through a number of potential activities, such as increasing the unmowed areas along the shore or agreeing to plant and maintain native shoreline species of trees or shrubs.
