REPORT:

SPRING 2019 FLOOD of the MISSISSIPPI RIVER SYSTEM

Gord Mountenay
Water Management Supervisor
September, 2019

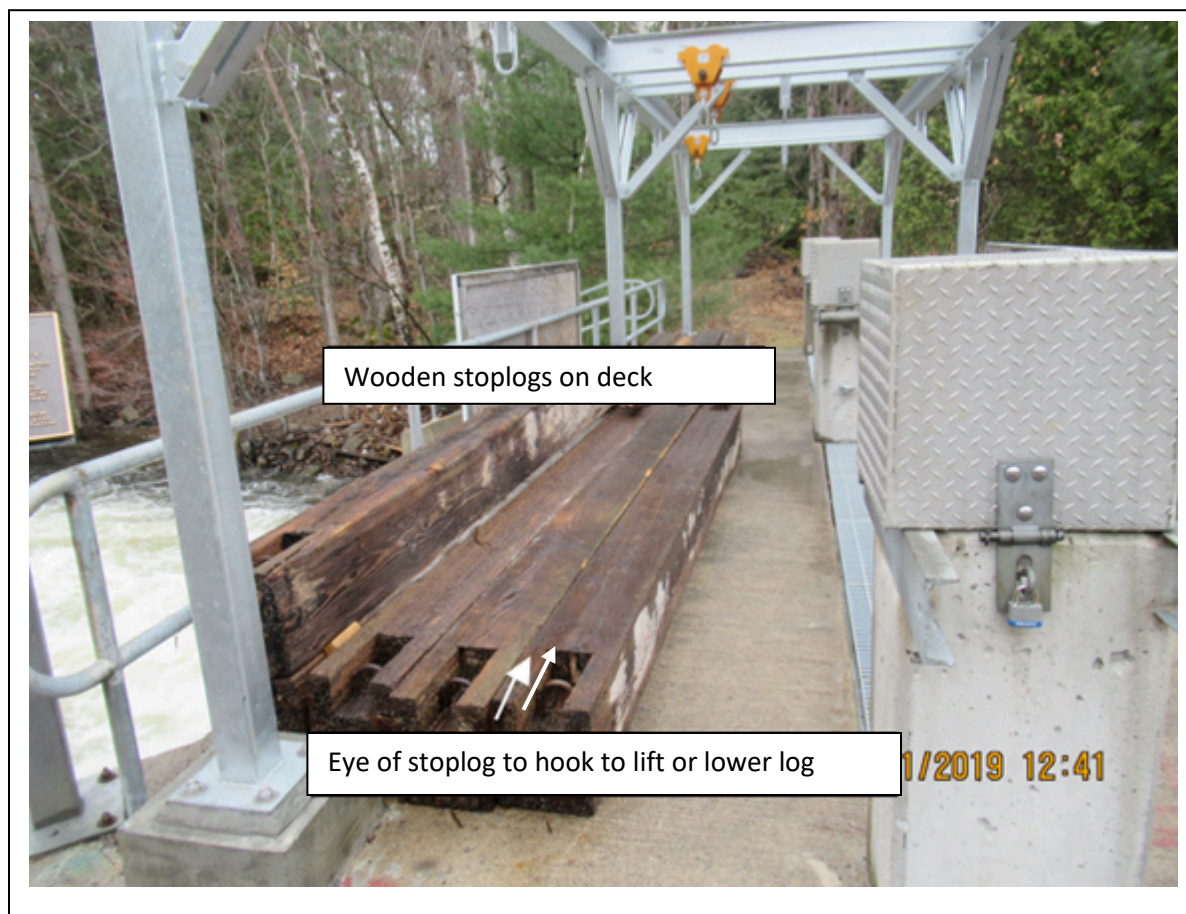
Photo 1 Stoplog description

All of the dams that are operable within the Mississippi river watershed have wooden stoplogs in them that are manipulated to raise and lower water levels.

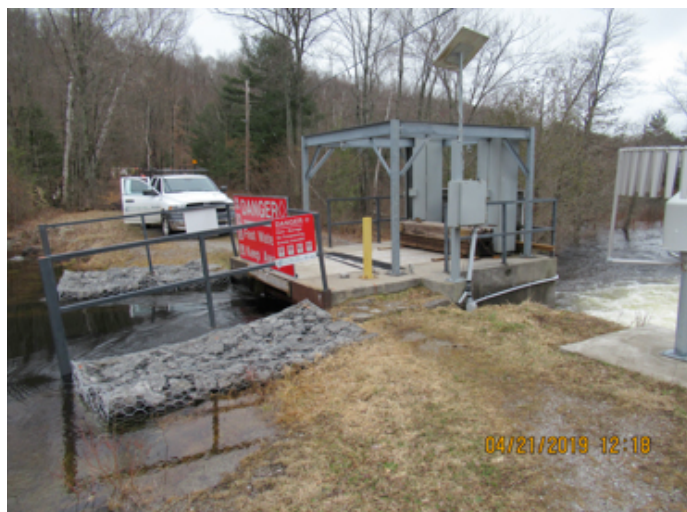
PHOTO 2 SHABOMEKA DAM

As flows began to recede, logs were replaced in the dam to maintain summer levels and assist in reducing downstream flooding. All logs were back in the dam by May 29th and water levels have been within the summer target range of 271.10 m to 270.90 m since April 26th.

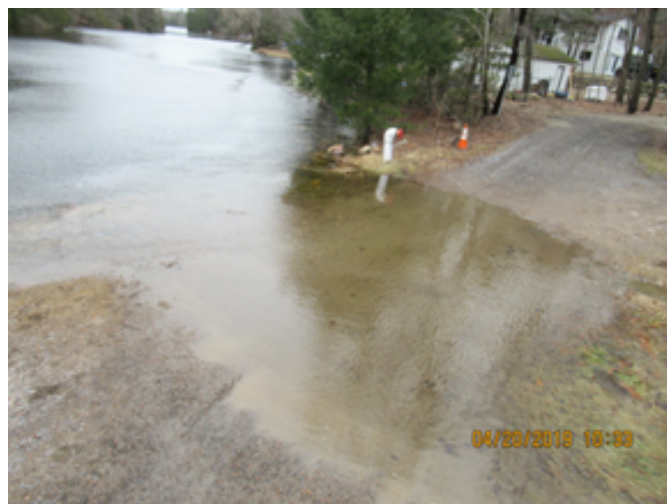
PHOTO 4 – MAZINAW LAKE DAM BYPASS APRIL 20

The lake peaked at 268.59 m on April 22. By the long weekend in May, levels had returned to within the target range although not all of the logs have been replaced in the dam. MVCA staff inspected the dam shortly after the peak and also had a consultant inspect the structure to ensure that the erosion which

occurred at the dam did not affect the stability of the dam to replace the stoplogs to maintain summer levels. It is expected that the erosion will be repaired by the end of August, 2019.

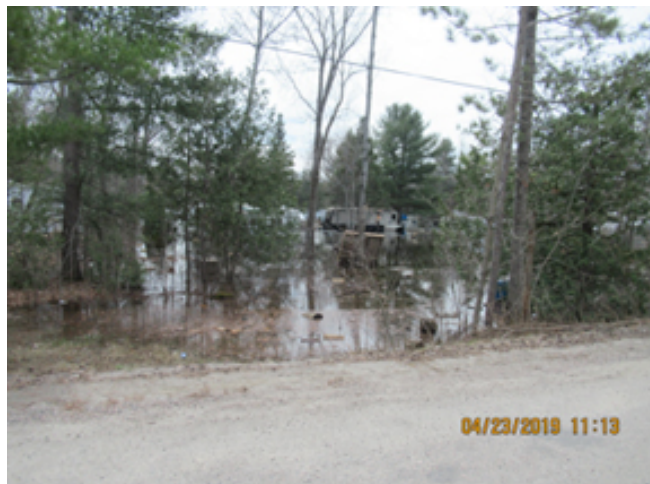
The outflows from Mazinaw Lake at its peak exceeded the top of the staff gauge by a considerable amount, estimated at approximately 0.80 m. Although there is very little documentation of levels on this lake, those observed in 2019 are believed to be the highest since 1992 when MVCA took over the ownership and operation of the dam and the new structure was completed.

Photo 10 – Little Marble Lake flooding April 23

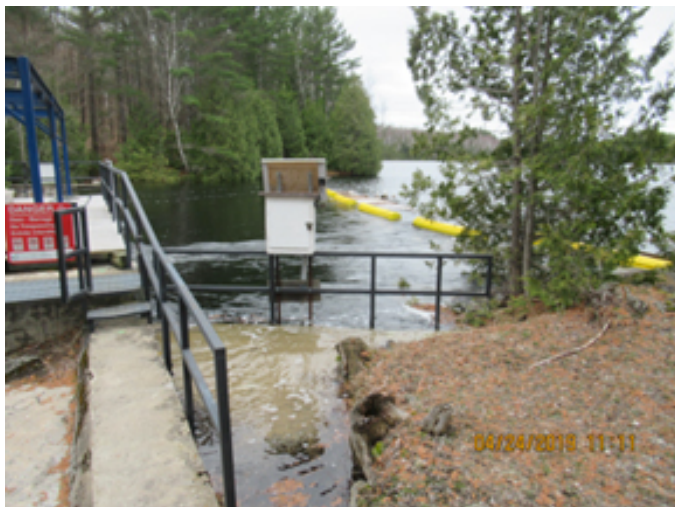
Photo 12 - Kashwakamak Lake Dam

As severe flooding began occurring both upstream and downstream of this structure, no opportunity existed for further log operations to mitigate downstream flooding. By April 23, levels had increased on the lake to 261.40 m and were still building from increased outflows out of Mazinaw Lake. Despite downstream conditions, it was deemed necessary to remove a log from the dam to try to slow down the rate of rise on the lake. Only one log was taken out to minimize the impact of increased flows downstream (to Farm Lake, the village of Ardoch and on Crotch Lake which was still building quickly). The 2nd log that had been replaced on the 15th was pulled the next day as levels continued to increase, now sitting at 261.48 m (roughly 25 cm over the summer target level). No further logs were removed from the dam and the lake peaked at 261.50 m on April 26, surpassing the previous high of 261.42 m in June 2002.

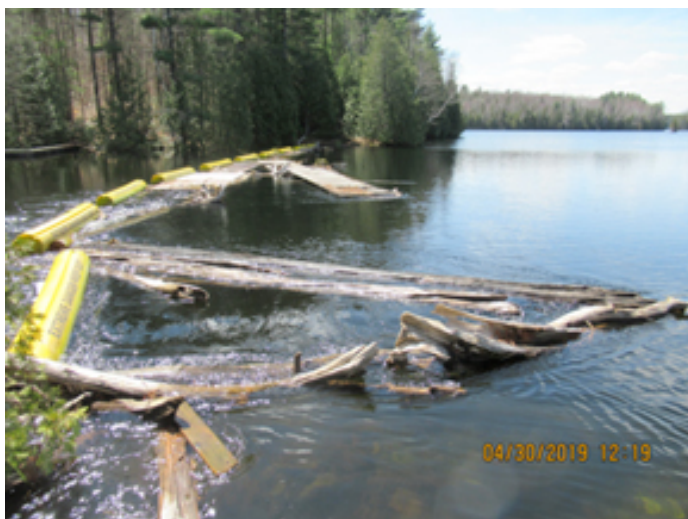
Photo 14 – Debris caught in Kashwakamak Lake Boom

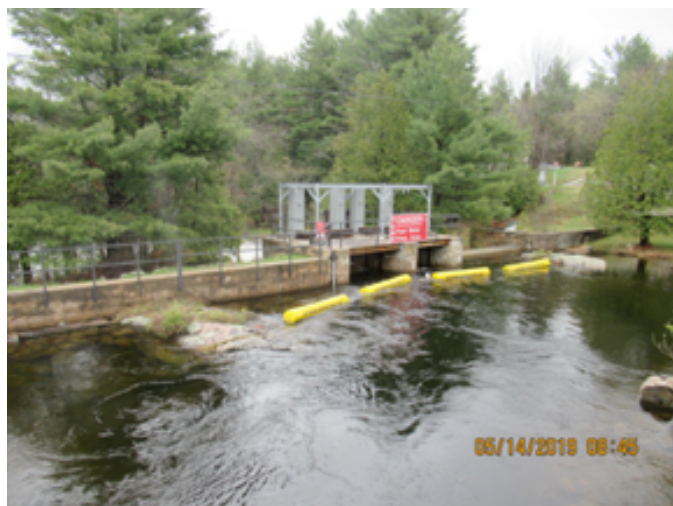
Photo 16 - Big Gull Lake Dam

As this is a headwater lake with very little inflow, it is critical to close off the dam as quickly as possible to maintain summer levels. As soon as levels approached the upper limits of the summer target operating range, logs began to be replaced. Due to a significant amount of debris getting caught in the logs as they were being replaced, one bay in the dam was stripped on 2 separate occasions before a good seal was achieved with minimal seepage. Water levels reached the summer operating range on May 23rd and all of the stoplogs were finally replaced in the dam on June 1st.

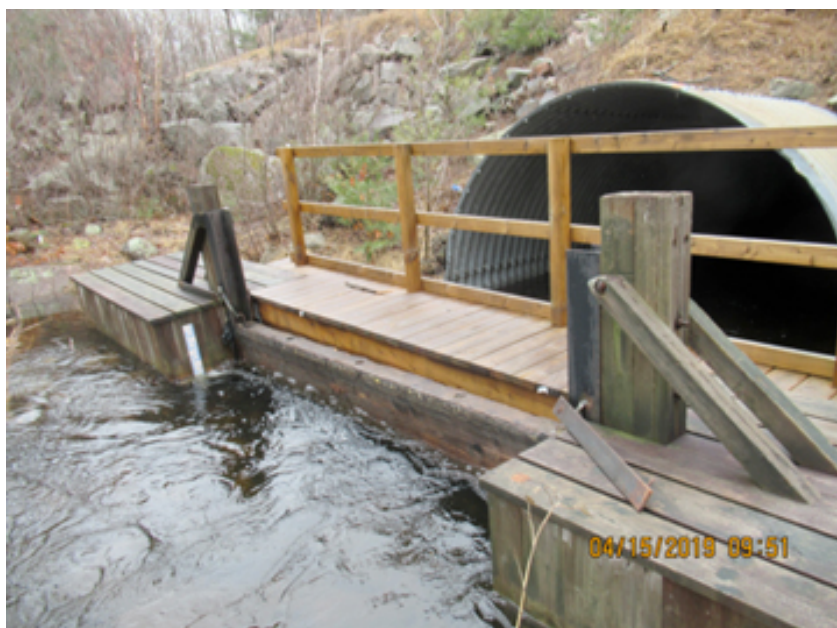
Photo 18 - Pine Lake Dam

Pine Lake dam is owned and operated by MVCA. It is a rock filled timber crib structure with a single control section containing three 0.20 x 0.20 x 3.35 m (8" x 8" x 11'-0") stoplogs in the bay. The stoplogs are bolted together and act as one log. The total drainage area above the dam is 15.3 sq. km. The primary purpose of this structure is to maintain summer water levels for tourism and recreation. There is a significant walleye fishery on the lake. The dam is drawn down in the fall occurs around September 15 to clean of the spawning beds prior to freeze up.

The logs are not put back in until the spring peak is over and levels begin to recede. This structure has historically been prone to vandalism. Water levels on Pine Lake were extremely high despite no logs in the dam. Since water levels are only obtained off a staff gauge (instantaneous reading) on a weekly basis, it is impossible to ascertain if this year's level reached or exceeded the highest ever on the lake but it matched (or was extremely close) those recorded in 1998, 2002, and 2017 at 255.25 m. An automated gauge collecting hourly data was installed at the dam in 2019.

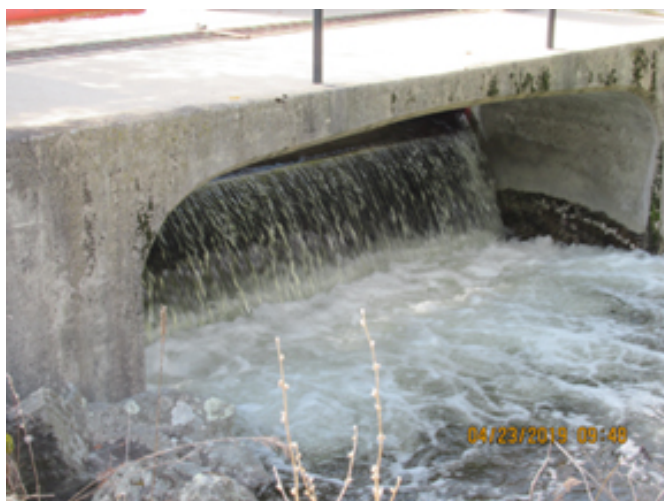
Photo 20 - Malcolm Lake Dam

Malcolm Lake Dam is owned by the Ontario Ministry of Natural Resources and Forestry in Bancroft and has been operated by MVCA since 1986. The dam is a concrete structure with a single control section containing three 0.20 x 0.30 x 4.27 m (10" x 12" x 14'-0") stoplogs. It has a 30 m overflow weir at an elevation of 253.06 m. The dam has a drainage area of 18.7 sq.km.

The dam is operated as a weir year round and only in very dry summers is a wedge placed between the top two of three stoplogs to maintain some flow in the creek when levels drop below the top of the weir. The highest observed level in 2019 was on April 23rd, lake level was 253.22 m. Water levels have historically only been collected on a weekly basis at this location but an automated gauge was installed on the dam in 2019 to collect hourly water level data. There were no issues with this structure in 2019.

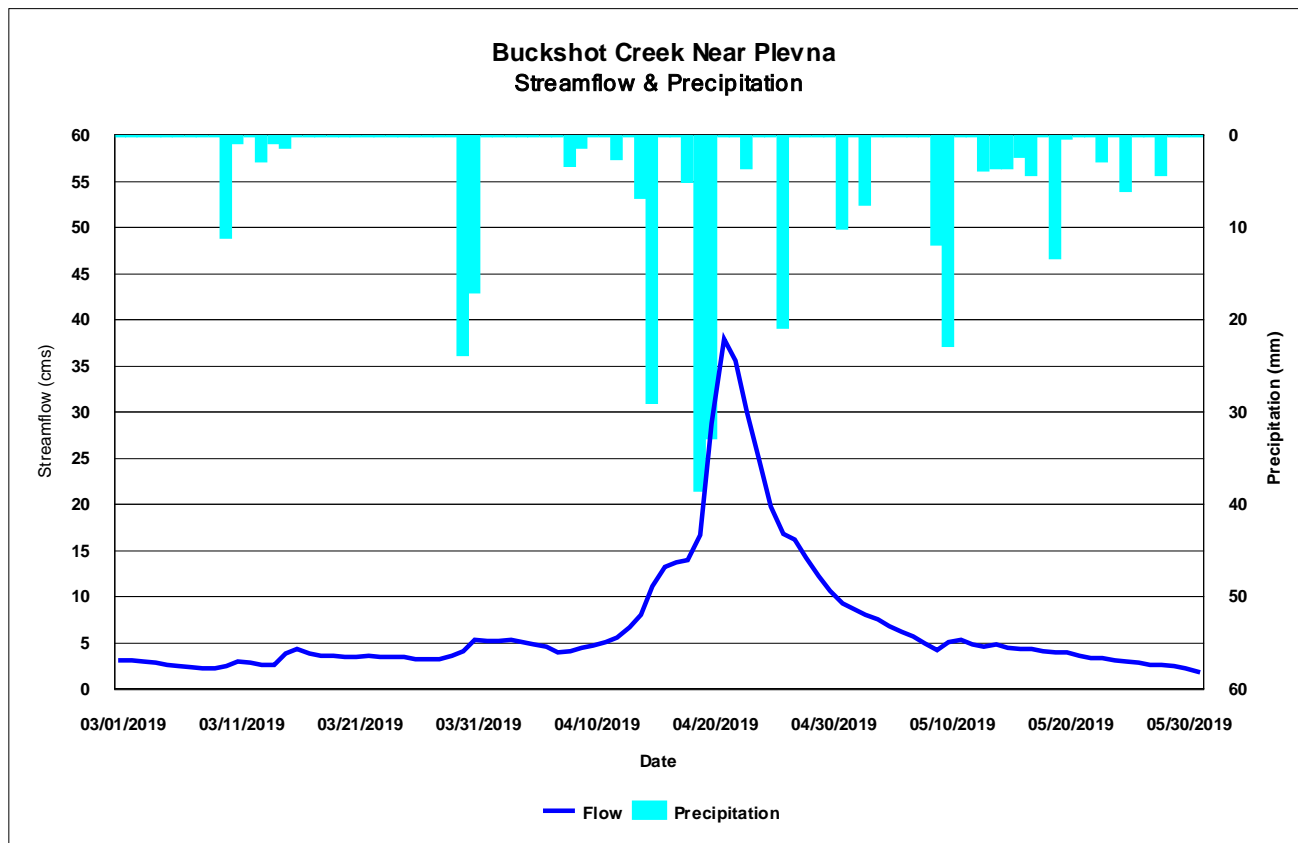
Figure 1 – Buckshot Creek stream gauge

Located on Buckshot Creek downstream of the Village of Plevna, this gauge measures the predominantly uncontrolled flows of the Buckshot Creek watershed. The gauging equipment is similar to the equipment in the Myers Cave gauging station. This gauge was installed in 1992 and operational in 1993 as a seasonal gauge. In 1996 it was changed to a year round station. The previous record peak flow was established in April 1998 at 32.5 cms. The peak flow recorded in 2019 was 38.9 cms however, the flow was likely higher than that because the road immediately downstream of the gauge was overtopped making the control for the gauge under those conditions questionable.

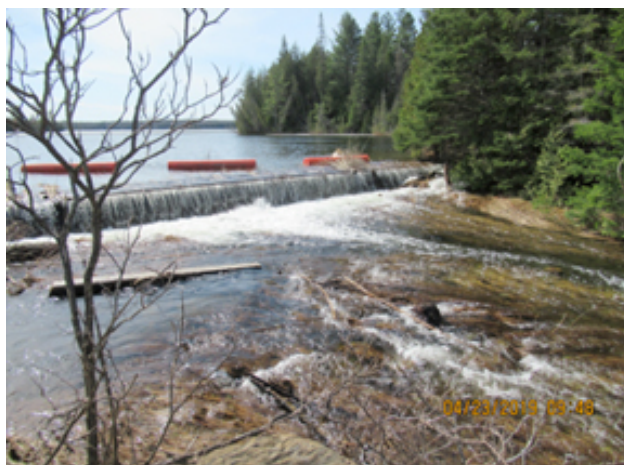
Photo 22 – Mississagagon Lake Dam

Levels steadily climbed through April but no log operations were done until after the system downstream had peaked. By April 30, the lake had reached 268.50 m and two logs were pulled from the dam to stabilize levels. On May 13, 2 additional logs were pulled in an effort to get levels back within the target range. The previous high water mark for this lake was reached in June 2002 and again in May 2017, reaching an elevation of 268.42 m.

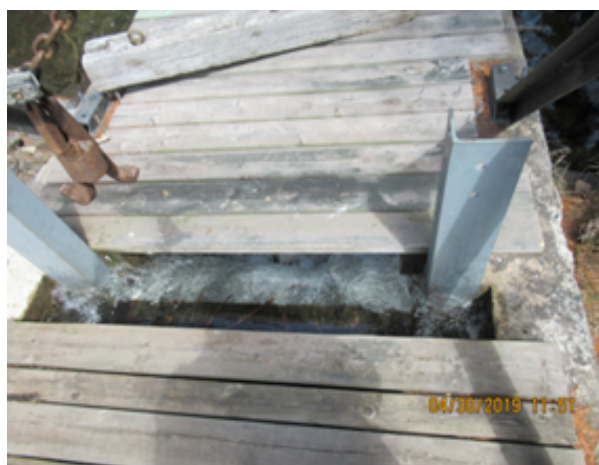
Photo 23 - Deck of Dam almost underwater

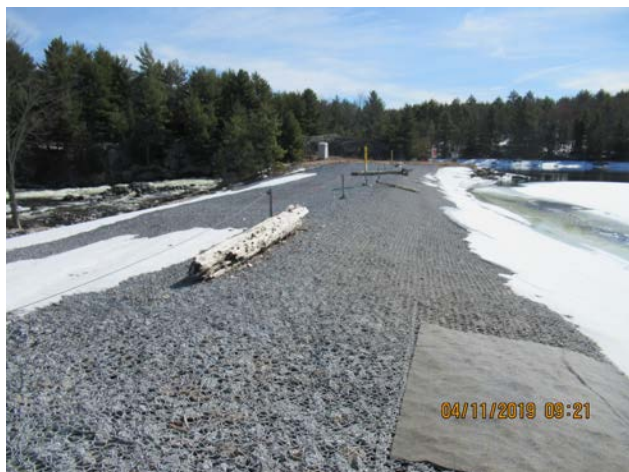
Photo 24 – Crotch Lake Dam Weir April 11

Between the 1st and 11th of April, 2 logs were replaced and levels had steadily climbed to 238.24 m (summer target is the top of the weir, 240.00 m). Moderate flood levels had been reached on Dalhousie Lake and flows in the downstream tributaries were increasing but were all still below the average spring peak flow conditions. The weather forecasts on the 12th, 13, and 14th of April all indicated 20-25 mm of rainfall on April 14 and no additional rainfall in the 5 day forecast.

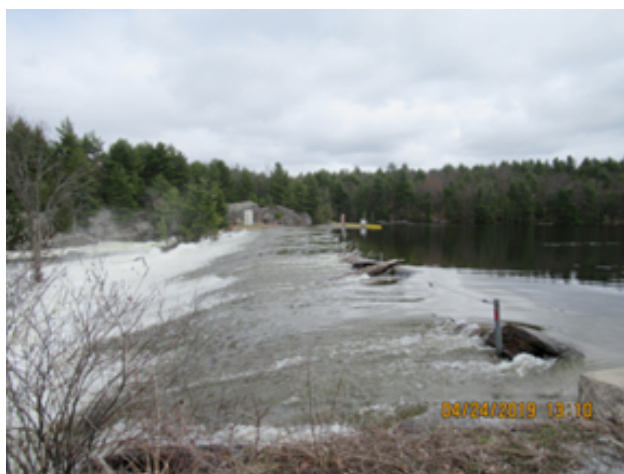
Photo 26 – Crotch Lake Dam Weir April 24

With Dalhousie Lake already at flood stage, no additional logs were removed from the dam either and at this point the upper system for all intents and purposes, became an unregulated system. Between April 21st and April 26th from 239.83 m to 240.37 m. The lake peaked on the 26th and as the dams in the upper watershed began to be operated, inflows into the lake dropped. As levels approached the summer

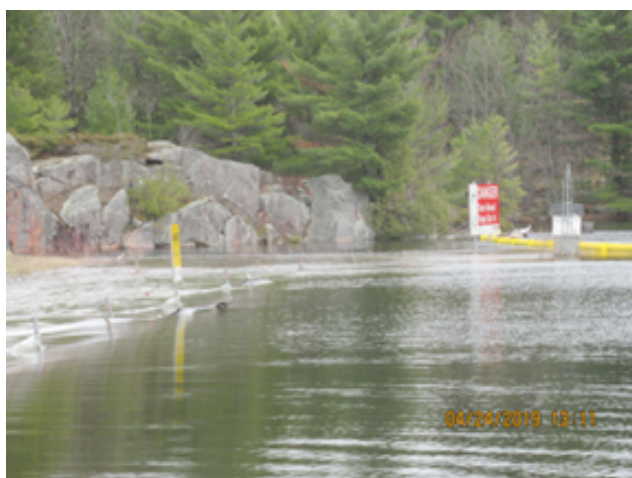
Photo 27 – Crotch Lake Dam April 24
Level 240.43 m

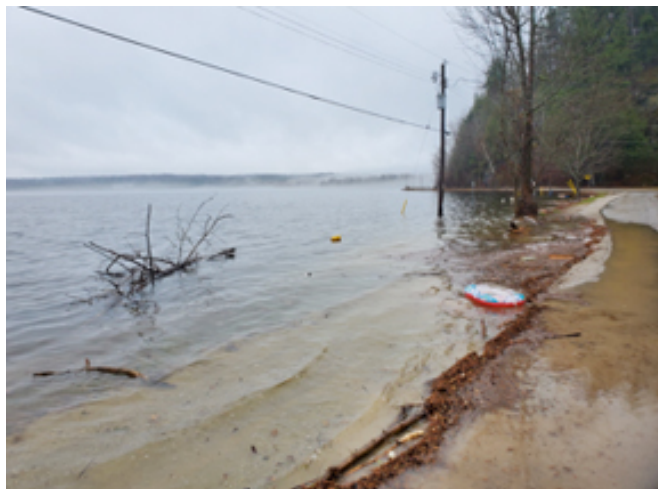
Numerous dwelling were flooded and the water level at the inlet and outlet of the lake was just below the girders of the highway bridges. The road at the beach at the upper end of the lake had 2 or 3 cm of water overtop of it.

Photo 33 Flooded beach Dalhousie Lake

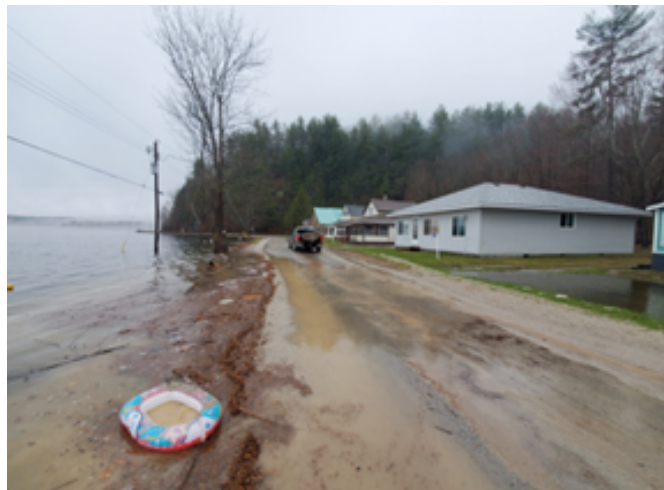
Photo 34 Flooded road Dalhousie Lake, Level 158.11 m

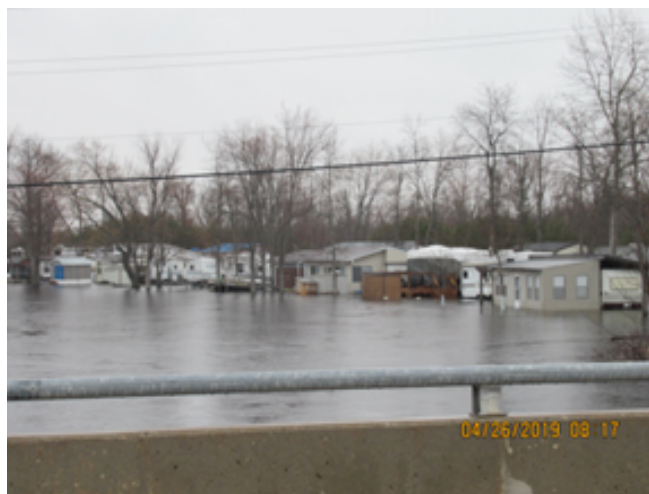
Photo 36 Flooding Downstream Dalhousie Lake bridge

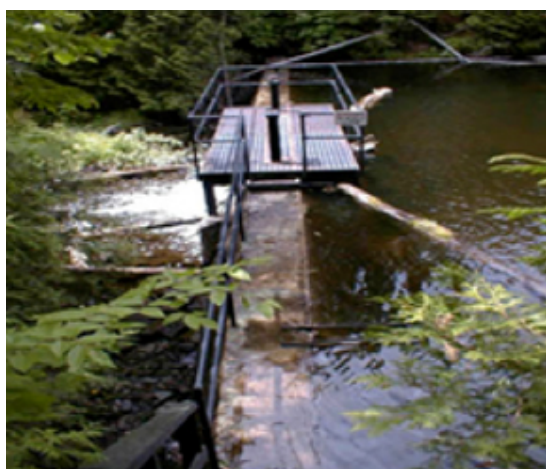
Photo 37 Summit Lake Dam

The Summit Lake dam is owned by the Ontario Ministry of Natural Resources and Forestry, Bancroft District and has been operated by MVCA since 1986i. It is a single bay concrete structure with a weir on either side of the control section. There are five 0.20 x 0.20 x 4.27 m (8" x 8" x 14'-0"). The dam has not been tied to a geodetic elevation so there is no weir elevation. It has a drainage area of 28 sq km. The primary purpose of this structure is to maintain water levels for a brown trout fishery, the only one in the Mississippi River watershed.

The operation of Summit Lake consists of removing the five stoplogs from the dam in the fall and replacing them in the spring. Water levels are not obtained on a regular. Nothing of significance occurred at this dam during the flood of 2019.

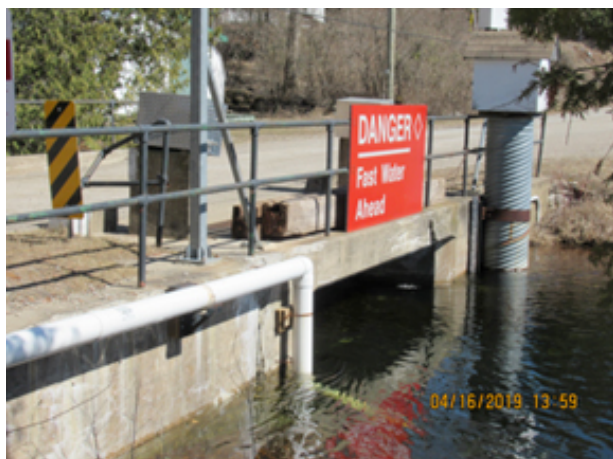
Photo 39 Palmerston Dam

Water levels remained fairly static throughout the majority of the winter. As runoff began and levels started to increase, the stoplogs were removed from the dam at a rate to keep water levels below the maximum for the lake of 272.15 m. The operation of this lake is tied closely to the Canonto Lake downstream, the removal of a ½ log from Palmerston dam usually associated with a full log from Canonto dam, matching increase inflow with a corresponding outflow and helping maintain stable levels through Canonto Lake. In 2019, there were no significant issues with the Palmerston Lake Dam. Flood levels were getting very close to the threshold for Canonto Lake dam and removal of additional logs was contemplated but delayed to allow assist the lower part of the river a n opportunity to peak. Levels began to recede at Canonto so no additional logs were pulled. Palmerston Lake peaked at 272.08 m on April 22, 2019. Canonto Lake peaked at 268.46 m on April 20, 2019.

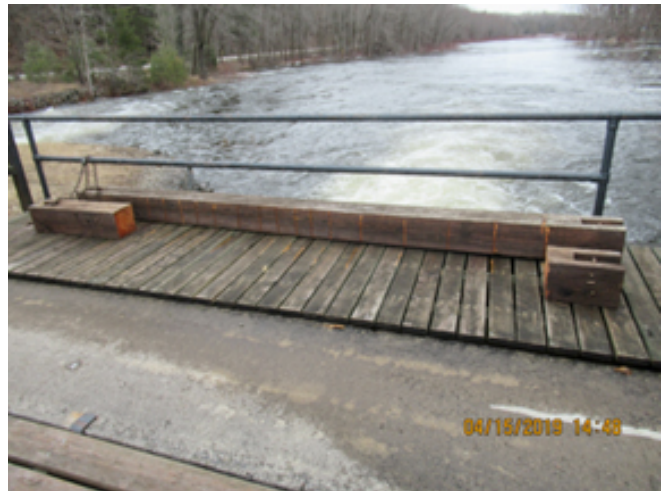
Photo 46 Vandalism of stoplogs at Widow Lake Dam

Vandalism was an issue at this dam in 2019, as two stoplogs were destroyed. However, by mid-May those logs had been replaced and all of the logs were back in the dam.

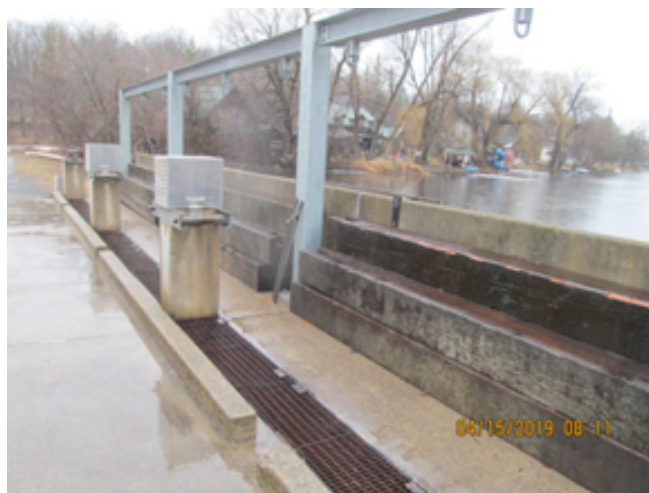
Photo 48 Stoplogs on Lanark Dam

In 2019, between March 31st and April 20th, a total of 29 stoplogs had been removed from the dam, bringing the total number of logs out of the dam to 32. Water levels peaked above the bridge at an elevation of 146.04 m on April 22nd while the corresponding level at the dam was 144.00 m.

Stoplogs began being replaced in the dam on April 27th and was almost a daily operation over the next two weeks until conditions stabilized and levels were consistent from the bridge to the dam. By the end of the month, there were still logs out of the dam.

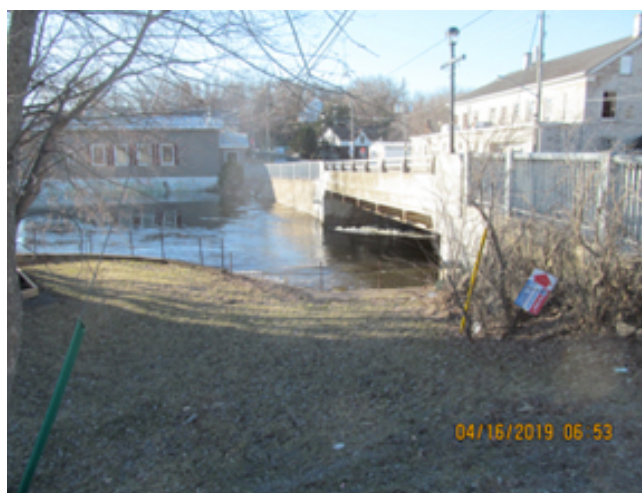
Photo 51 Main Street Bridge Control Above Lanark Dam

As flows increase, the dam is operated to keep levels at the bridge below 144.50 m as long as possible. Once 32 stoplogs have been removed from the dam, removal of additional logs from the dam has very little impact on flood levels above that bridge. Since there is no storage along the river, removal of the stoplogs can't occur until flows begin to increase from an environmental perspective. As well, to mitigate issues downstream, not all the stoplogs can be removed at once so they are typically removed in stages over the course of several days mimicking the increase in flows coming to the structure.

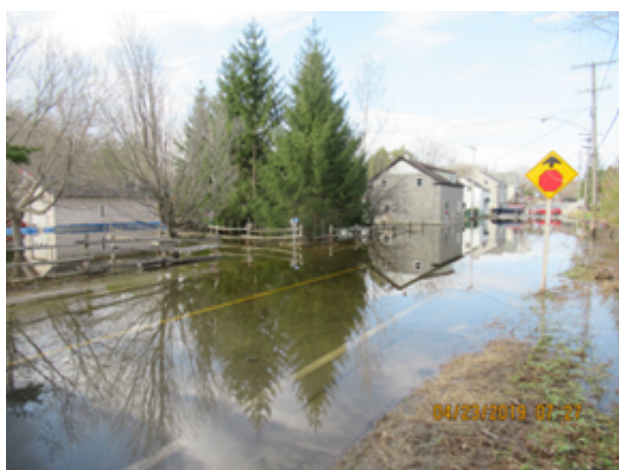
Photo 52 Flooded Road in Lanark Village

The dam is operated as much as possible to reduce flood levels within the village however due to channel restrictions upstream and no storage, it has a very limited capacity to meet this objective.

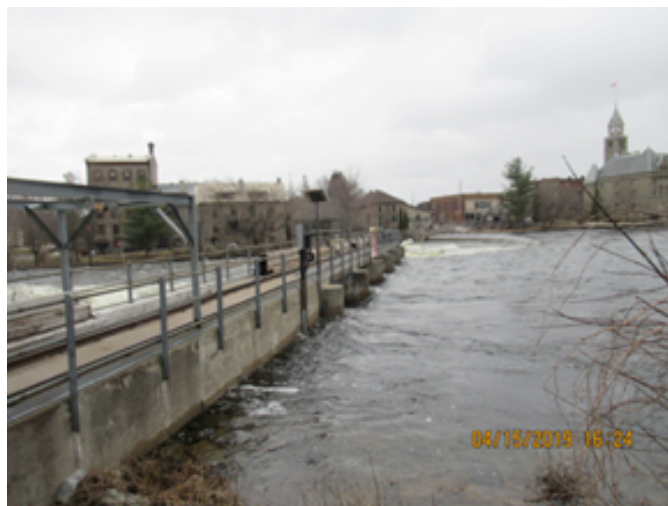
Photo 56 Carleton Place Dam View From Upstream

As flows began to recede, the dam was closed off to mimic those dropping inflows. As with other dams, it is important to close bays one at a time to minimize seepage that causes issues later on. The dam began being closed off on May 8th. Due to the volume of water still coming down the system it wasn't until early June that all of the logs were back in the dam.
