Feedmill Creek 2015 Summary Report

Monitoring Activity in the City of Ottawa

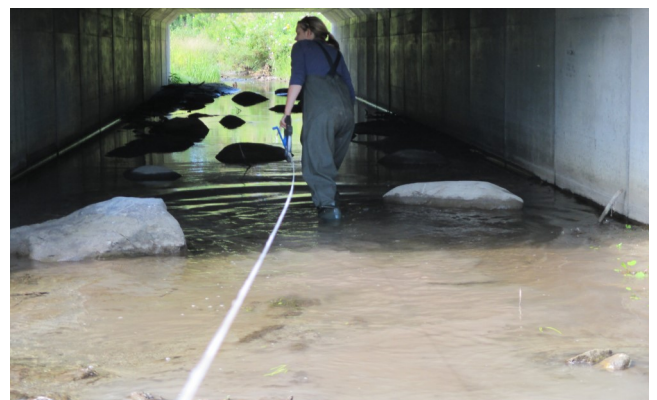
A culvert on Feedmill Creek, near Tanger outlet mall

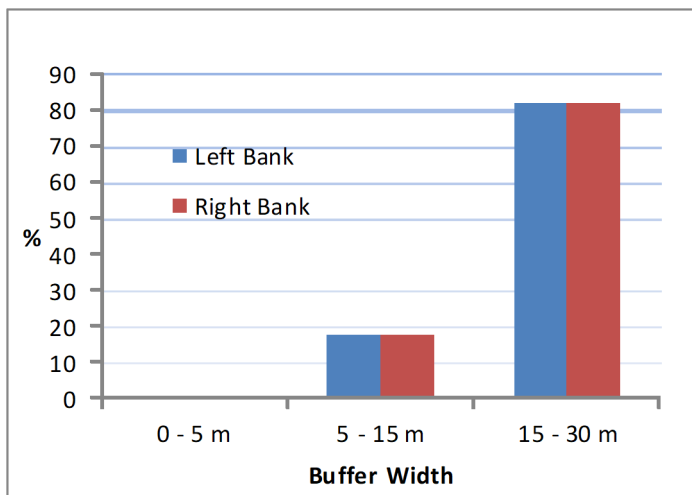
Figure 5: Riparian buffer widths along Feedmill Creek.

Environment Canada's Guideline: *How Much Habitat is Enough?* recommends a minimum 30 m wide vegetated buffer along at least 75% of the length of both sides of a watercourse. Therefore, for this assessment, we record the width of the riparian buffer within 30 m of either side of the watercourse. As summarized in Figure 5, we found that the sections of Feedmill Creek that were surveyed have a relatively good riparian buffer. Results show that 82% of the left and right bank has a buffer width greater than 15 meters, and no sections have a buffer of 5 m or less.

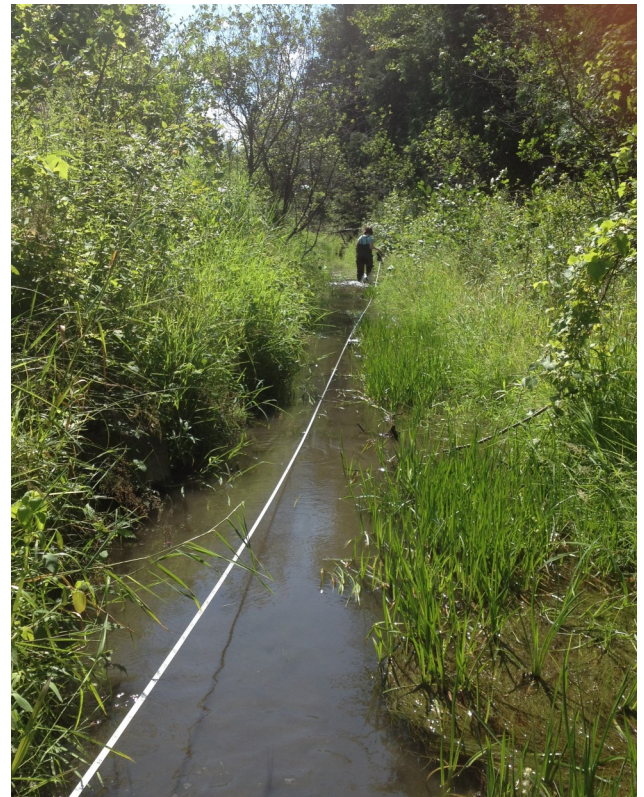
Figure 6: Vegetated buffer width along Feedmill Creek.

Figure 6 shows the differences in riparian buffer widths along Feedmill Creek. The best buffers were seen along the surveyed sections at the south where the stream flows through uncultivated wetland. Through the middle section, the creek flows through large open fields with a mix of meadow and scrubland buffers, consistently 15-30 m wide. At the downstream end the buffer decreases to 5-15 m, as it passes through the Tanger mall property.

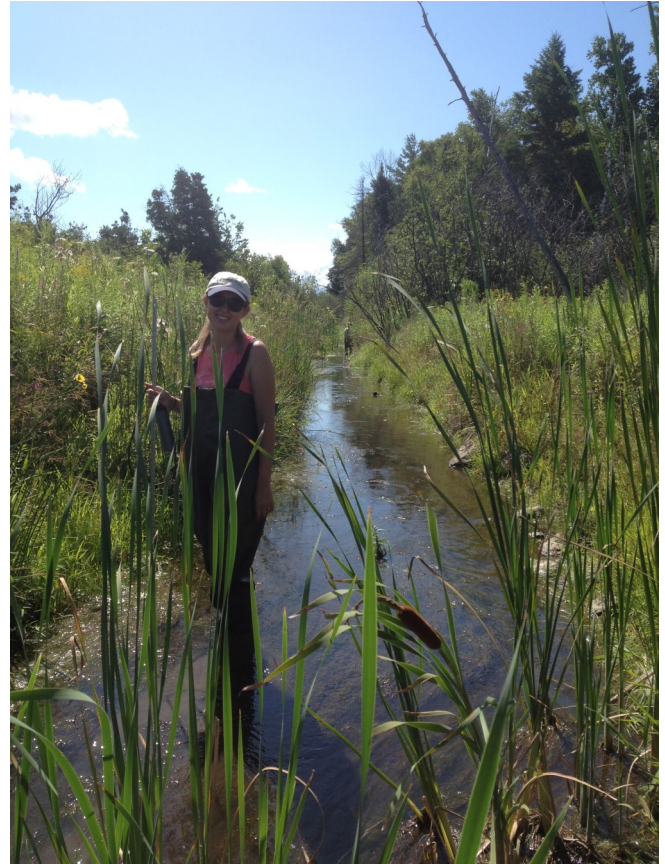
Figure 8: Percentage of each surveyed section of Feedmill Creek with overhanging trees and branches.

Figure 8 shows the data quantified as the percent of creek sections classified according to the various amounts of overhanging trees and branches. For example, 55% of the 22 surveyed stream sections were classified as having zero overhanging trees and branches along both the left and right bank. 32% of the surveyed stream was found to have less than 21% overhanging branches.

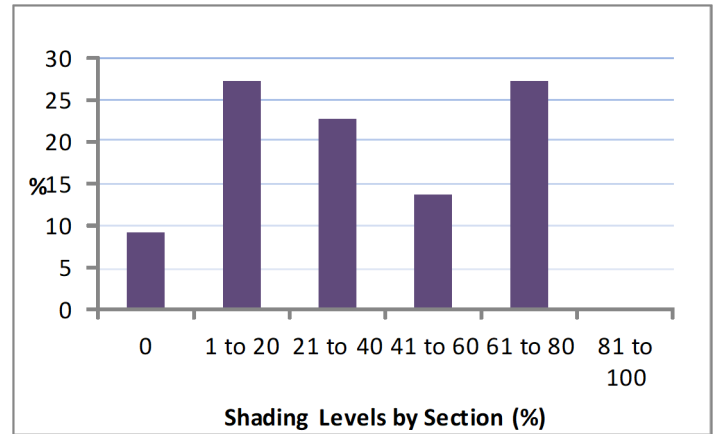
Figure 10: Shading along Feedmill Creek.

Figure 10 shows the data quantified as the percent of creek sections classified according to the various levels of shading. For example, 27% of the 22 stream sections that were surveyed were classified as having 1 to 20% shading along the entire section. With 9% at zero shading, 27% at 1 to 20 percent, and 23% at 21 to 40 percent, more than half of the surveyed stream has less than 41% shading.

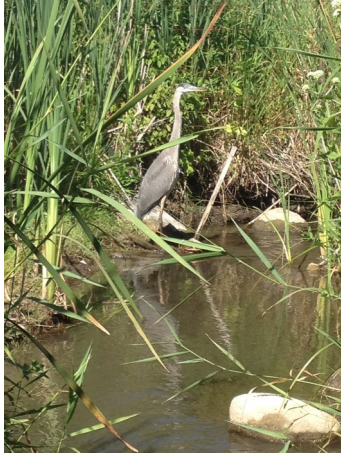
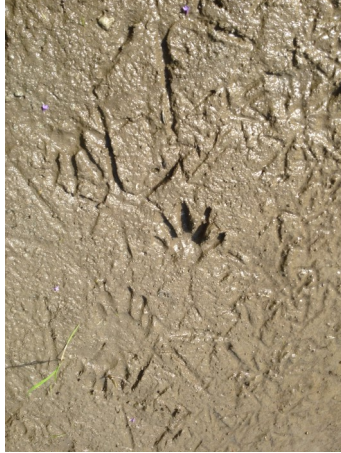
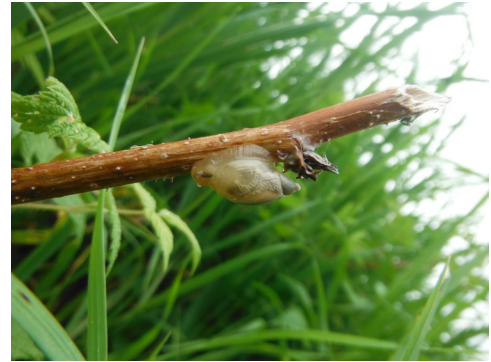
There were many species of wildlife observed during this assessment of Feedmill Creek. Many raccoon tracks were seen, especially near a culvert at the downstream end. Green frogs, dragonflies, damselflies, minnows, a snail, and various aquatic insects were also present. The highlight was an up close sighting of a great blue heron around a bend in the creek, seen in the photo below.

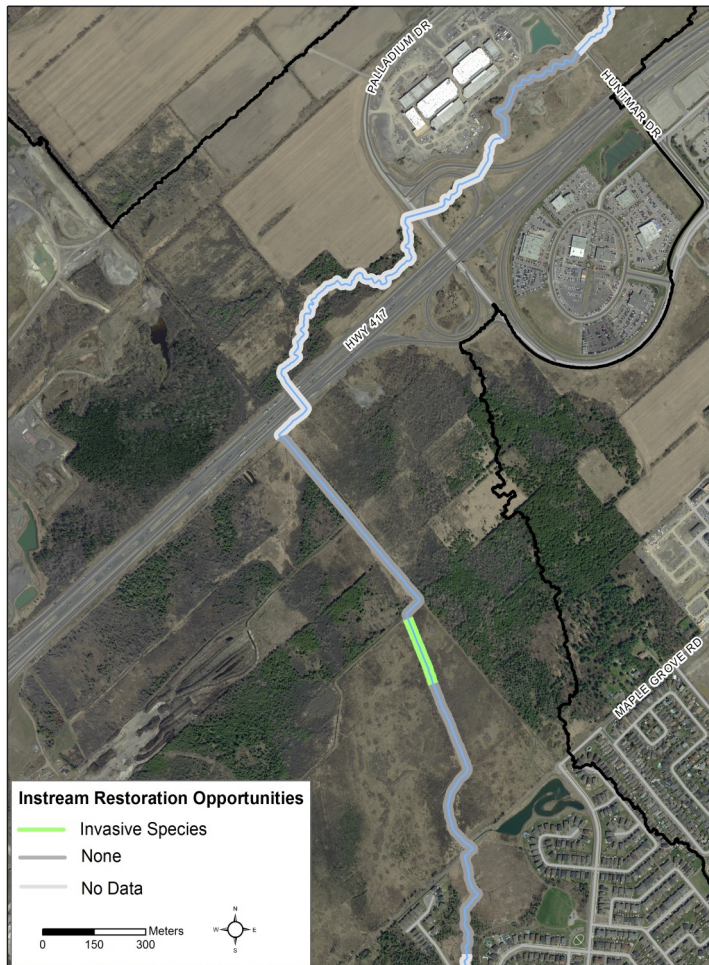
Figure 17: Areas for potential restoration projects along Feedmill Creek.

Figure 17 depicts the locations identified by MVCA staff and volunteers, as areas for potential riparian restoration activities (planting along the shoreline). There was only one site near the middle of Feedmill creek that was identified as a potential restoration site. It was observed to have a large number of purple loosestrife which could be removed.

The next steps will be to approach the landowners and work with them on a voluntary basis to enhance their shorelines through a number of potential activities, such as increasing the unmowed areas along the shore or agreeing to plant and maintain native shoreline species of trees or shrubs.
