# Carp A Tributary Catchment Report 2019

## Monitoring Activity in the City of Ottawa

## Carp A

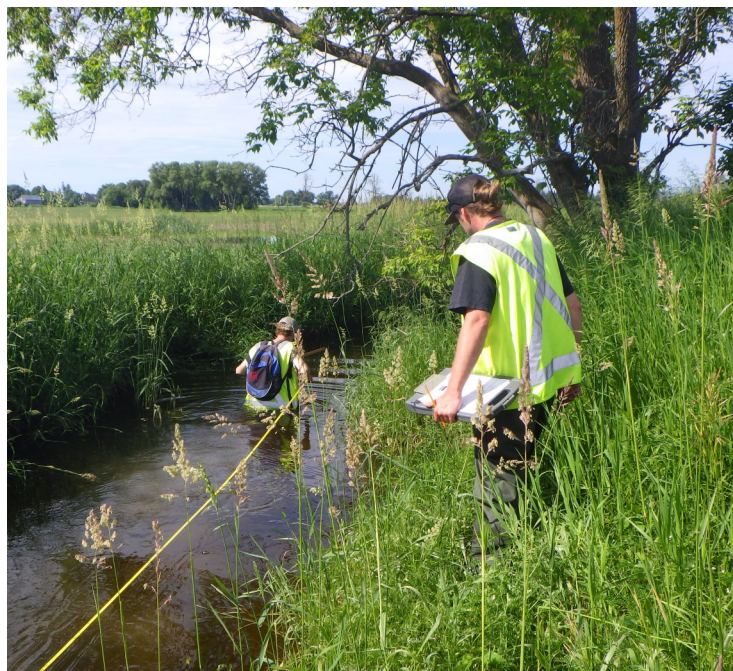
**Figure 8:** Percentage of each surveyed section of Carp A with overhanging trees and branches.

Overall, Carp A has a low percent coverage of overhanging trees and branches, as seen in Figure 8 with 80% of the reaches having no overhanging cover. This reflects the surrounding natural vegetative community, where the creek flows between an agricultural field and March Road. The majority of these areas are dominated by tall grasses.

Figure 8 shows the data quantified as the percent of creek sections classified according to the various amounts of overhanging trees and branches.

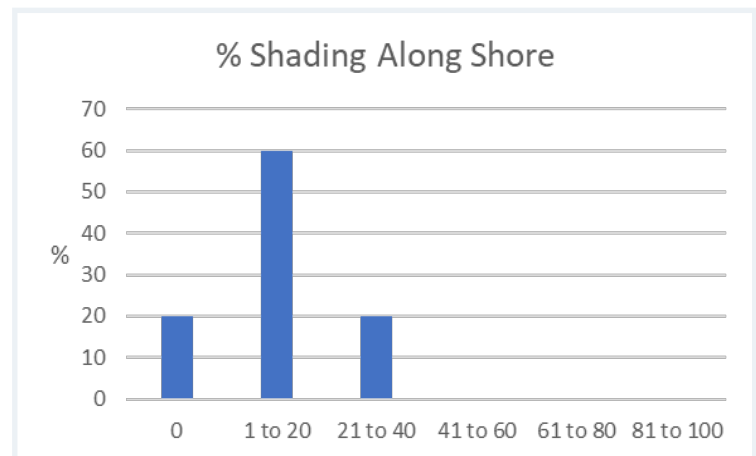
**Figure 11:** Shading along Carp A.

Figure 11 shows the data quantified as the percent of creek sections classified according to the various levels of shading. For example, 20% of the 6 sections that were surveyed were classified as having between 21 and 40% shade coverage.

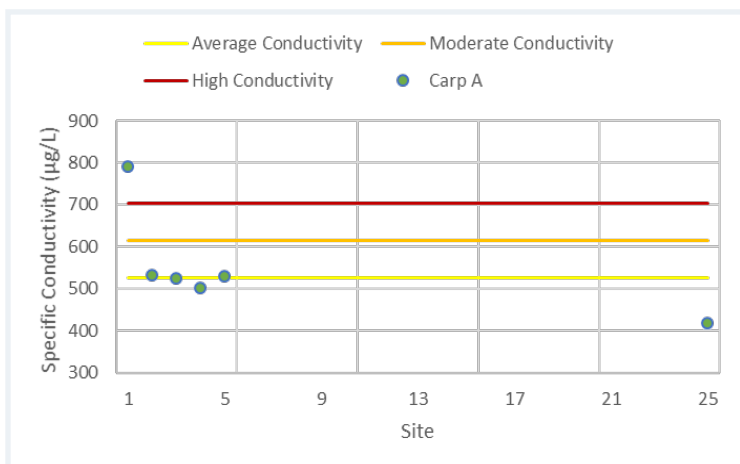
**Figure 20:** Specific conductivity results from Carp A.

**Conductivity** is defined as the ability of water to pass an electrical current, and is an indirect measure of the saltiness of the water caused by dissolved ions. Fish cannot tolerate large increases in ion concentrations in the water. Factors that can change the conductivity of freshwater include climate change and human activity. Warmer climate conditions increase the evaporation of water, leaving existing water with higher concentrations of dissolved ions (higher conductivity). Use of road salts and fertilizers around the stream can also elevate ion levels, along with industrial and human wastewater. Because of all these factors, conductivity of a stream can fluctuate greatly with readings between 0 and 10,000 microSiemens/centimeter ( $\mu\text{S}/\text{cm}$ ). Environment Canada (2011) sets a target of 500  $\mu\text{S}/\text{cm}$  as part their Environmental Performance Water Quality Index. The average specific conductivity of Carp A is 525.1  $\mu\text{S}/\text{cm}$ , putting it just above the target level. The highest reading was at the outlet to the Carp River where some mixing of waters may occur.

Since background conductivity can vary between systems, the 2019 results have been compared to the surveyed average for Carp A as seen in Figure 20.

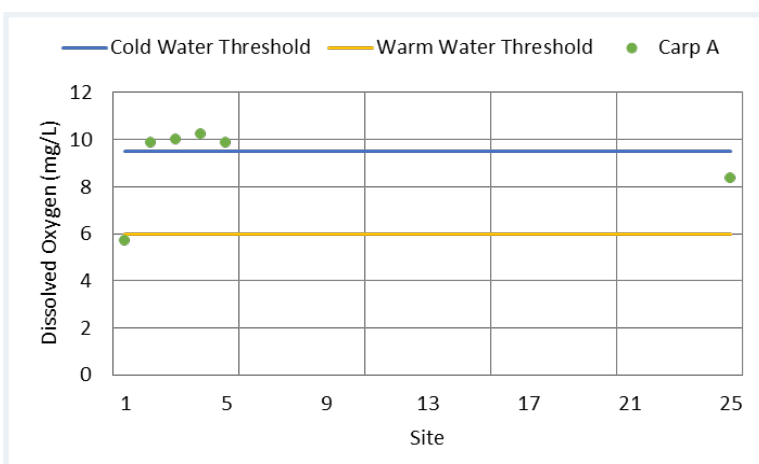
**Figure 21:** Dissolved oxygen concentration results from Carp A.

The average amount of dissolved oxygen in Carp A measured at 9.42 mg/L, indicating that large reaches of the creek have adequate dissolved oxygen levels for most warm water fish to thrive. There is only 1 section that is just below the ideal dissolved oxygen concentrations for warm water fish, and this occurred at the junction with the Carp River. When water depths and channel connectivity permit, fish may migrate away from low oxygen areas such as this one.

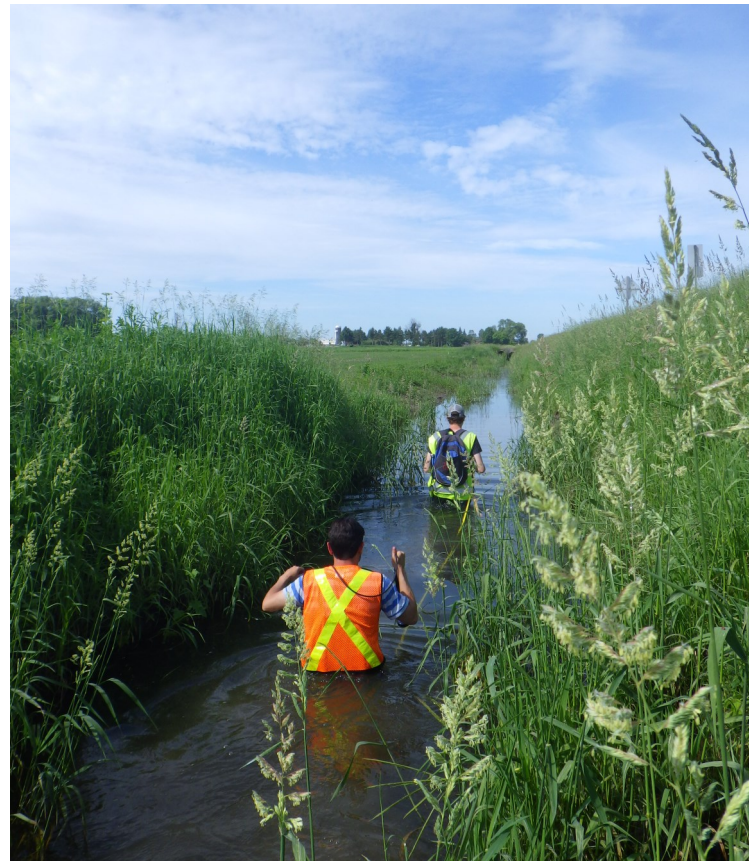
**Figure 22:** Dissolved oxygen concentration and saturation results for Carp A.

As seen in Figure 22 the lower reach of Carp A had good concentrations and percent saturation levels for dissolved oxygen. However, at the junction with the Carp River the oxygen levels were quite low.

In the upper reach oxygen concentrations were acceptable for warm water fish, however the saturation levels were less than 100%. This could have been due to the low flow conditions experienced at that time of the summer.

Dissolved oxygen concentration levels and saturation levels were typically high throughout the surveyed reaches with a moderate saturation at the upper reaches and low concentration and saturation values at the outlet as shown on page 13. This indicates that some reaches have less than ideal conditions for aquatic organisms.

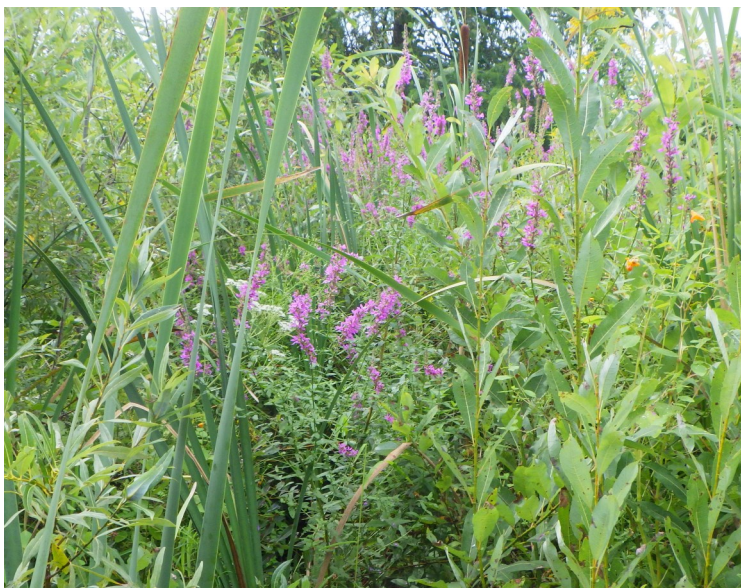
The purple flowers are Purple Loosestrife growing along Carp A.

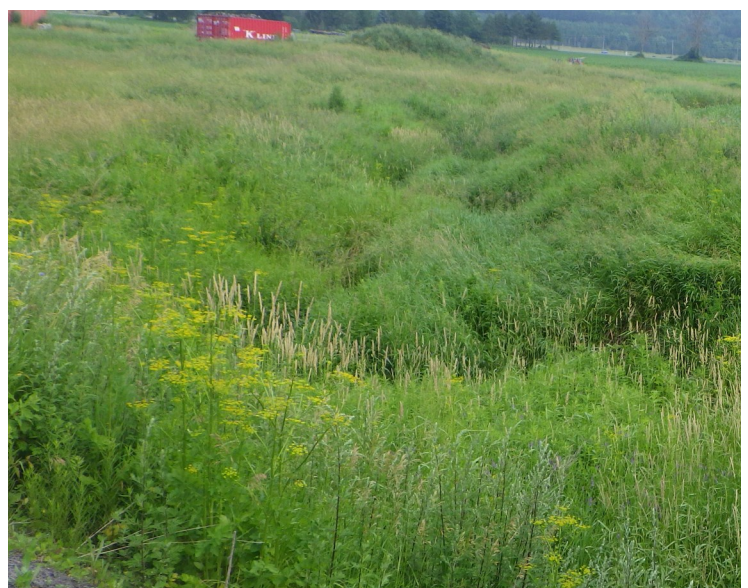
The yellow flowers are Poison Parsnip growing along Carp A.
