Carp B Tributary Catchment Report 2019

Monitoring Activity in the City of Ottawa

Carp B Tributary

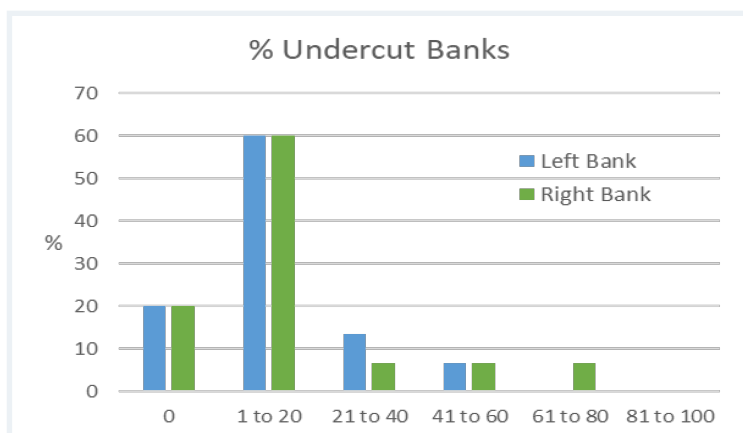
Figure 12: Percent undercut stream banks along Carp B.

Figure 12 shows the percentage of undercut stream banks along each surveyed section of Carp B. Overall, the sections of the Carp B tributary that were surveyed were found to have very little undercutting. However, 7% of the left bank and 14% of the right have a greater than 40% undercutting.

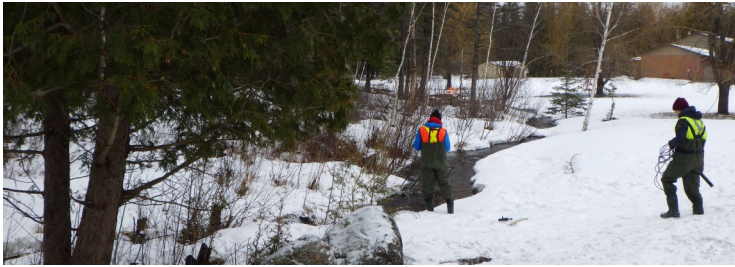
Flow conditions within a HDF can be highly variable as a result of changing seasonal factors. Flow conditions are assessed in the spring and summer to determine if features are perennial (flowing year round), or if they are intermittent (drying up during the summer). Flow conditions in headwater systems will change year-to-year depending on local precipitation patterns.

All four sites had either minimal flow or substantial flow during the spring visit and had the same result during the summer visit .

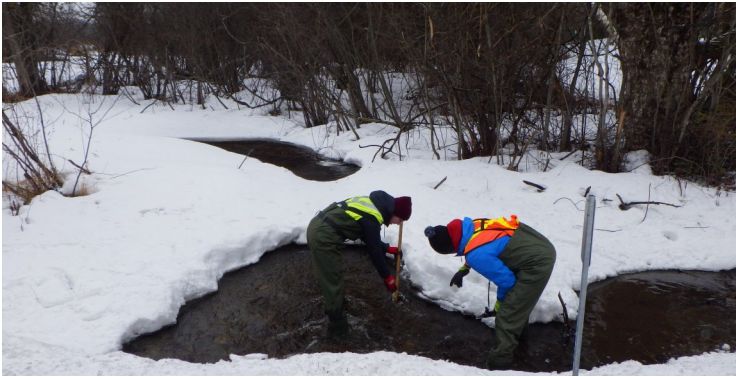
Channel modifications are assessed at each headwater drainage feature site. Modifications include dredging, hardening, realignment, entrenchment and anthropogenic on-line ponds.

Channel modifications noted at the Carp B HDF sites include channelization and roadside ditch maintenance.

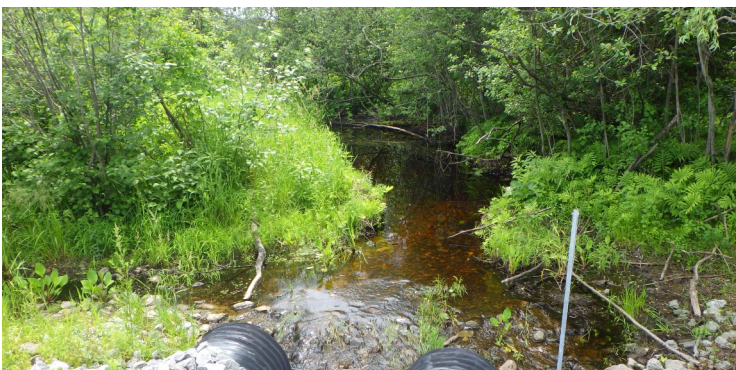
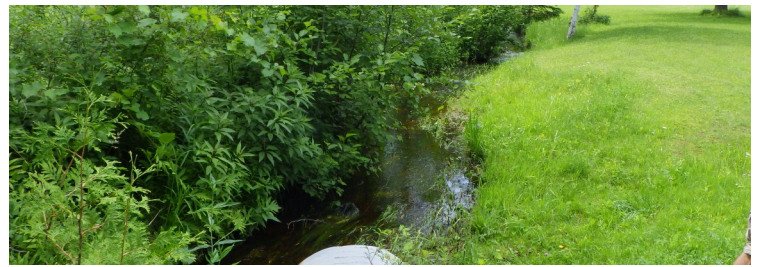
Feature vegetation type is the dominant vegetation type found directly within each headwater feature channel, whereas riparian vegetation type is evaluated as the dominant vegetation within 3 zones from the shoreline of each headwater feature (0-1.5 m, 1.5-10 m and 10-30m).

There are 7 vegetation classifications: None, Lawn, Crops, Meadow, Scrubland, Wetland, and Forest.

Meadow, scrubland and forest were the dominant feature vegetation types. Meadow, scrubland and none were the dominant riparian vegetation types.
