Carp C Tributary 2016 Summary Report

Monitoring Activity in the City of Ottawa

Carp C Tributary

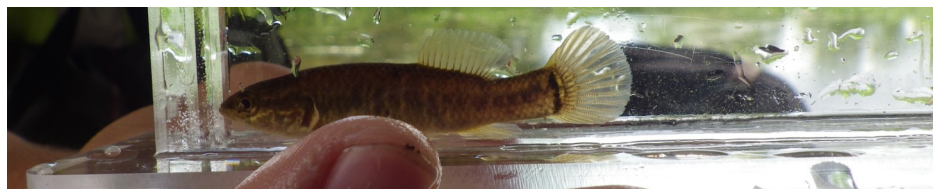
Fish species found in Carp C: Brassy Minnow, Brook Stickleback, Common Mudminnow (pictured above), Creek Chub, Dace sp., Northern Pearl Dace, White Sucker, Blacknose Dace, Fathead Minnow.

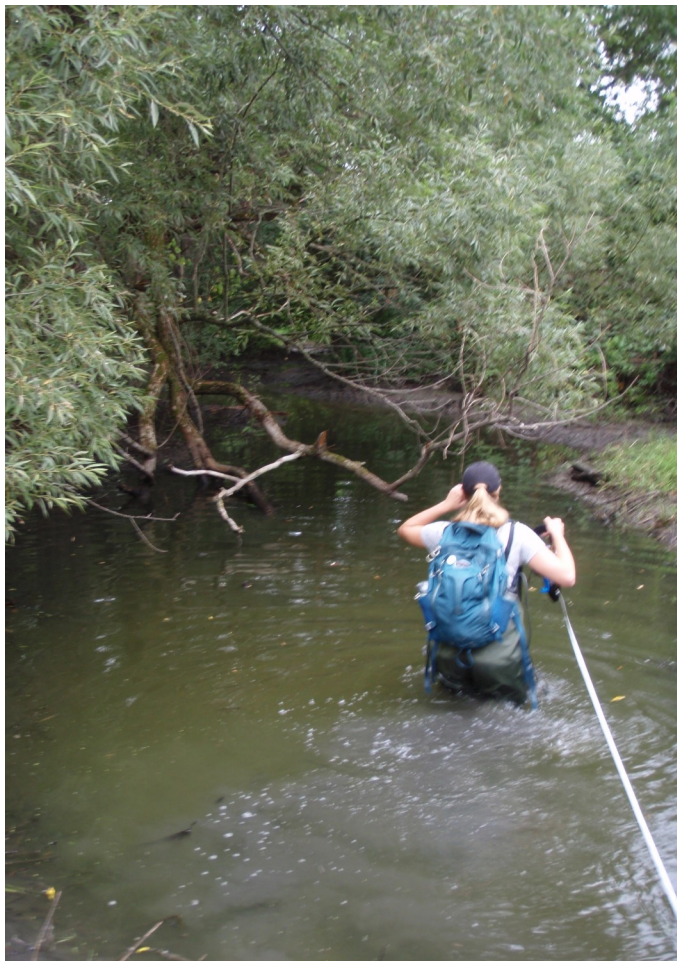
Figure 3: Locations of the monitoring sites along Carp C.

In 2016, permission was granted to survey 41 sections of Carp C, shown in Figure 3, which cover approximately 4.1 km of the creek. Only 4 of the possible 41 sections were successfully surveyed due to severe drought conditions. Survey dates were limited so effort was focused closer to the road crossings and aerial imagery is being used to help understand sections that were not walked.

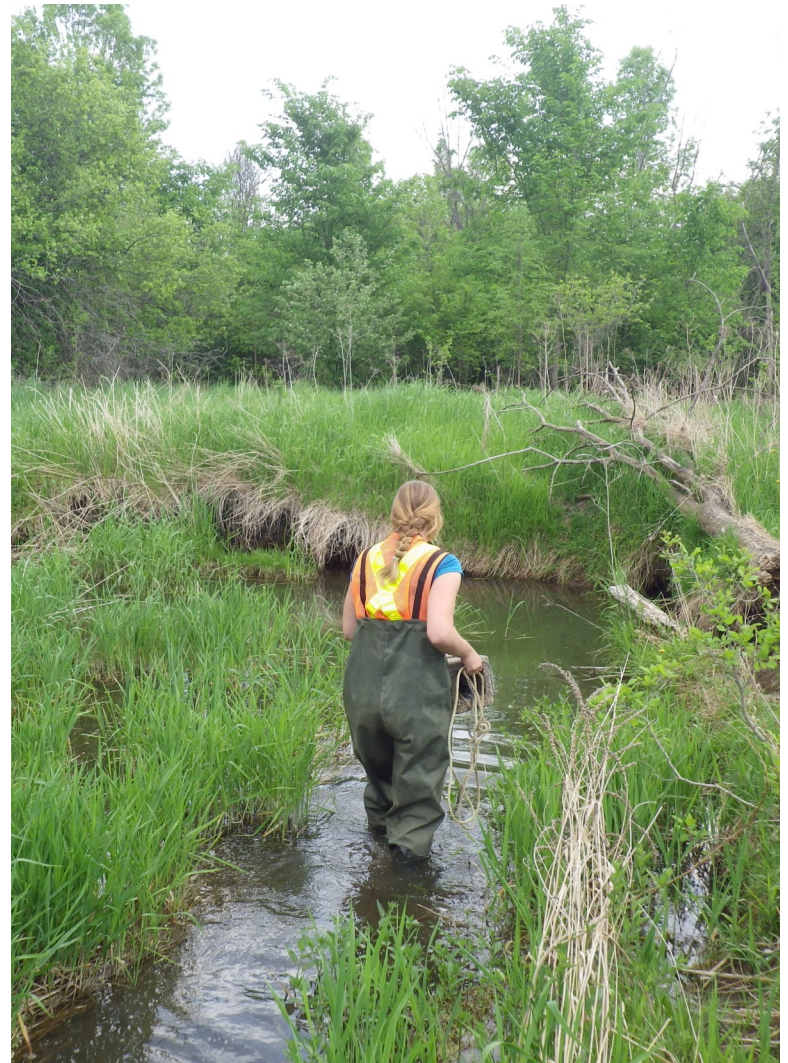
Figure 7: Vegetated buffer width along Carp C.

Results show that 100% of the surveyed section's left and right banks have a buffer width in the 15-30 m range. As seen in Figure 7, aerial imagery was used to provide an estimate for the areas not walked, distinguished by the black outlines. The green portions on the map show where the buffer of tall grasses extends beyond 30 m.

Overall the majority of the tributary downstream of Diamondview Rd (3.4 kms) has a good buffer zone of undisturbed grasses, shrubs or trees. Some areas have a reduced buffer due to the road network or the shape of the active agricultural fields.

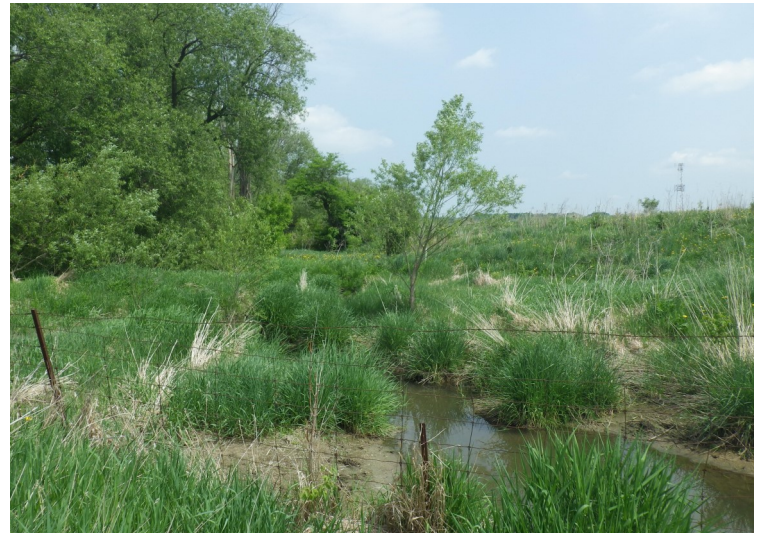
Figure 9: Percentage of each surveyed section of Carp C with overhanging trees and branches.

Figure 9 shows the data quantified as the percent of creek sections classified according to the various amounts of overhanging trees and branches. For example, one of the surveyed stream sections was classified as having 61-80% overhanging trees and branches while the three other reaches where found to have less than 40% overhanging branches.

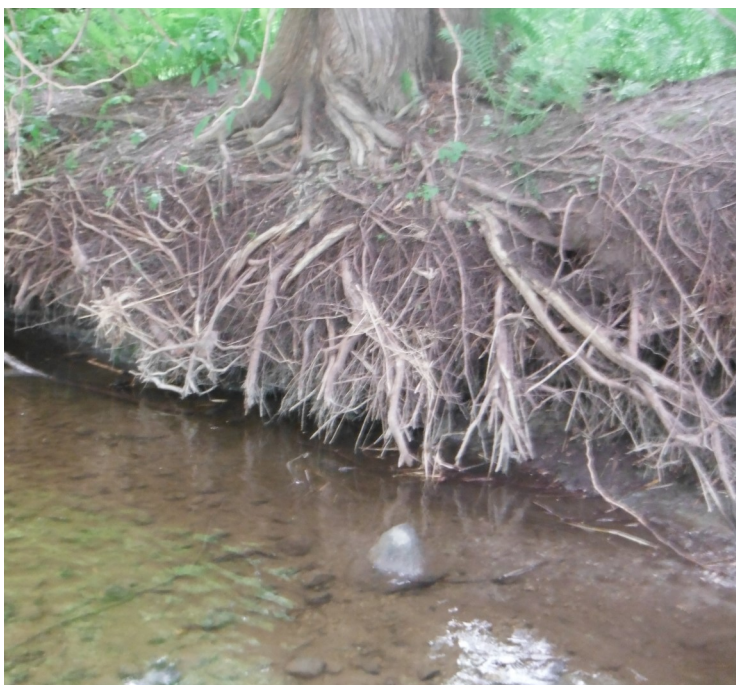
Figure 12: Undercut stream banks along Carp C.

Figure 12 shows the percentage of undercut stream banks along each surveyed section of Carp C. Overall, the sections of Carp C that were surveyed were found to have very little undercutting. The one pocket of undercutting, just south of Donald B. Munro Drive, occurred in an area of tight meanders and shallow rooting grasses. If it is relatively stable, it should be left to provide refuge and shelter habitat. If the area appears unstable and the landowners are willing, there is potential for a shoreline planting project to help improve stability.

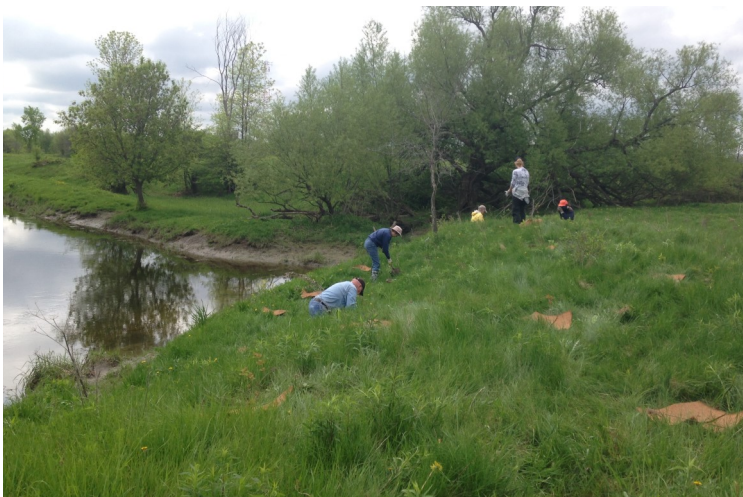
Figure 20: Volunteers helping with a shoreline planting project along the Carp River and Carp C tributary in 2014.

In 2014 MVCA organized a shoreline planting project along the western shore of the Carp River and along the northern bank of the outlet of Carp C (Figure 20).

These areas were mostly tall grasses with some trees and signs of shoreline erosion. They now also have a mix of native trees and shrubs enhancing the biodiversity, shoreline soil retention, and once the plantings become established they will contribute to stream shading.

The next steps will be to approach the landowners and work with them on a voluntary basis to further enhance their shorelines through a number of potential activities, such as agreeing to more plantings of native species.

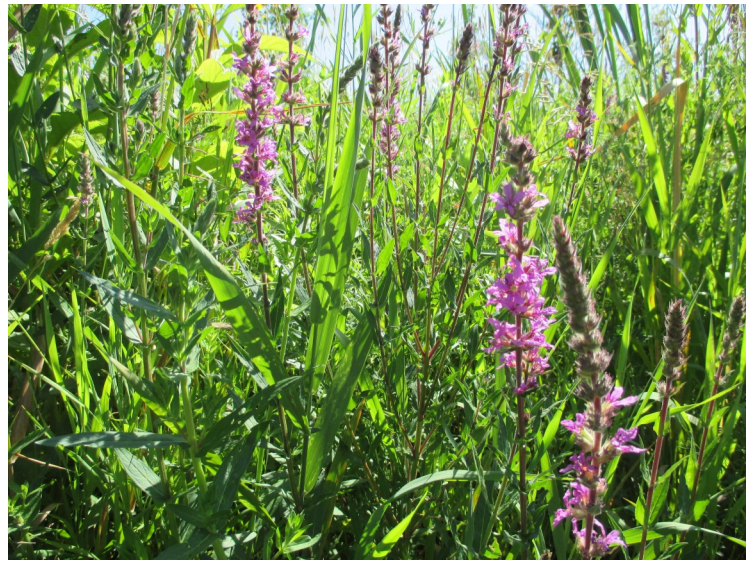
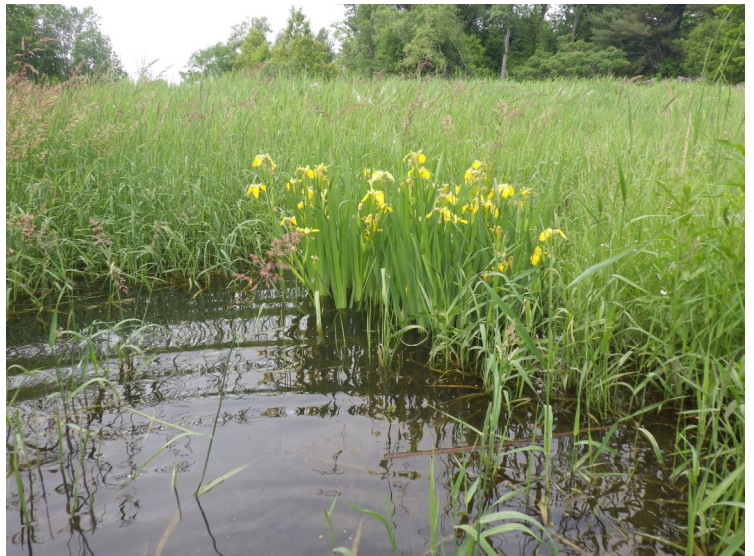
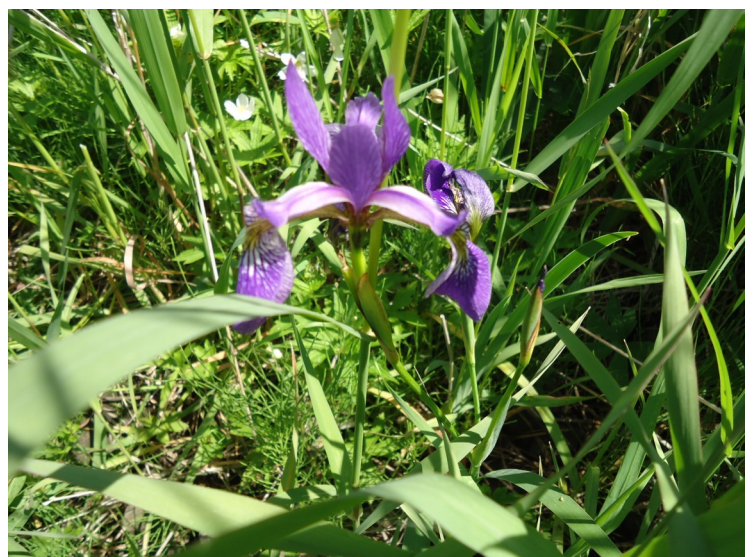
Photos top to bottom: Invasive Purple Loosestrife, Invasive Yellow Iris, Native Blue-Flag Iris.
