# Carp C Tributary Catchment Report 2019

## Monitoring Activity in the City of Ottawa

## Carp C

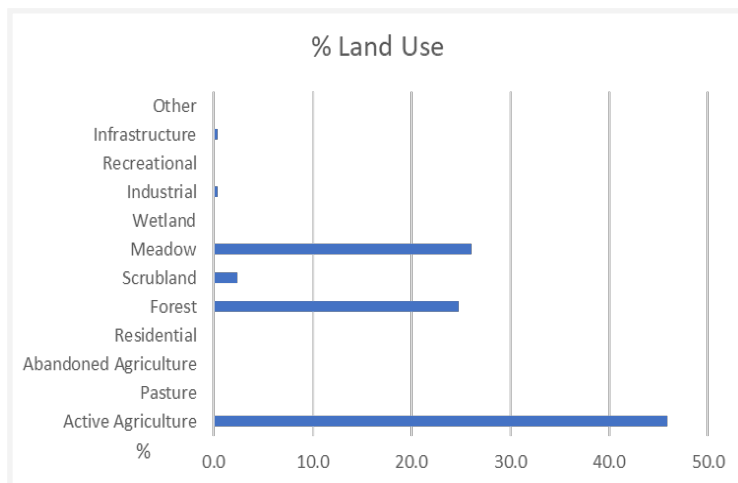
**Figure 4:** Land use alongside Carp C.

Of the eleven categories, active agricultural (46% ) is the most prominent category of land use followed by meadow at 26%.

As described on page 2, the land use in the watershed is dominated by agriculture. This is reflected well in the percentages seen in Figure 4 (46% active agriculture). The remainder of the land uses adjacent to the surveyed sections were predominantly meadow and forest. This is a benefit to the creek as well as the surrounding landscape. Forest cover provides shade, habitat and food for a wide variety of animals, cools the water and protects the banks from erosion. Scrubland (2%) rounds out the diversity of habitats on the landscape and contributes to erosion mitigation.

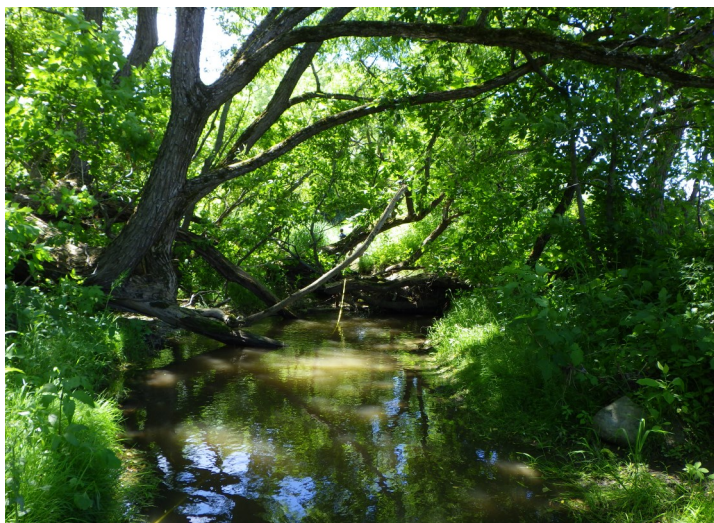
**Figure 8:** Percentage of each surveyed section of Carp C with overhanging trees and branches.

Overall, Carp C has a low percent coverage of overhanging trees and branches, as seen in Figure 8 with 92% of the left bank and 88% of the right bank having less than 41% overhanging cover. This reflects the surrounding natural vegetative community, where the creek passes through sections of wetland and meadow habitat, areas dominated by tall grasses or shrubs, and in some areas it reflects clearing of the vegetation too close to the creek.

Figure 8 shows the data quantified as the percent of creek sections classified according to the various amounts of overhanging trees and branches. For example, only 8% of the left bank reaches and 12% of the right bank reaches surveyed stream were found to have greater than 40% overhanging branches providing nutrients and shade to the creek.

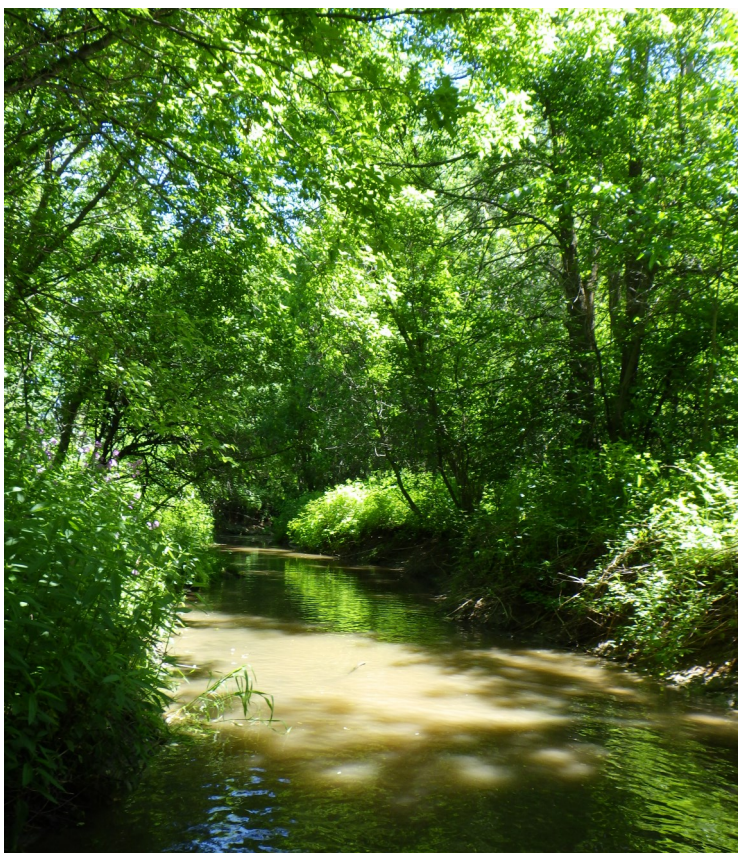
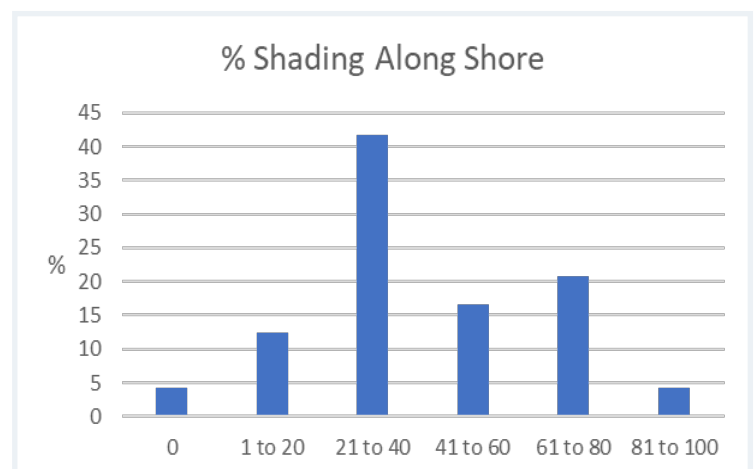
**Figure 11:** Shading along Carp C.

Figure 11 shows the data quantified as the percent of creek sections classified according to the various levels of shading. For example, 17% of the 24 stream sections that were surveyed were classified as having less than 20% shading.

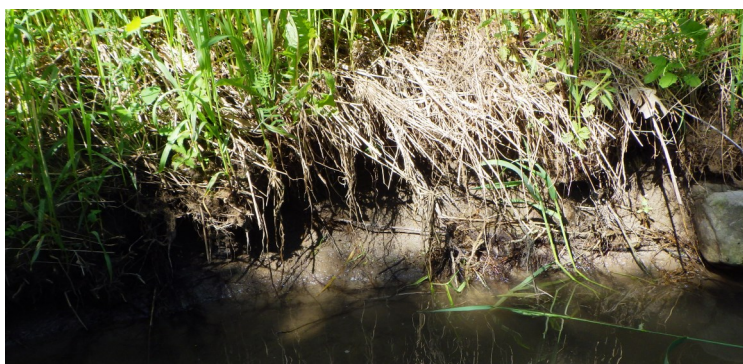
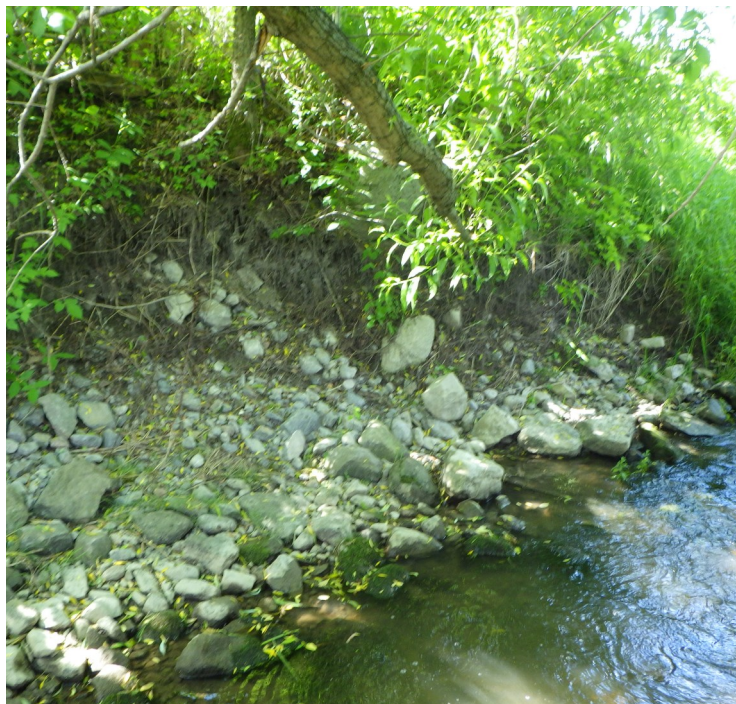
**Figure 12:** Percent undercut stream banks along Carp C.

Figure 12 shows the percentage of undercut stream banks along each surveyed section of Carp C. Overall, the sections of Carp C that were surveyed were found to have very little undercutting. However, 8% of the left bank and 4% of the right have a high degree undercutting.

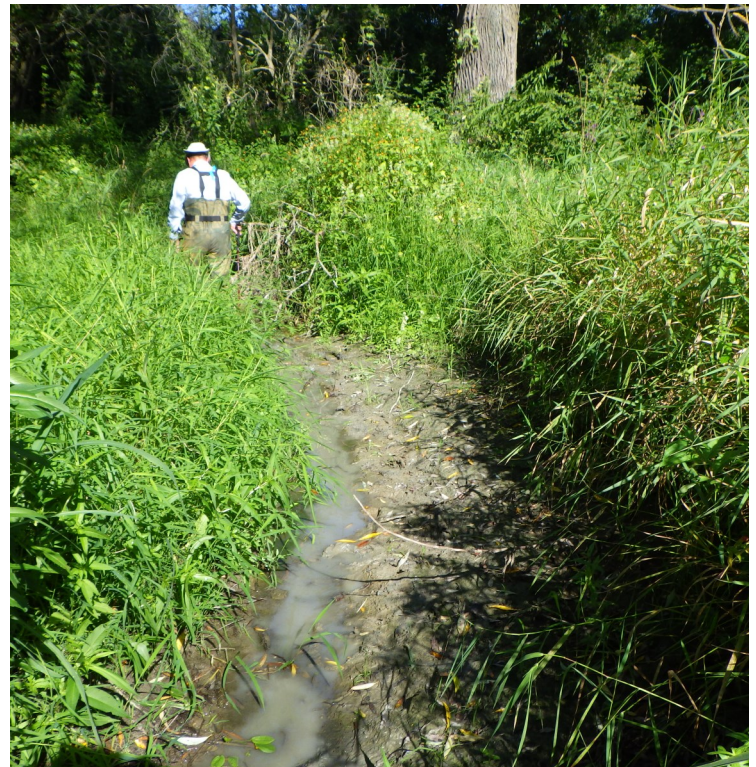
**Figure 22:** Dissolved oxygen concentration and saturation results for Carp C.

This indicates that the majority of the surveyed sections in the Carp C tributary were in a low oxygen state during the summer site visits which would have placed stress on warm water fish species and other biota.

Oxygen concentration levels were low with 9 sections having low oxygen concentration and 13 more sites with low saturation levels as shown in Figure 22. This indicates that some reaches have less than ideal conditions for aquatic organisms.

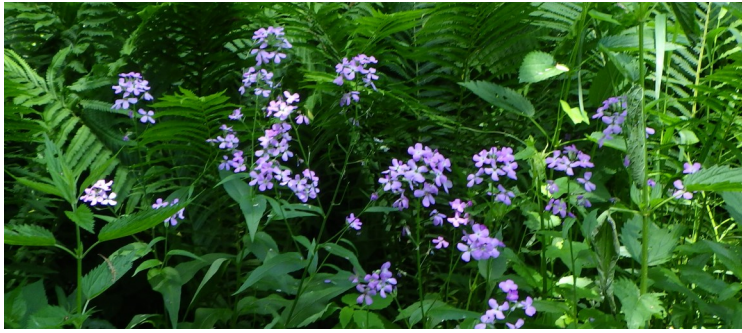
Photo Above: The purple flower is Dames Rocket

Photo Below: Purple Loosestrife

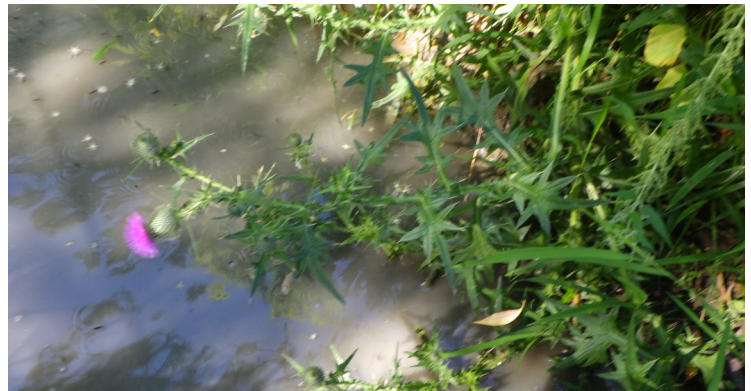
Photo above: A Bull Thistle leaning over the tributary.

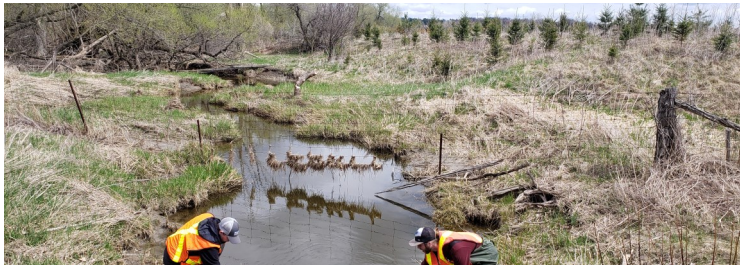
Surface flows were considered minimal for two sites during both visits, and the third was completely dry. During the July visit.

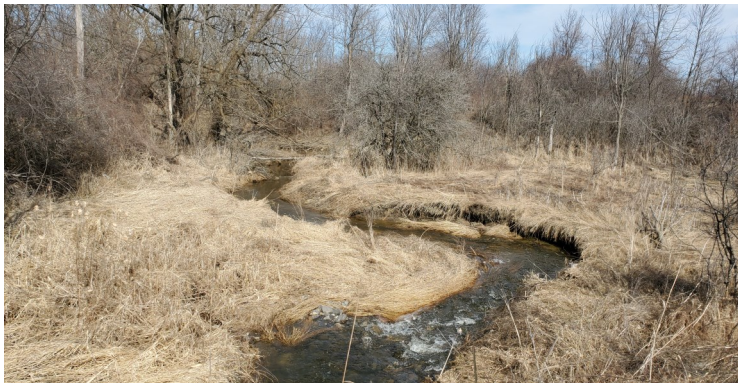
Channel modifications are assessed at each headwater drainage feature site. Modifications include dredging, hardening, realignment, entrenchment and anthropogenic on-line ponds.

Channel modifications noted at the Carp C HDF sites include channelization and roadside ditch maintenance.

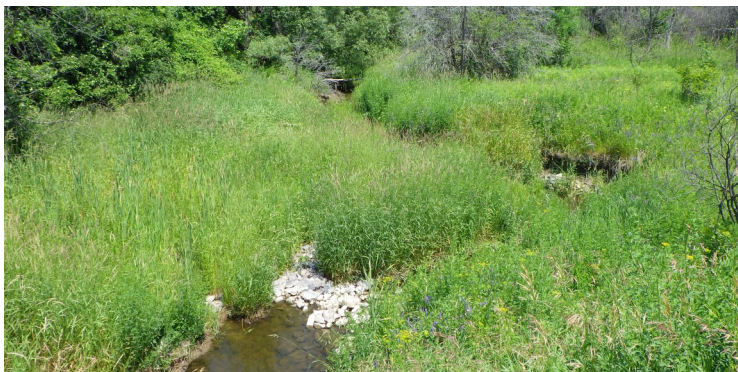
Feature vegetation type is evaluated as the dominant vegetation type found directly within each headwater feature channel, whereas riparian vegetation type is evaluated as the dominant vegetation within 3 distance zones from the shoreline of each headwater feature (0-1.5 m, 1.5-10 m and 10-30m).

There are 7 vegetation classifications: None, Lawn, Crops, Meadow, Scrubland, Wetland, and Forest.

Meadow and wetland were the dominant feature vegetation types. Meadow, scrubland and wetland were the dominant riparian vegetation types.
