# Carp Creek

## 2017 Catchment Report

### ***Monitoring Activity in the City of Ottawa***

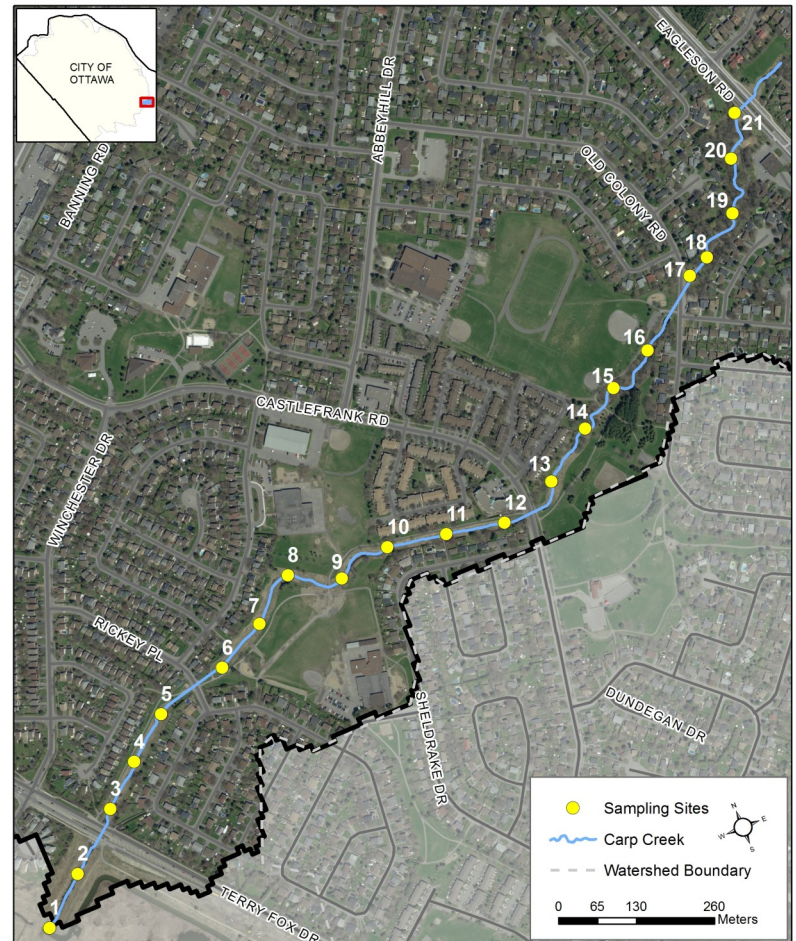
**Figure 3:** Map depicting the Carp Creek monitoring sites.

In 2017, permission was granted to survey 21 sections of Carp Creek, shown on Figure 3, which cover approximately 2.1 km of the main creek.

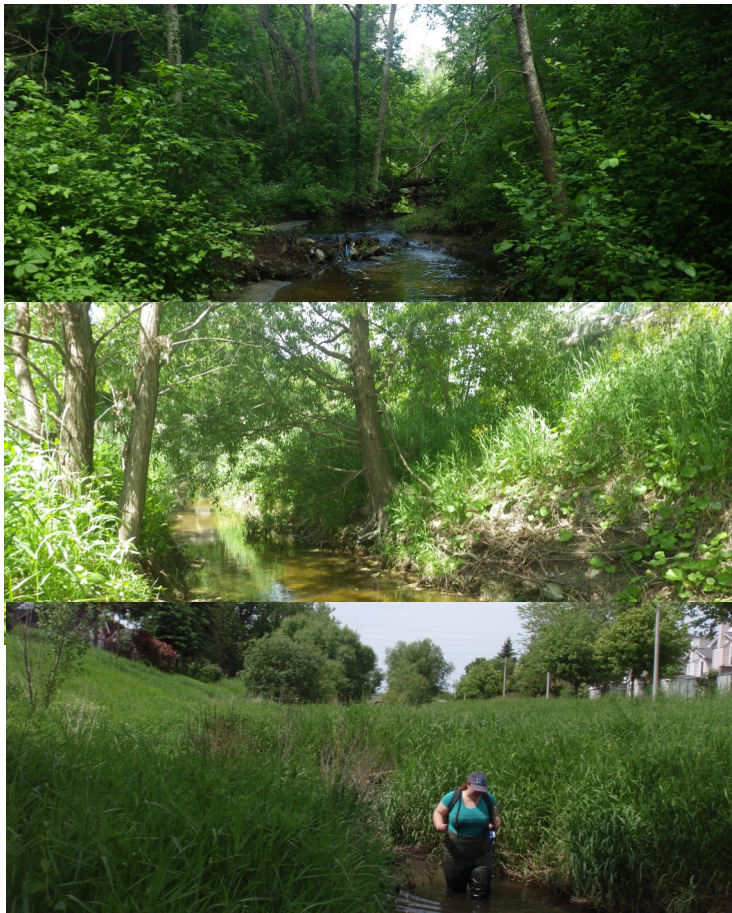
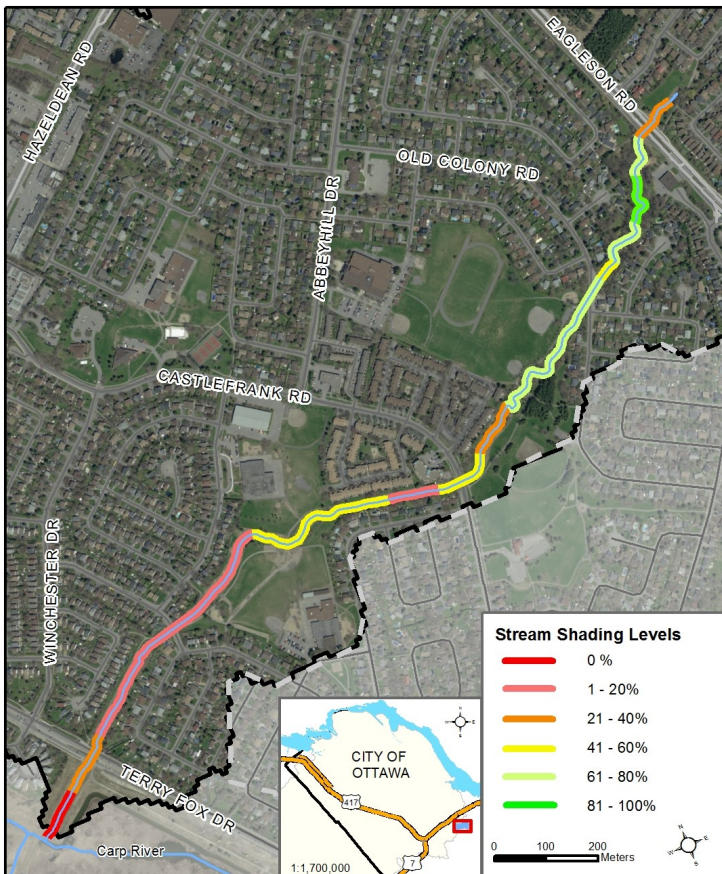
**Figure 10:** Stream Shading along Carp Creek.

Figure 10 shows the variability in the amount of stream shading along different sections of Carp Creek. We can see that the shading is extremely variable. This is due to the diversity of riparian vegetation along the creek, with large sections of tall grasses and open park land in the downstream areas, with more trees as you move upstream. With the exception of crossings, the area between Eagleson Road and Clarence Maheral Park is forested providing the creek with greater than 81% shade in its upper reach. The variability in shade can be seen in the three photographs to the left.

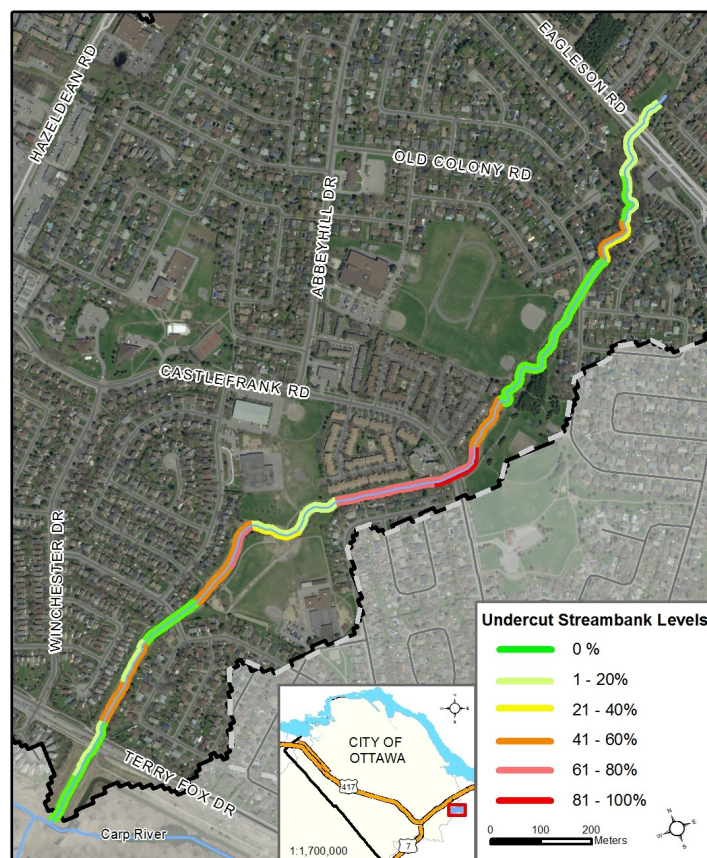
**Figure13:** Map of undercut banks along Carp Creek.

There are a number of reaches in Carp Creek that are demonstrating bank erosion beyond undercutting. These contribute sediment to the downstream reaches potentially clogging spawning areas or flows through culverts. MVCA and the City of Ottawa are discussing possibilities for restoration in some of these areas.

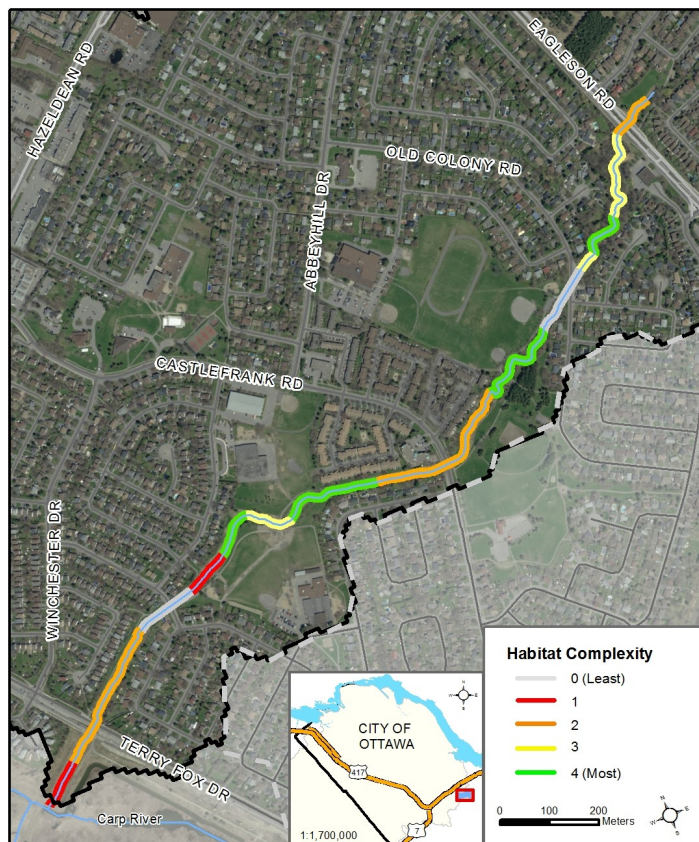
**Figure 14:** Habitat Complexity results for Carp Creek.

The habitat complexity score seen in Figure 14 below is based on the presence or absence of gravel, cobble, or boulder substrates as well as the presence of woody material in each surveyed reach of Carp Creek. The presence of one of the variables carries a score of 1. A reach with all four features receives a score of 4 or high habitat complexity.

Only 4 of the 21 reaches received a score of 1 or less. This is likely due to the proximity of major road crossings and engineering of the channel altering the instream habitat and availability of woody debris.

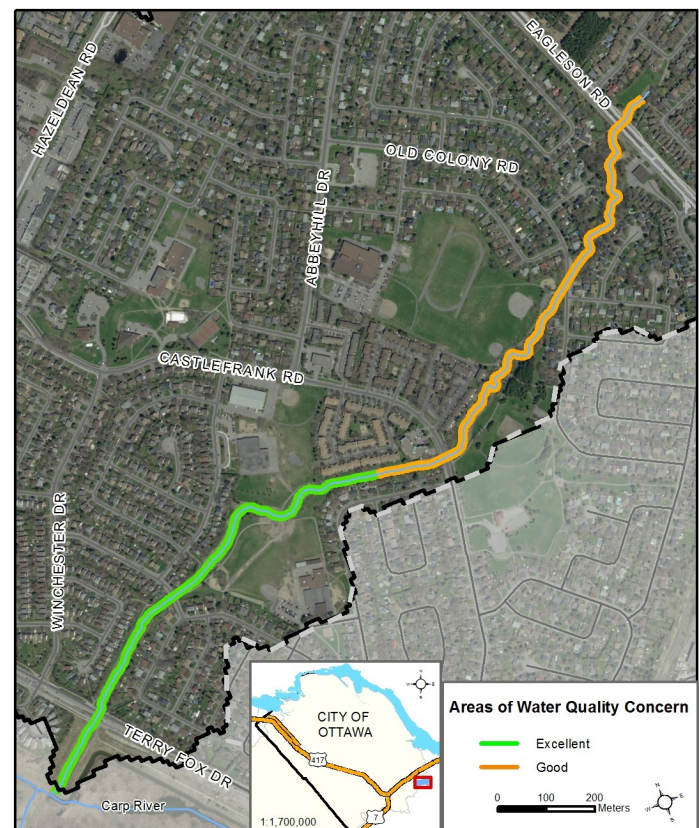
**Figure 23: Areas of Water Quality Concern for Carp Creek.**

In Carp Creek there were no sites outside of the expected pH range, and conductivity values were fairly good throughout with slightly higher values in the upper reaches. Dissolved oxygen was good for cold and warm water biota in the lower reaches and good for warm water biota in the upper reach. However, in the upper reaches dissolved oxygen saturation was <100%. This combined with the slightly elevated conductivity values in the upper reaches resulted in the Good score shown in Figure 23.

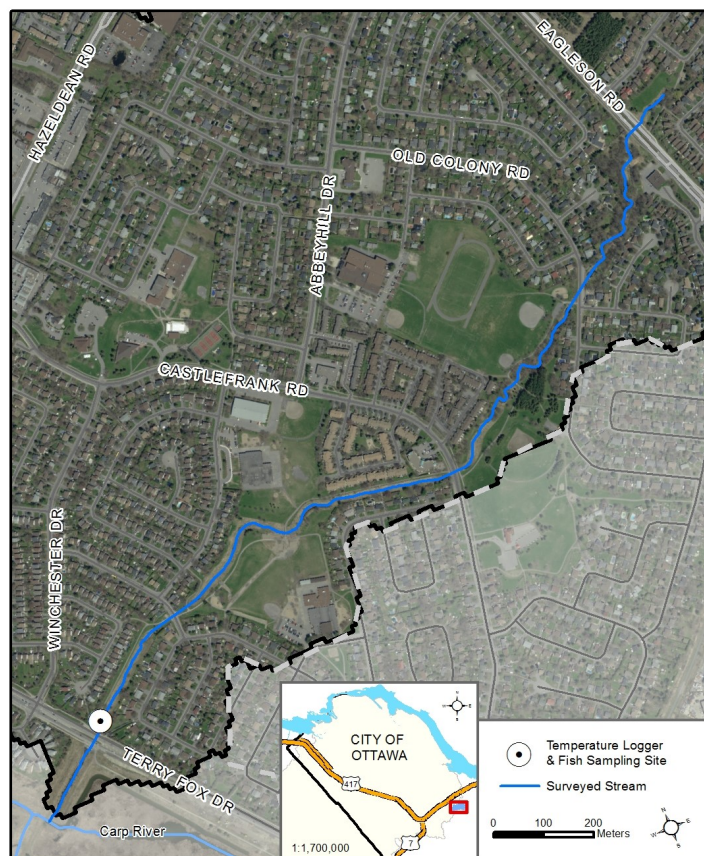
**Figure 24:** Location of the temperature logger and fish sampling site on Carp Creek.

Temperature is an important parameter in streams as it influences many aspects of physical, chemical and biological health. Figure 24 shows where the temperature datalogger was deployed in Carp Creek from May to October 2017 to give a representative sample of how water temperature fluctuates throughout the summer season.

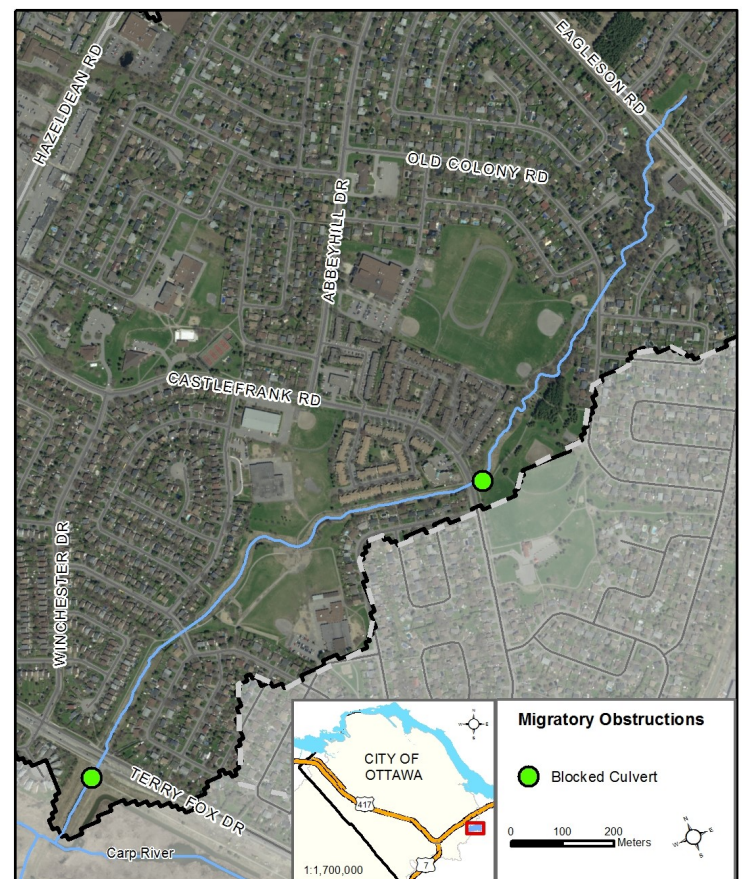
**Figure 26: Map of migratory obstructions on Carp Creek, 2017.**

As seen in Figure 26, 2 blocked culverts were noted during the survey of Carp Creek.

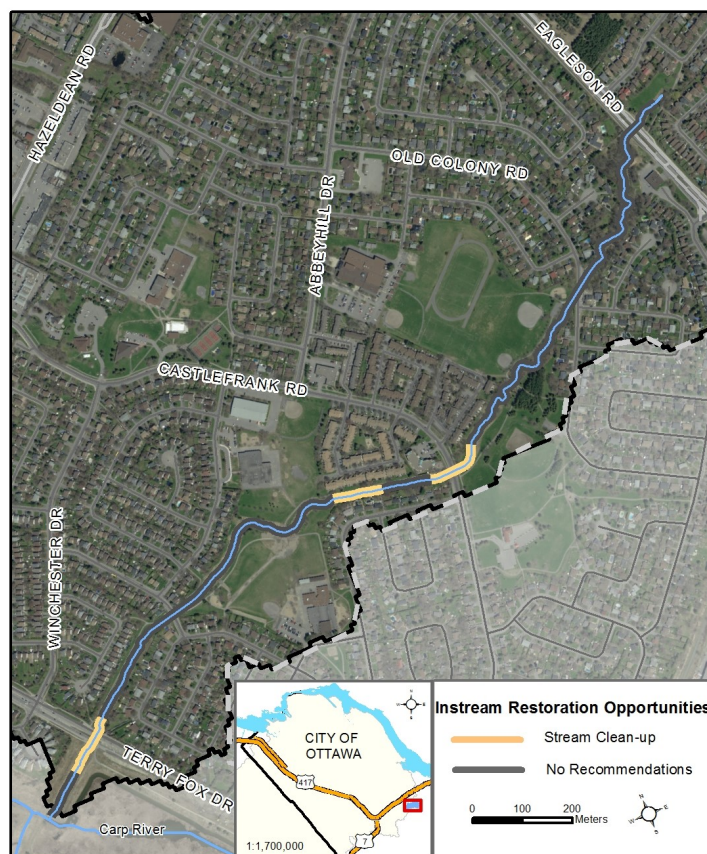
**Figure 27:** Areas for potential restoration projects along Carp Creek.

A much larger project will be to organize some reoccurring Himalayan Balsam pulls as this invasive species is found along the entire channel.

Other potential steps will be to contact landowners and community members to explore the potential for collaboration to work together on a voluntary basis to enhance their shorelines through a number of potential activities, such as increasing the unmowed areas along the shore, garbage clean ups and invasive species removal days.

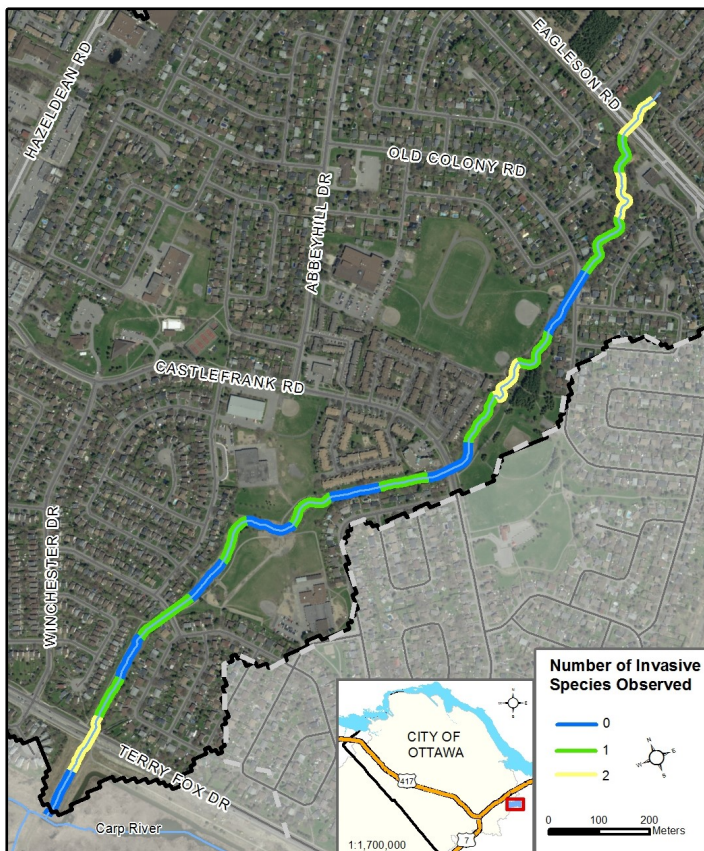
**Figure 28:** Identified invasive species abundance in Carp Creek.

Figure 28 shows that although there are seven identified invasive species in the Carp Creek Corridor, they are not all found everywhere.

Invasive species such as Buckthorn, Wild Parsnip, Himalayan Balsam, Purple Loosestrife and Garlic Mustard continue to grow throughout the creek corridor. This year Giant Hogweed and Dog Strangling Vine were also identified in the upper reaches during the survey.

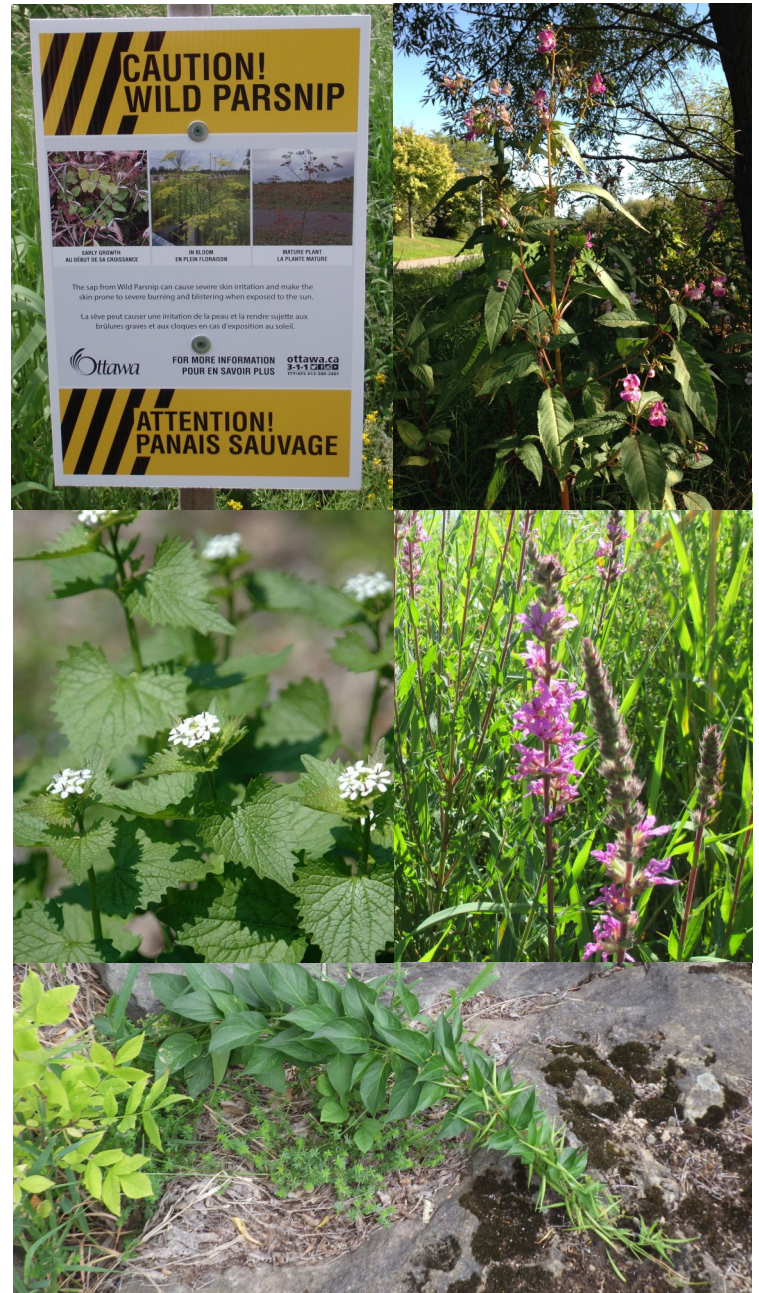
Carp Creek valley lands contain Wild Parsnip, Himalayan Balsam, Purple Loosestrife and Garlic Mustard (Shown above, clockwise), lastly at bottom Dog Strangling Vine.
