Huntley Creek

2017 Catchment Report

Monitoring Activity in the City of Ottawa

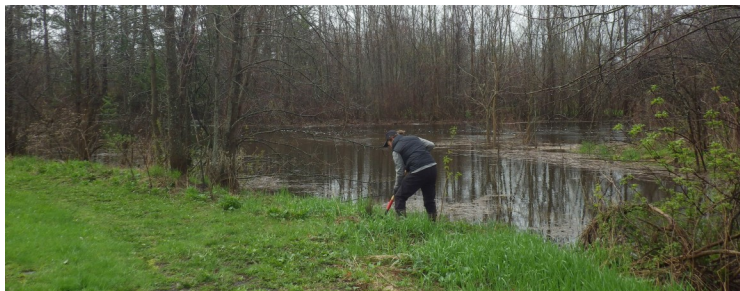
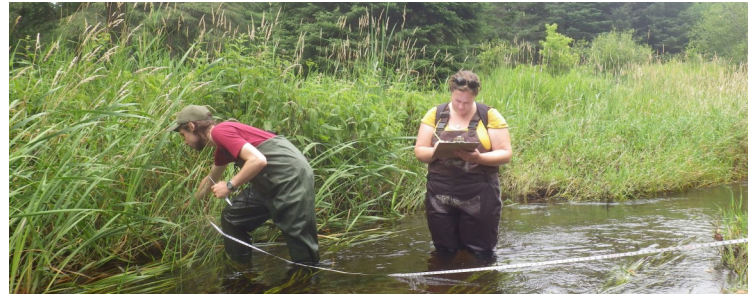
The photos above and below are examples of sites where MVCA has made a partnership with property owners along Huntley Creek to improve their riparian buffer zones.

The next steps will be to contact landowners and explore the potential for collaboration with them on a voluntary basis to enhance their shorelines through a number of potential activities, such as increasing the width of unmowed areas along the shore and/or agreeing to plant and maintain native shoreline species of trees or shrubs. This will improve shoreline buffer widths as well as improve stream shading as the trees and shrubs mature.

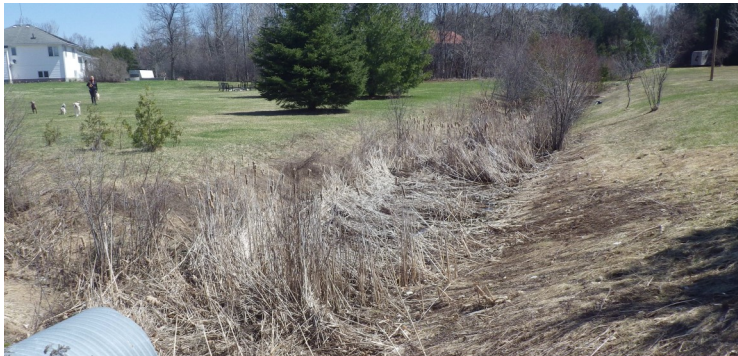
HDF Vegetation

Forest and Wetland were the dominant feature vegetation types. Wetland, Forest, Scrubland and Meadow were the dominant riparian vegetation types. Lawn and crops were present near a few features as can be seen in the photo above.
