Cody Creek

2018 Catchment Report

Monitoring Activity in the City of Ottawa

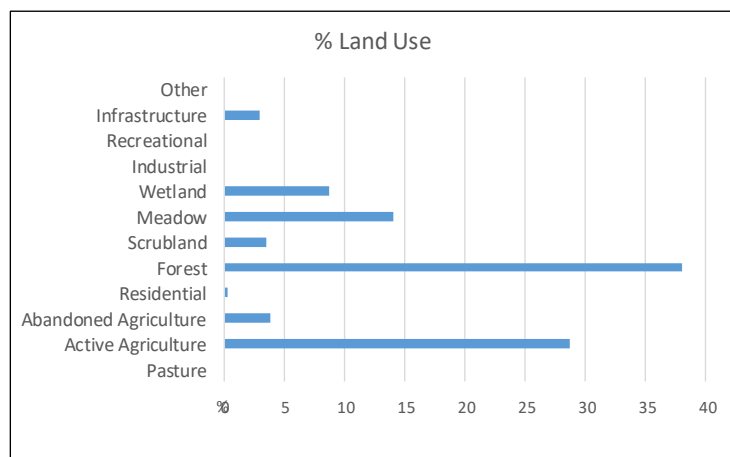
Figure 4: Land use alongside Cody Creek.

Of the eleven categories, industrial and recreational were not found to be present along surveyed sections. At 38%, forest represents the most prominent category of land use followed by active agriculture at 29%, and meadow at 14%.

As described on page 2, the land use in the watershed is dominated by agriculture. This is reflected well in the percentages seen in Figure 4 (29% active, 4% abandoned). However, the land use observed directly adjacent to the creek is dominated by forest (38%). This is a benefit to the creek as well as the surrounding landscape as this forest cover provides shade, habitat and food for a wide variety of animals, cools the water and protects the banks from erosion. Meadow (14%) and wetland habitat (9%) round out the diversity of habitats on the landscape and contribute to erosion mitigation.

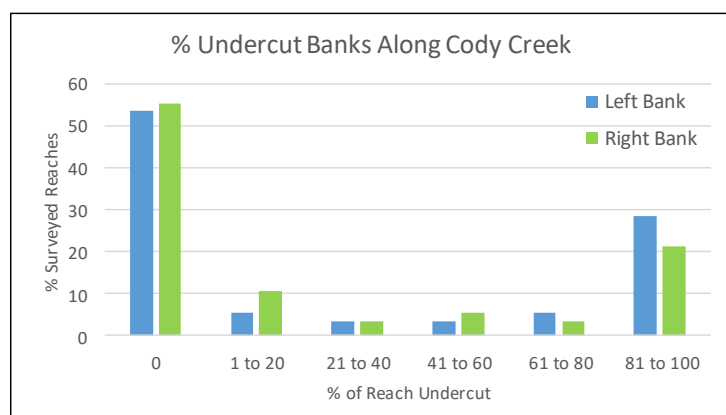
Figure 12: Percent undercut stream banks along Cody Creek.

Figure 12 shows the percentage of undercut stream banks along each surveyed section of Cody Creek. Overall, the sections of Cody Creek that were surveyed were found to have very little undercutting. However, 29% of the left bank and 21% of the right have a high degree undercutting. Other shoreline erosion types such as slumping and landslide locations were also noted during the surveys.

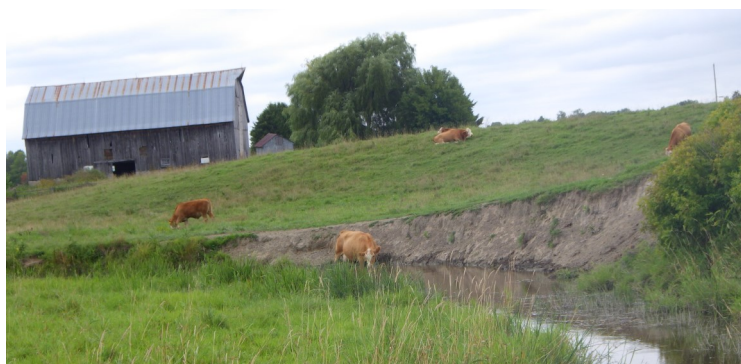
Figure 28: Extent of cattle access in the surveyed sections of Cody Creek.

Of the 16 reaches where cattle access to the creek was observed, 12 reaches had notable field erosion along the banks. Foot traffic along the banks as well as the close grazing of the vegetation makes it hard for the plants to grow deep strong root systems that would help hold the predominantly clay soils together during high water level or flow events.

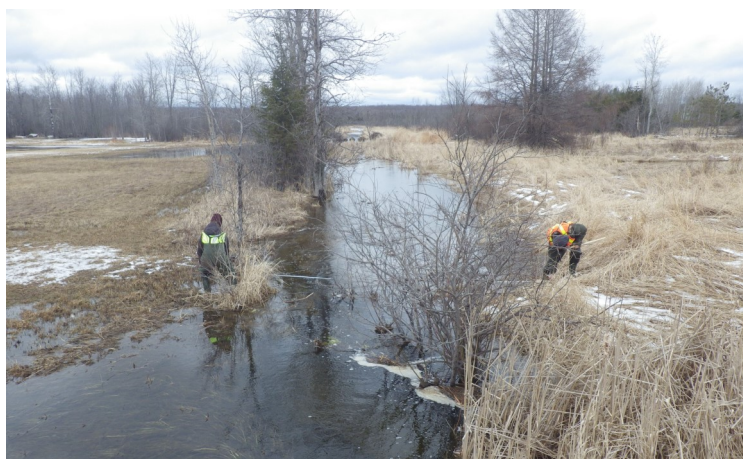
Figure 29: Headwater drainage feature sampling sites in the Cody Creek watershed.

The City Stream Watch program assessed 12 Headwater Drainage Features in the Cody Creek subwatershed in 2018 (Figure 29).

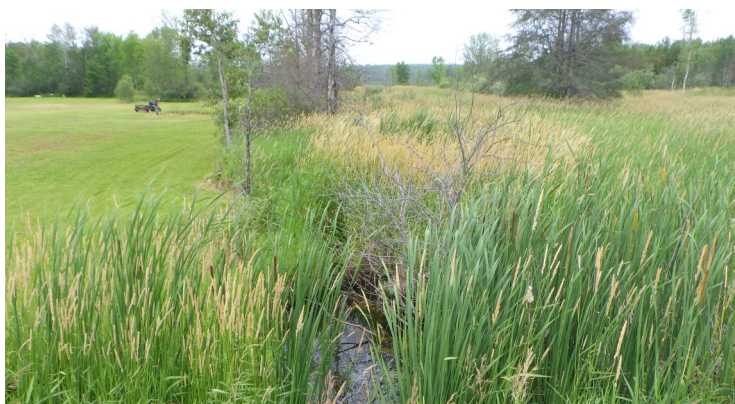
There were drought conditions in the summer of 2018, however only 3 of the monitored headwater features were dry in August.

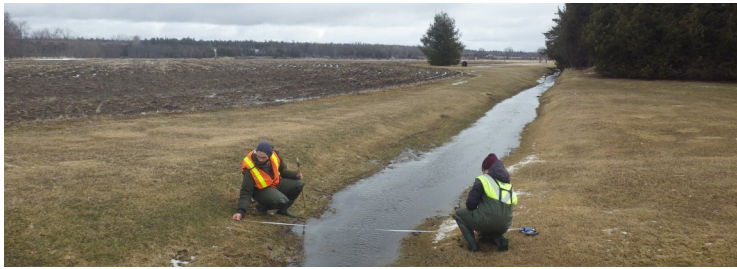
Channel modifications noted at the Cody Creek HDF sites include channelization and roadside ditch maintenance.

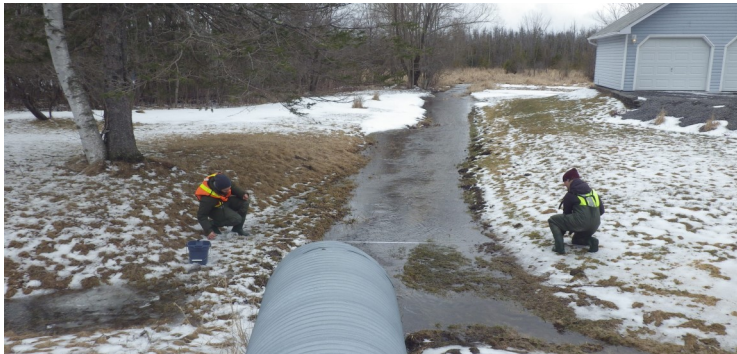
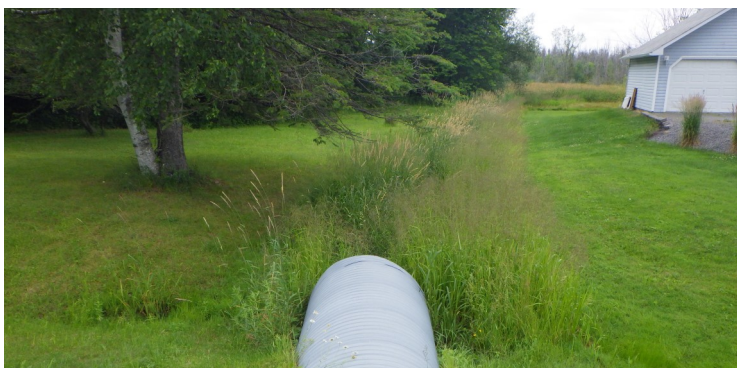
Meadow and Scrubland were the dominant feature vegetation types. Cropped Land, Scrubland and Lawn were the dominant riparian vegetation types. Examples of crops and lawns near two features assessed can be seen in the photos above and below.
