Poole Creek

2018 Catchment Report

Monitoring Activity in the City of Ottawa

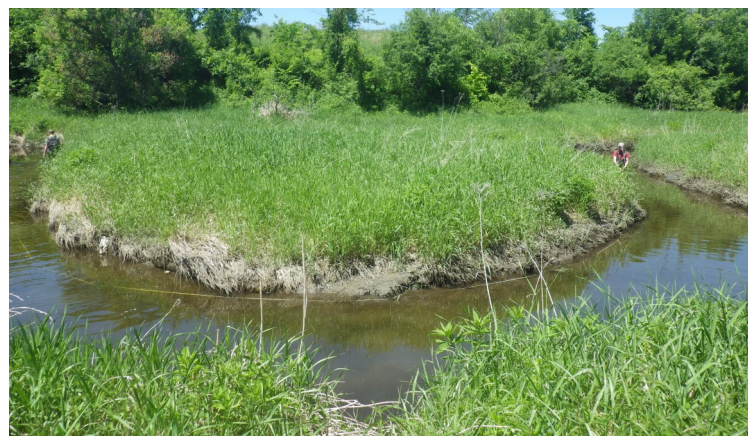
The categories of land use include infrastructure, active agriculture, pasture, abandoned agricultural fields, residential, forests, scrubland, meadow, and wetland. Figure 4 shows the overall percent of land use that was observed adjacent to Poole Creek.

The land use in the overall watershed is dominated by forest and wetland cover in the headwaters and urban development with park space corridors along the creek (Figure 2). Figure 4 shows the land use types found along the surveyed sections of Poole Creek. The meadow spaces are predominately in the lower reaches of the creek where there is less forest cover. This meadow habitat may not provide much shade to the water but it does provide a wide vegetated buffer which supports a diversity of plants and animals and helps slow overland runoff and soak up nutrients that might otherwise impact the creek.

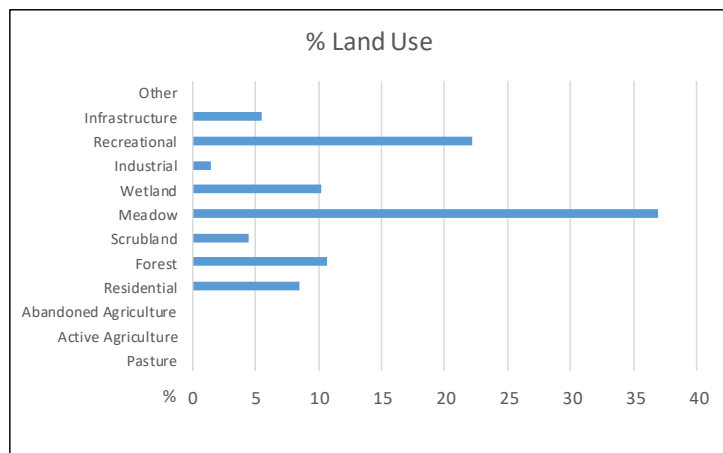
Figure 4: Land use alongside Poole Creek.

The three agricultural categories were not found to be present along surveyed sections of Poole Creek.

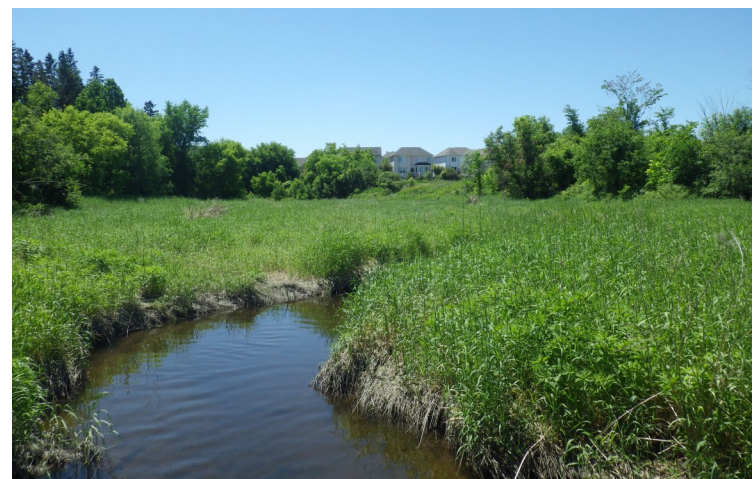
Overall, Poole Creek has a high amount of coverage from overhanging trees and branches, as seen in Figure 8, with 60% of the reaches having some level of overhanging trees and branches. This reflects the surrounding natural vegetative community where the creek passes through forested areas and treed park spaces.

Figure 8 shows the data quantified as the percentage of creek sections classified according to the various amounts of overhanging trees and branches. For example, over 40% of the 53 surveyed stream sections were classified as having zero overhanging trees and branches along both the left and right bank. In contrast, over 40% of the surveyed stream sections were found to have greater than 41% overhanging branches providing food and shade to the creek.

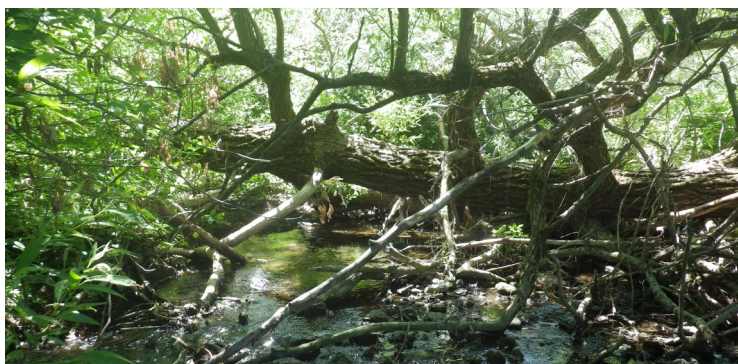
Figure 9 shows the distribution of the areas with overhanging trees and branches or without. For example the portion of the creek east of Stittsville Main Street (behind the grocery store) has few overhanging trees or branches as it is a cattail marsh, whereas the portions of the creek west of Stittsville Main Street are in the forested area beside the arena and have a high abundance of overhanging trees and branches.

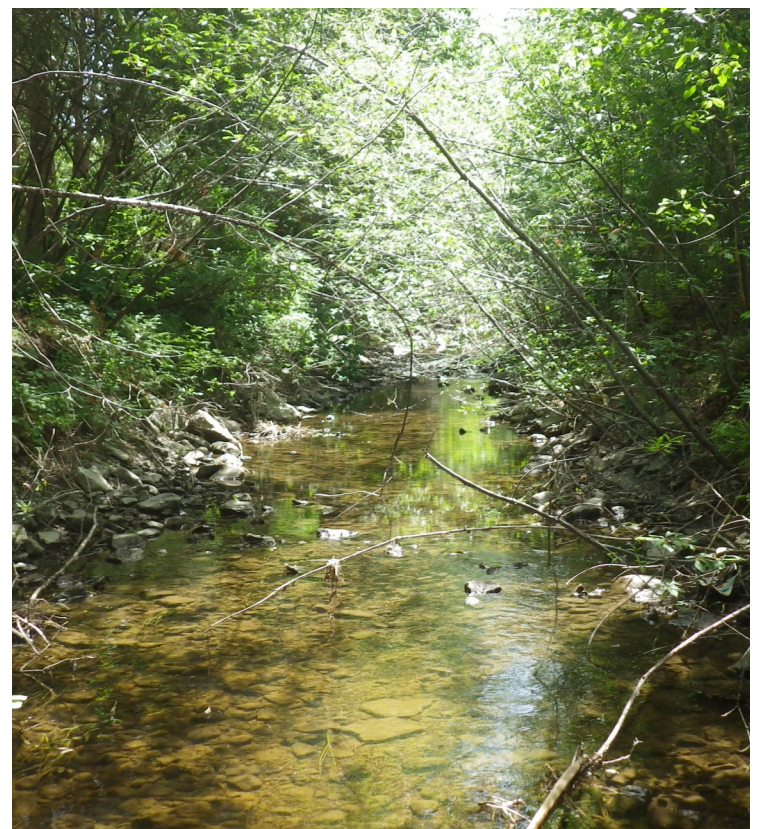
Figure 10 shows the variability in the amount of stream shading along different sections of Poole Creek. The variability is due to the diversity of riparian vegetation along the creek, with large sections of open meadow, wetland or shrub land contrasted with areas of shade producing forest. (Figure 7)

The distribution of the 11% forest cover, and its associated shade provided to the creek, is best illustrated in Figure 10.

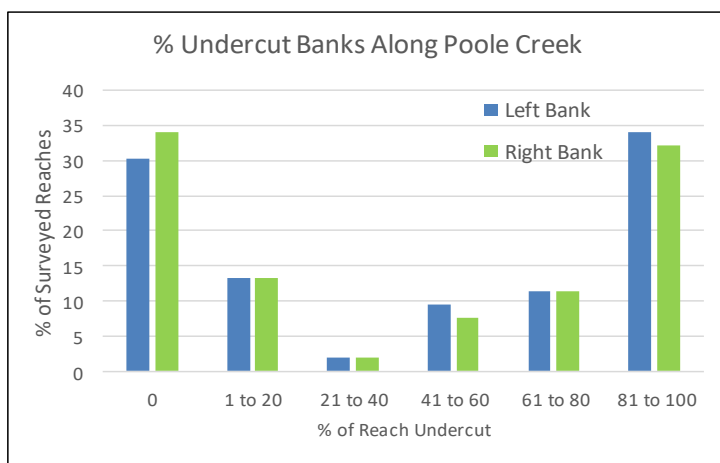
Figure 12: Percent of undercut stream banks along Poole Creek.

Figure 12 shows the percentage of undercut stream banks along each surveyed section of Poole Creek. Overall, the sections of Poole Creek that were surveyed were found to have a high amount of undercutting with over 40% having greater than 60% undercutting along their lengths.

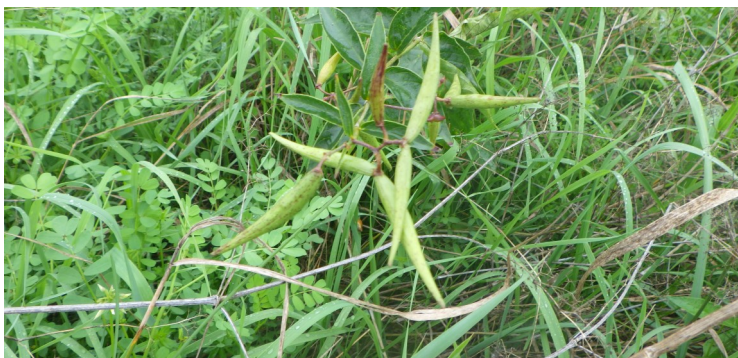
Top: Dog Strangling Vine seed pods on the banks of Poole Creek.

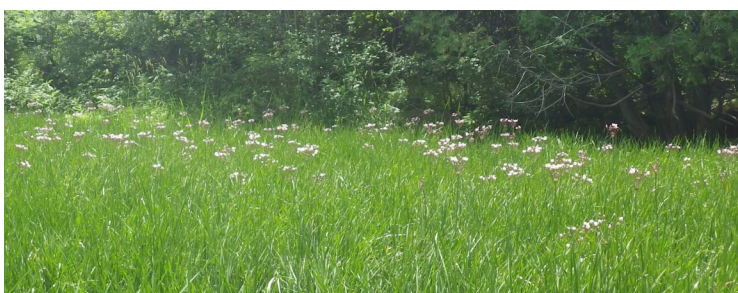
Bottom: A colony of Flowering Rush in Poole Creek.

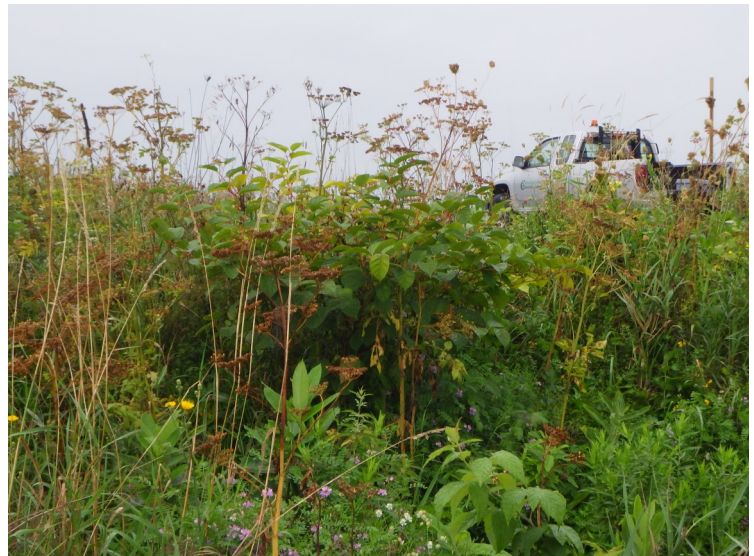
Poison Parsnip and Japanese Knotweed along Poole Creek.
