Kizell Drain 2016 Summary Report

Monitoring Activity in the City of Ottawa

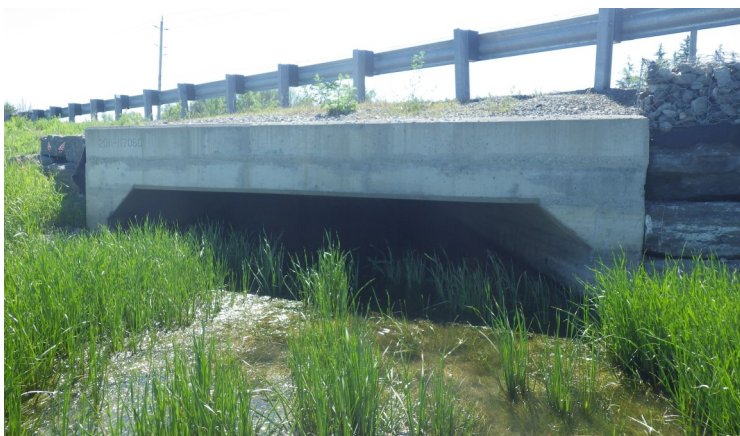
Figure 3: Locations of the monitoring sites along Kizell Drain.

In 2016, permission was granted to survey 44 sections of Kizell Drain, shown on Figure 3, which cover approximately 4.4 km of the main channel. The portions of the drain that were not sampled represent mostly the wetland areas that could not be assessed using the macro stream assessment protocol and areas where permission was not granted.

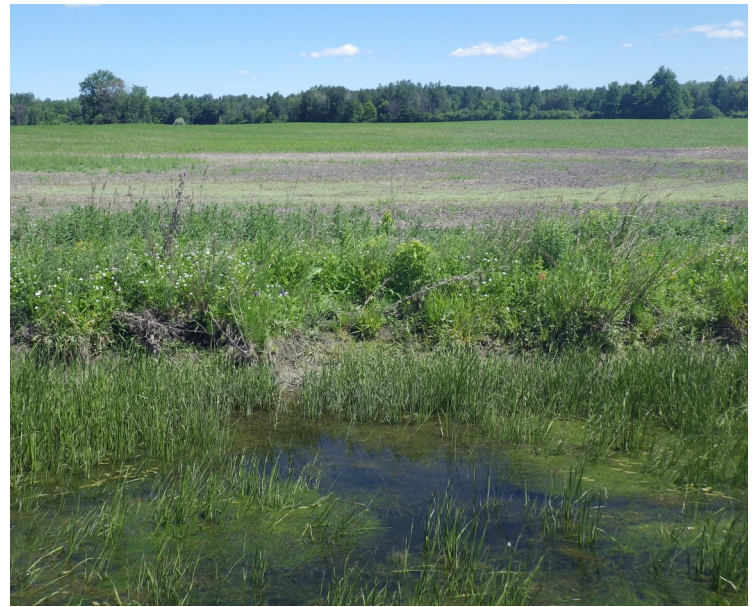
Figure 6: Riparian buffer widths along Kizell Drain.

Environment Canada's Guideline: *How Much Habitat is Enough?* recommends a minimum 30m wide vegetated buffer along at least 75% of the length of both sides of a watercourse. Therefore, for this assessment, we record the width of the riparian buffer within 30m of either side of the watercourse. As summarized in Figure 6, we found that the sections of Kizell Drain that were surveyed have a relatively good riparian buffer. Results show that 57% and 73% of the left and right bank respectively, has a buffer width of 5-15 meters. 31% and 27% of sections have a buffer of 5 m or less. The photo to the top right, shows a lack of buffer between agricultural lands and Kizell Drain in the red areas on the map. Another contributing factor to a reduced buffer is the alignment of the road network where Carling Avenue crosses Kizell Drain.

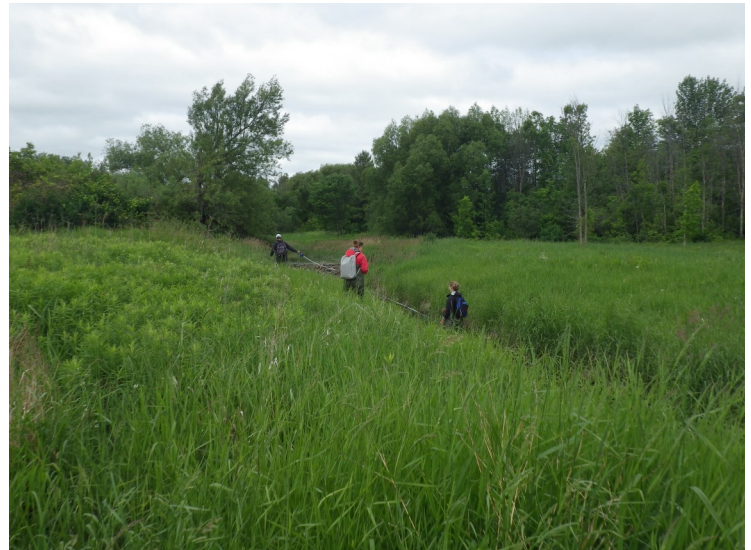
Figure 10: Stream Shading along Kizell Drain.

Figure 10 shows the variability in the amount of stream shading along different sections of Kizell Drain. We can see that the shading is extremely variable. This is due to the diversity of riparian vegetation along the creek, with large sections of open meadow/wetland habitat in the lower reaches and dense forest cover near the Beaver Pond outlet as seen in the photos in the lower right.

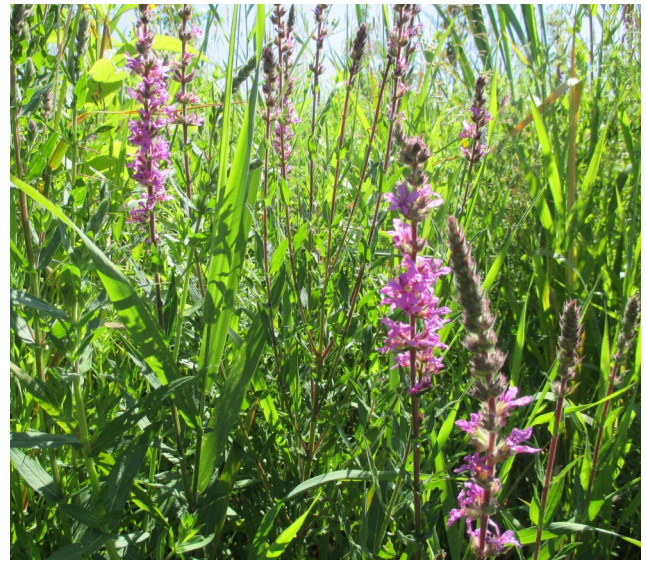
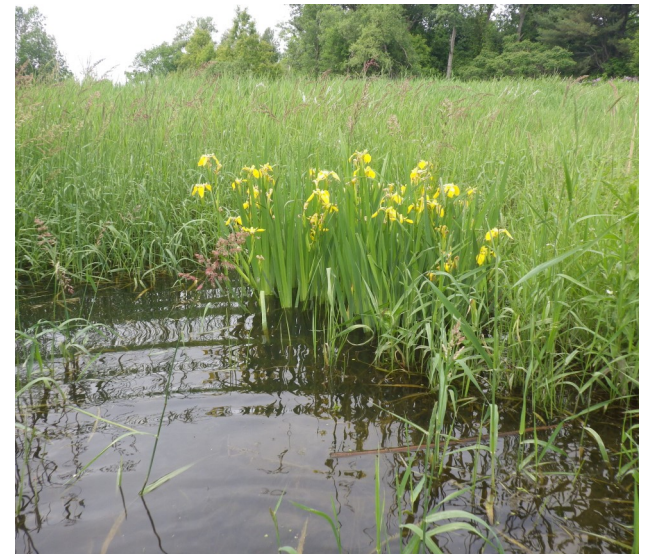
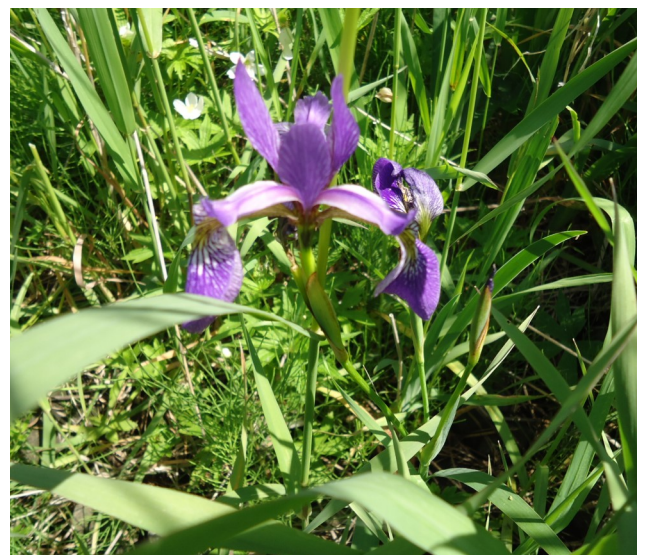
Photos top to bottom: Invasive Purple Loosestrife, Invasive Yellow Iris, Native Blue-Flag Iris.

Other potential enhancement activities would involve removing a small stand of Yellow Iris, and doing a garbage clean up where a park pathway crosses the drain in the upstream reach.
