Shirley's Brook 2016 Summary Report

Monitoring Activity in the City of Ottawa

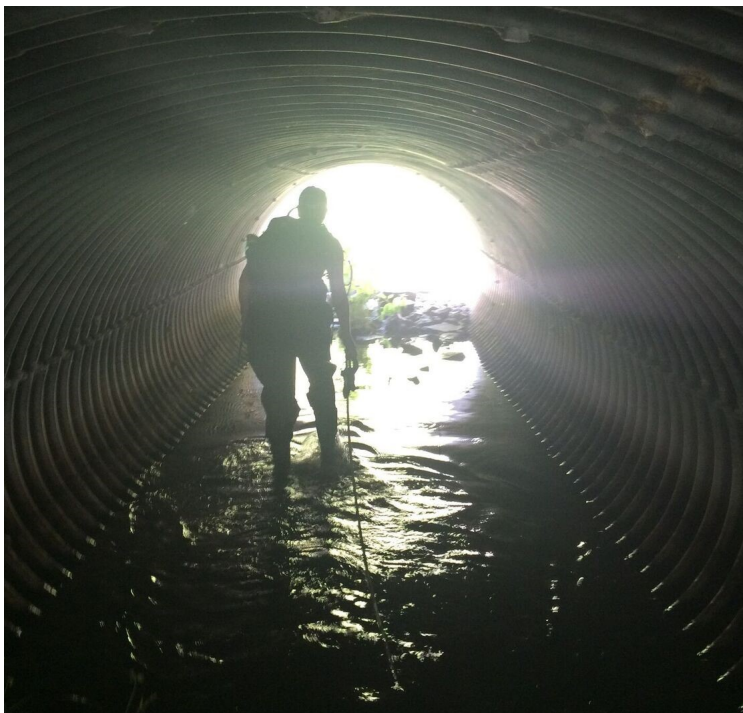
Figure 3: Locations of the monitoring sites along Shirley's Brook.

In 2016, permission was granted to survey 52 sections of Shirley's Brook, shown on Figure 3, which cover approximately 5.2 km of the main channel. The portions of the brook that were not sampled represent the wetland areas that could not be assessed using the macro stream assessment protocol, the golf course and areas where permission was not granted.

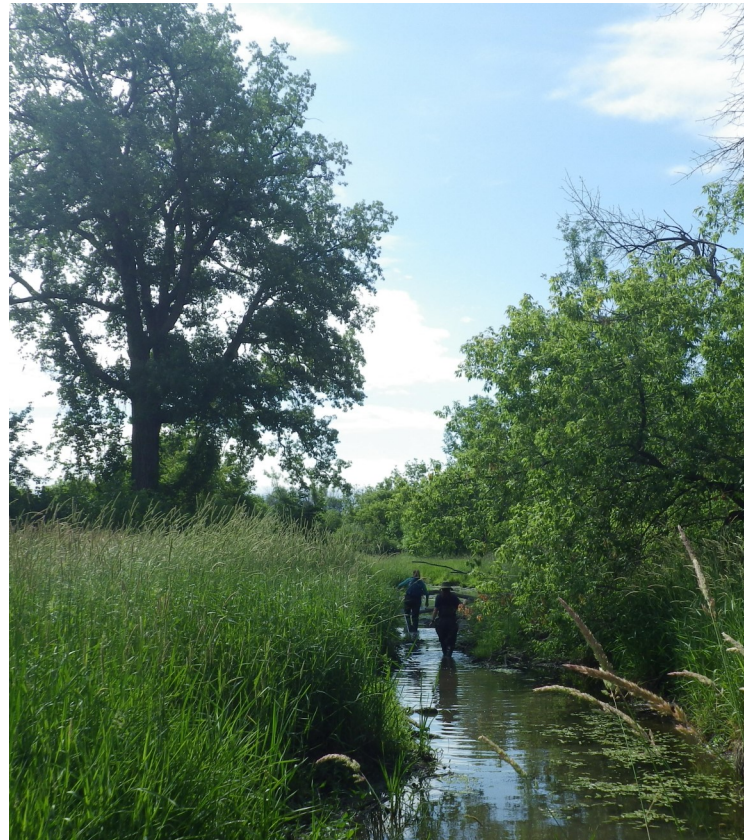
Figure 11: Shading along Shirley's Brook.

Figure 11 shows the data quantified as the percent of creek sections classified according to the various levels of shading. For example, 60% of the 45 stream sections that were surveyed were classified as having low to moderate amounts of shade (1 to 60% shading/ 100m section).

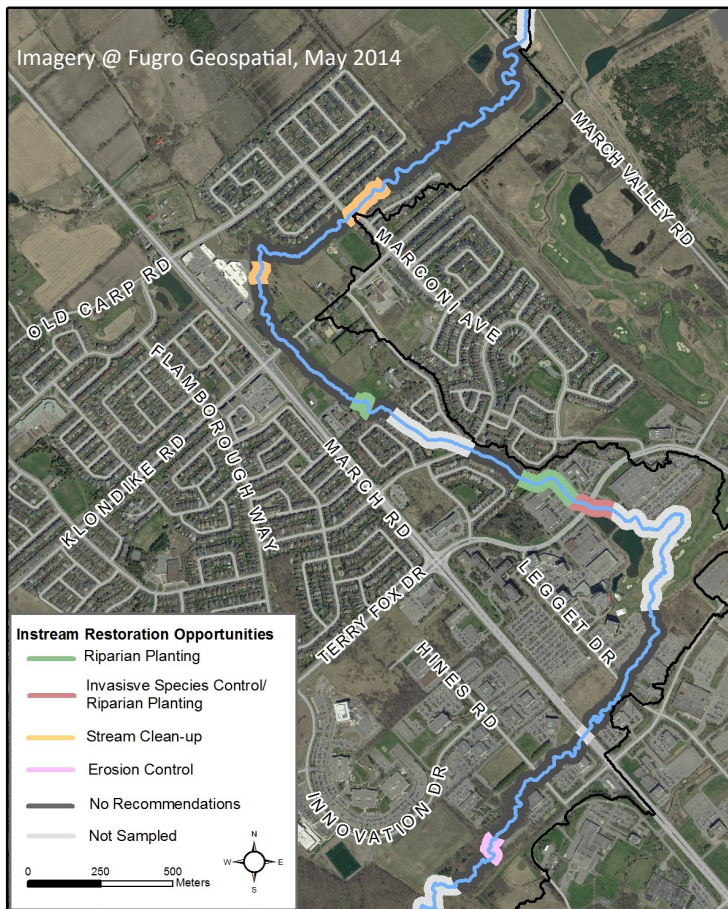
Figure 20: Areas for potential restoration projects along Shirley's Brook.

Figure 20 depicts the locations identified by MVCA staff and volunteers, as areas for potential restoration activities.

The next steps will be to approach the landowners and work with them on a voluntary basis to enhance their shorelines through a number of potential activities, such as increasing the unmowed areas along the shore or agreeing to plant and maintain native shoreline species of trees or shrubs.

Other activities that would benefit Shirley's Brook include the removal of invasive species such as Yellow Iris and Dog-Strangling Vine, and garbage clean-ups near road crossings as well as behind commercial buildings.
