# CARP CREEK EMBANKMENT RESTORATION CONSERVATION ONTARIO CLASS ENVIRONMENTAL ASSESSMENT ADDENDUM - PROJECT PLAN REPORT

Project No.: CM-17-0429-02

March 2021

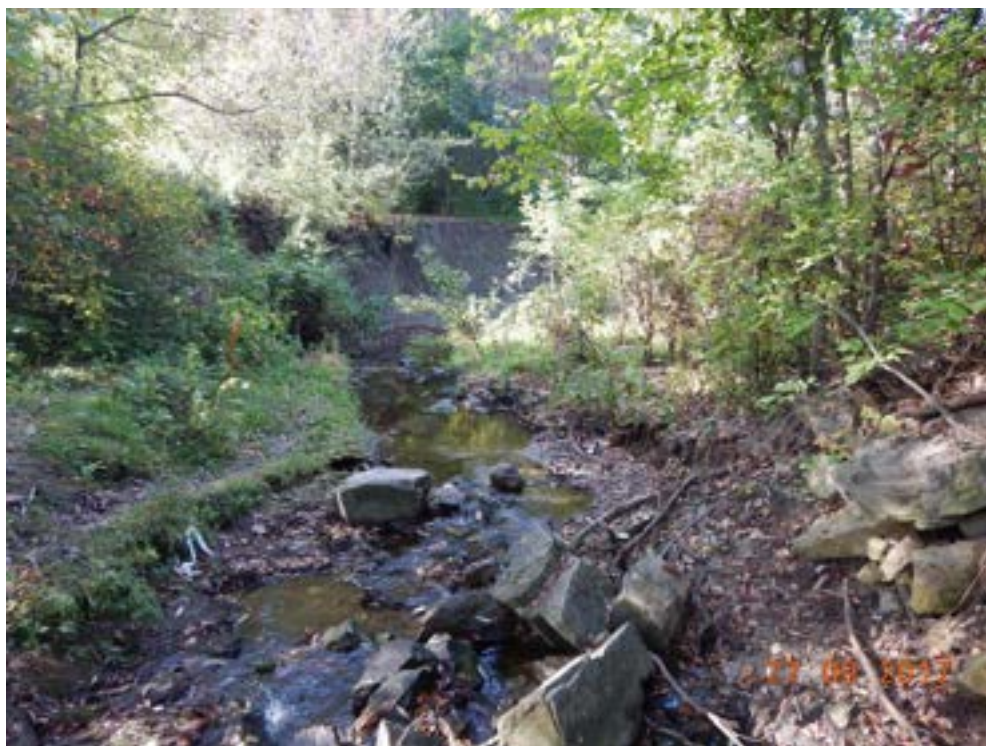
Photo 1: Carp Creek study area, watercourse and embankment scour downstream of riffle and pool, facing southwest (downstream)

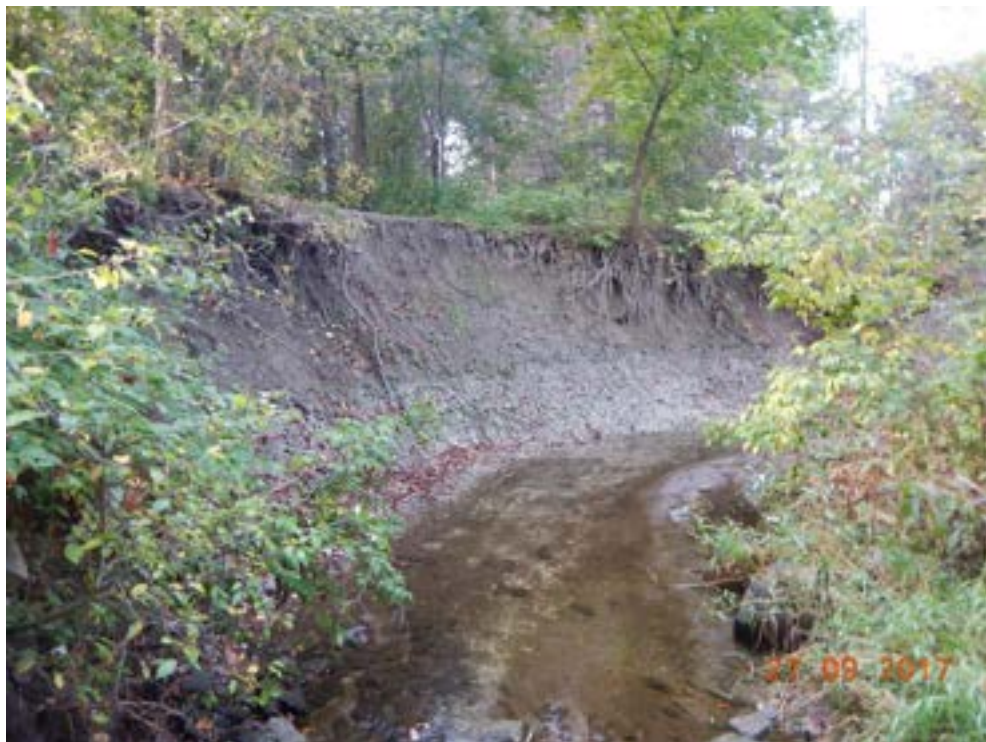
Photo 3: Eroded embankment, facing southwest

The creek embankment at the above noted property is excessively eroding (south embankment) which has produced approximately 3.3 m of close to vertical cut through the existing topsoil and clay. The clay at the exposed surface was observed weathered. The eroded area is located at a sharp creek meander, which is exposed to excessive erosion forces at the time of high flood level and high velocity.

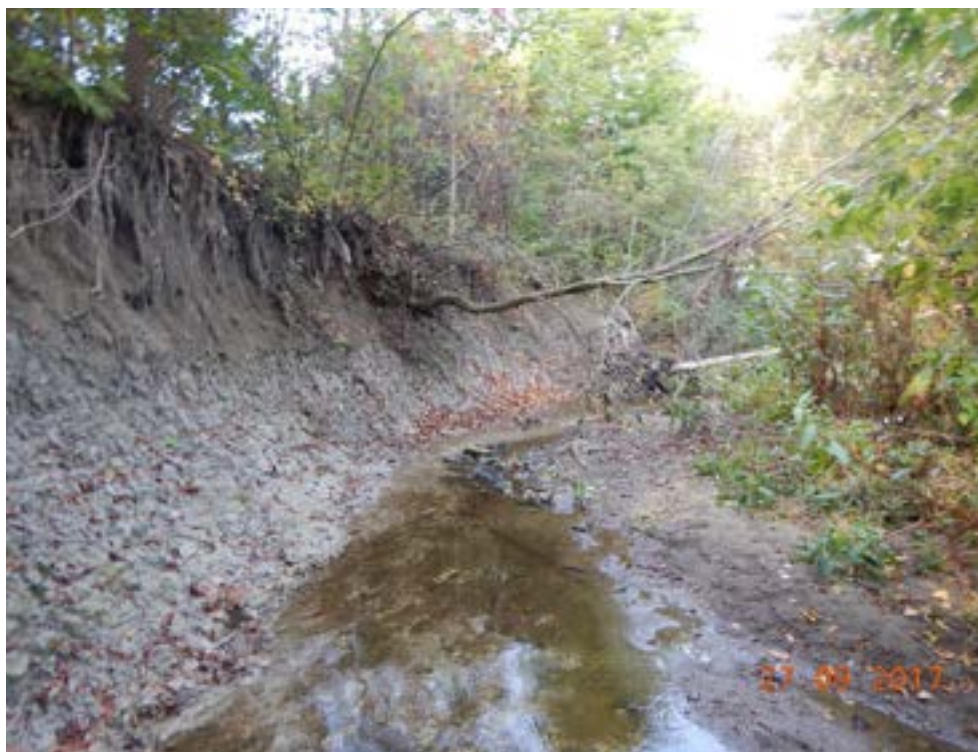
Photo 4: Eroded embankment, facing southwest

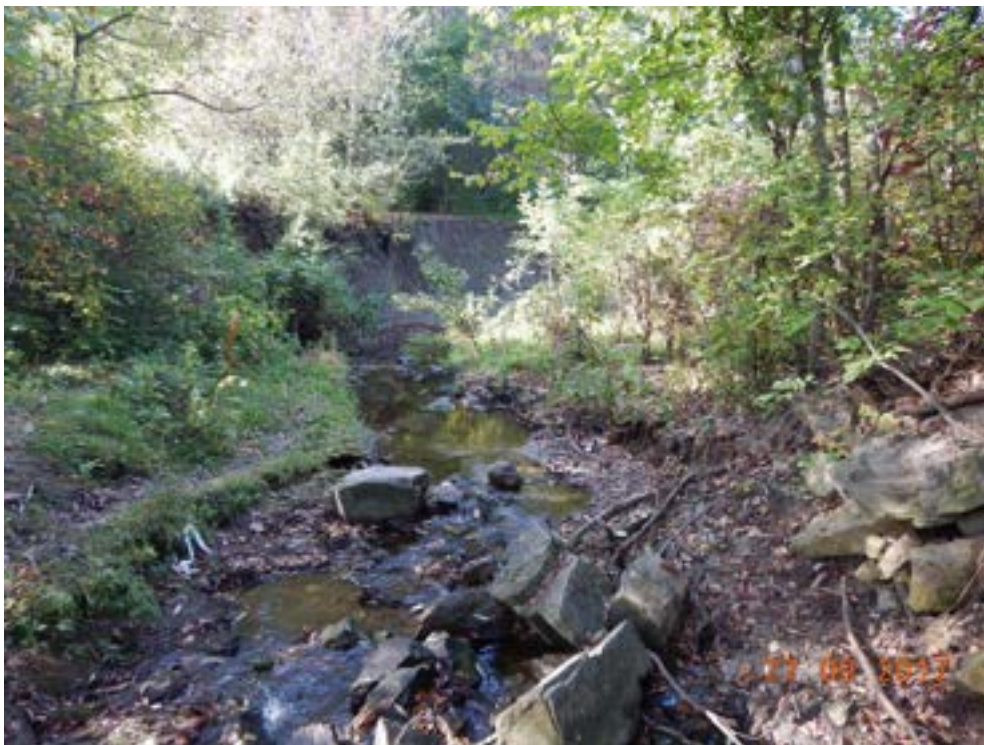
Photo 1: Carp Creek study area, watercourse and embankment scour downstream of riffle and pool, facing southwest (downstream) (considered the east bend). 27 September 2017.

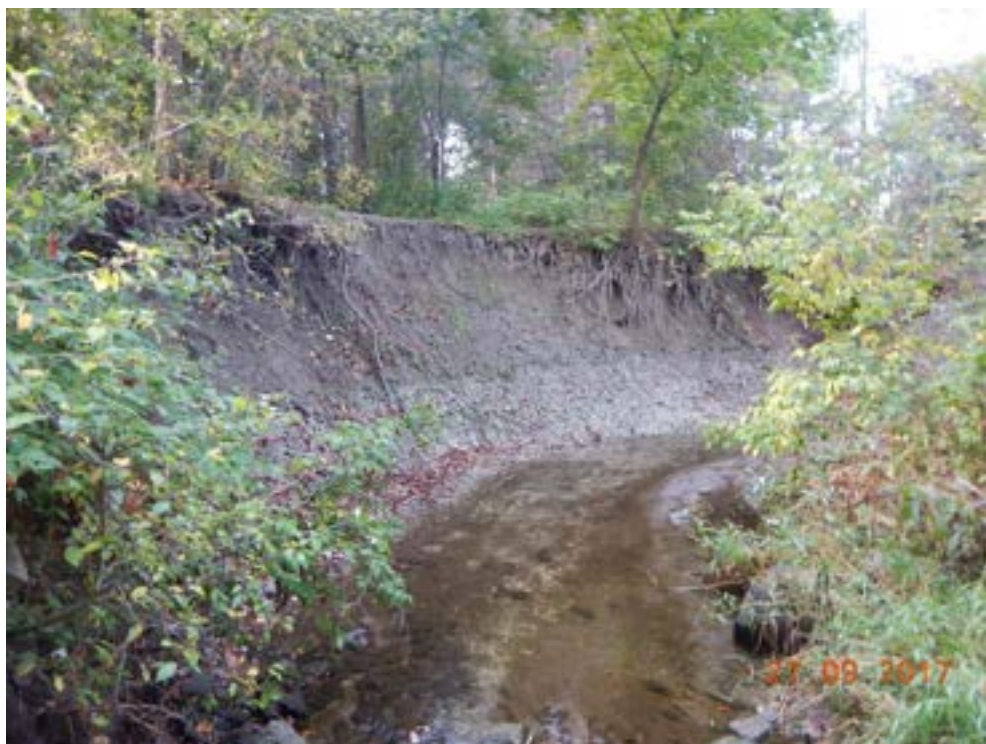
Photo 3: Eroded embankment at east bend, facing southwest. 27 September 2017.

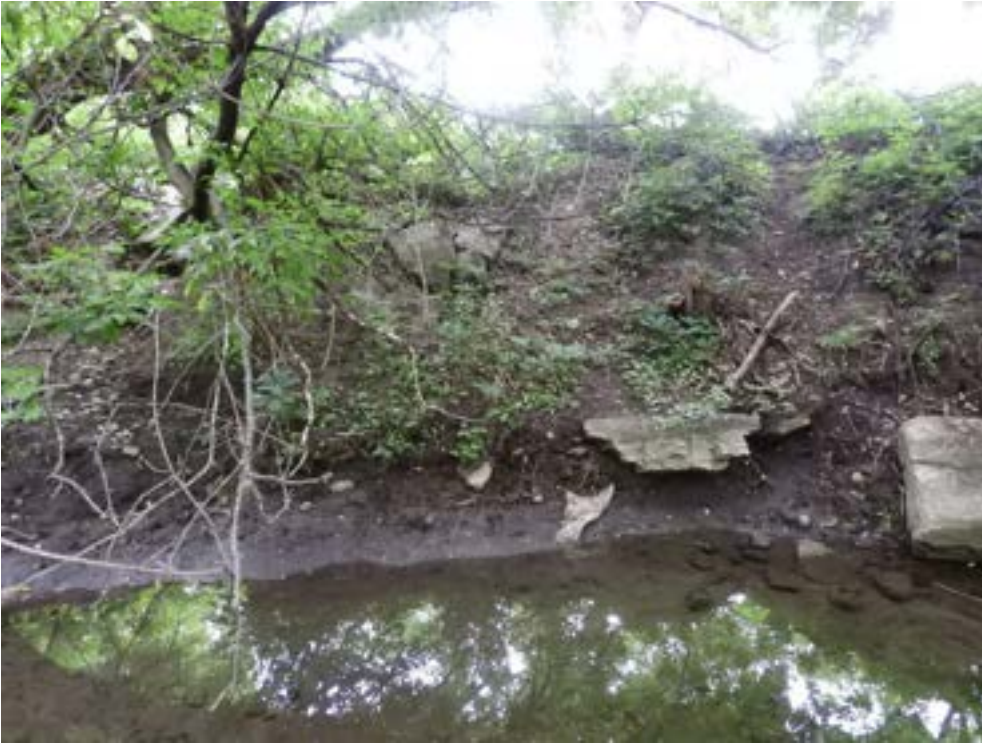
Photo 5: Eroded embankment at west bend, facing north. 24 June 2020.

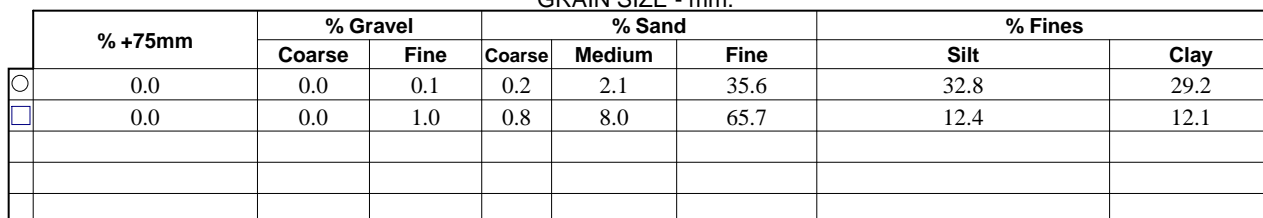
**Figure 3**

SOIL DATA					
SYMBOL	SOURCE	SAMPLE NO.	DEPTH (ft.)	Material Description	USCS
○	Carp Creek	BH2001SS03	5.0-7.0'	Clayey Silty Sand	
□	Carp Creek	BH2002SS04	7.5-9.5'	Sand some Silt some Clay trace Gravel

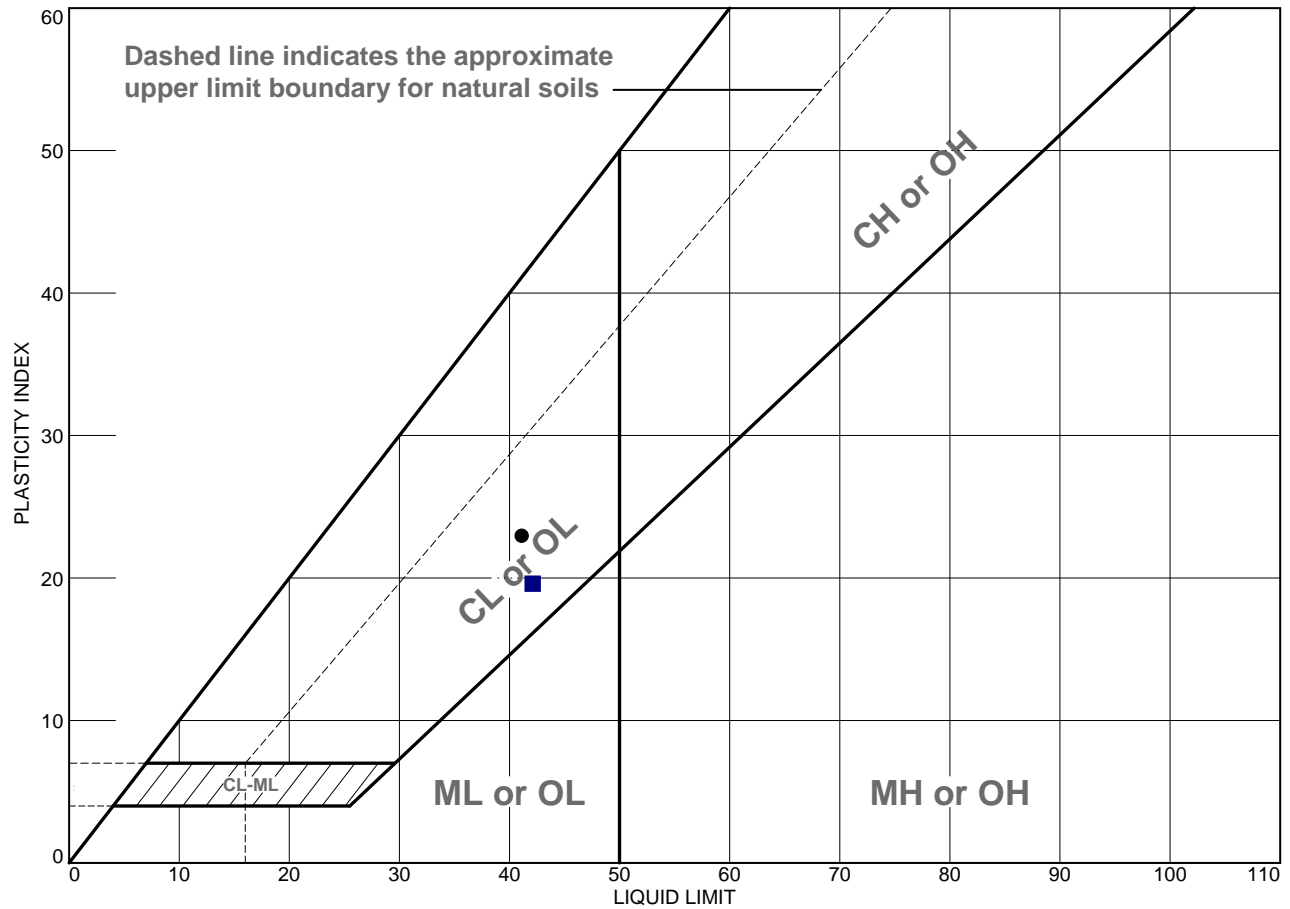
# LIQUID AND PLASTIC LIMITS TEST REPORT

MATERIAL DESCRIPTION	LL	PL	PI	%<#40	%<#200	USCS
●	Clay Low Plasticity	41.2	18.3	22.9			
■	Clay Low Plasticity	42.1	22.5	19.6

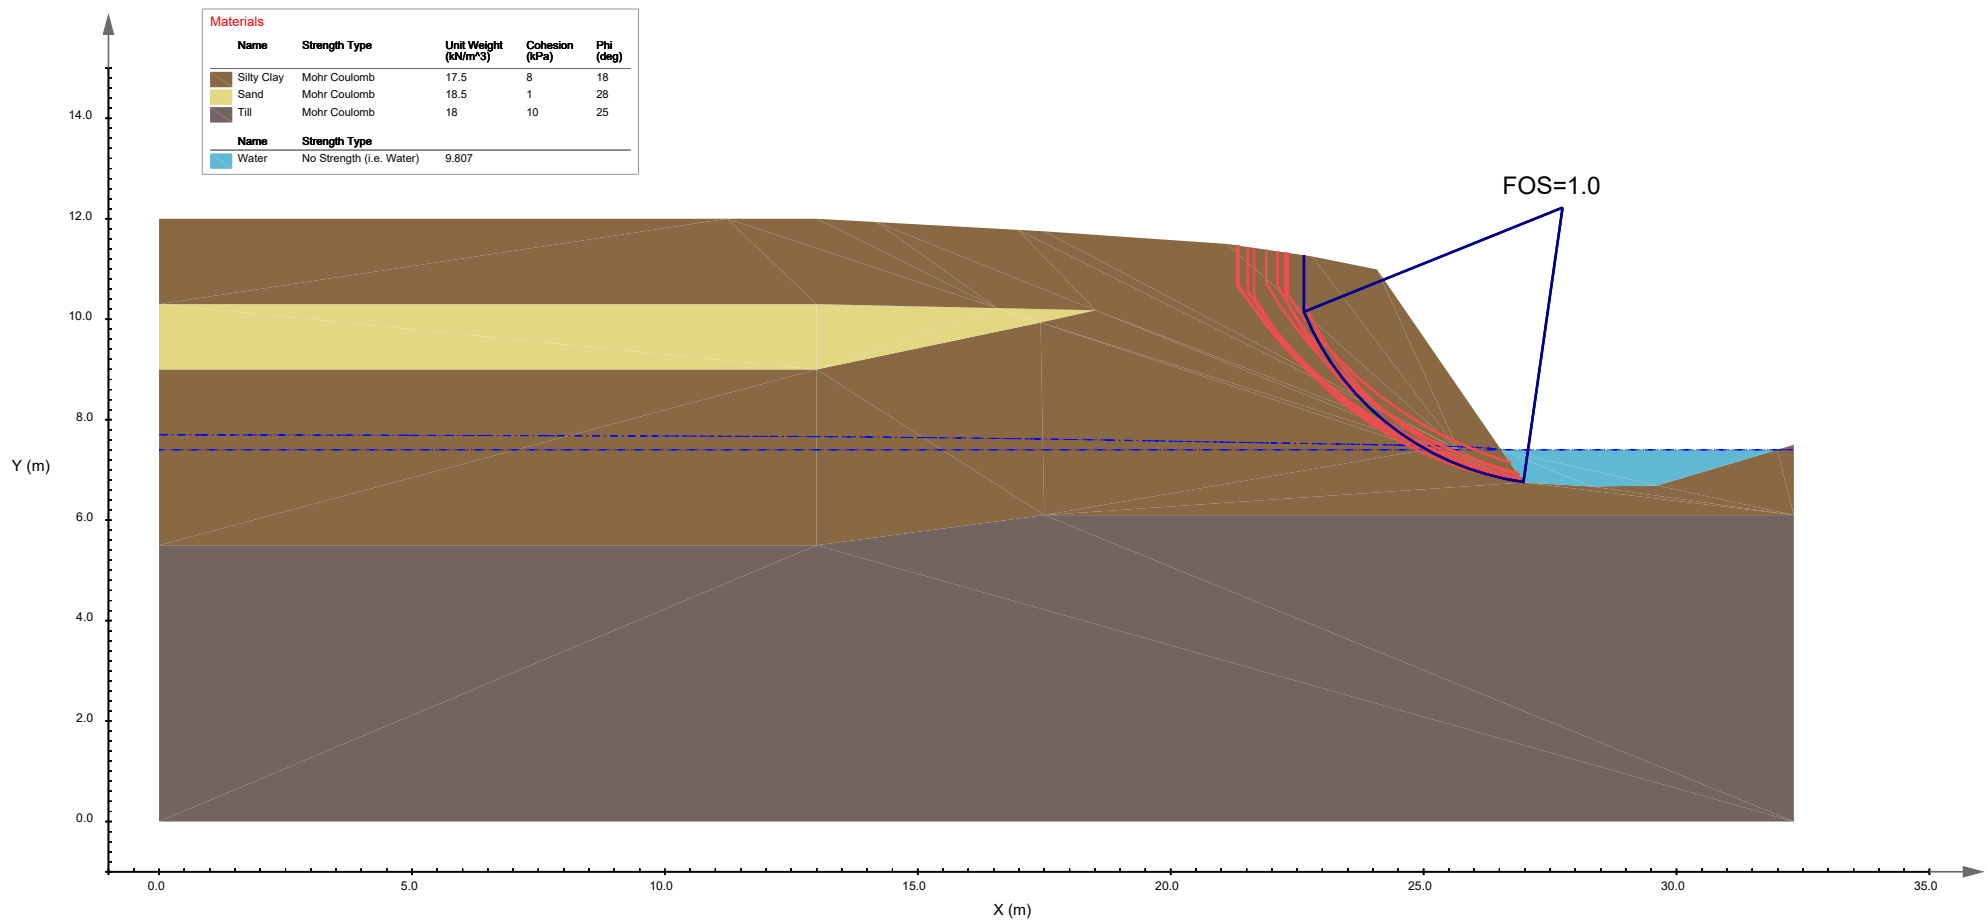
PROJECT			Carp Creek Restoration	
TITLE			Slope Stability Analysis	
McINTOSH PERRY	PROJECT No.		0CM-17-429-	File No.
	Author		FIGURE 1	
	Date		2020-08-12

- Slope stability analyses were performed to evaluate the current slope condition, to provide a suitable backslope gradient and to estimate the factor of safety (FOS) against failure. Slope stability analyses for Long-term condition under sustained loads and short-term condition under seismic loading were performed using SoilVision's limit equilibrium software, SVSlope, and finite element software, SVFlux GT coupled analysis. The model was developed based on existing site topography and soil stratigraphy. Tension cracks due to the presence of a desiccated clay layer was considered in the analyses.

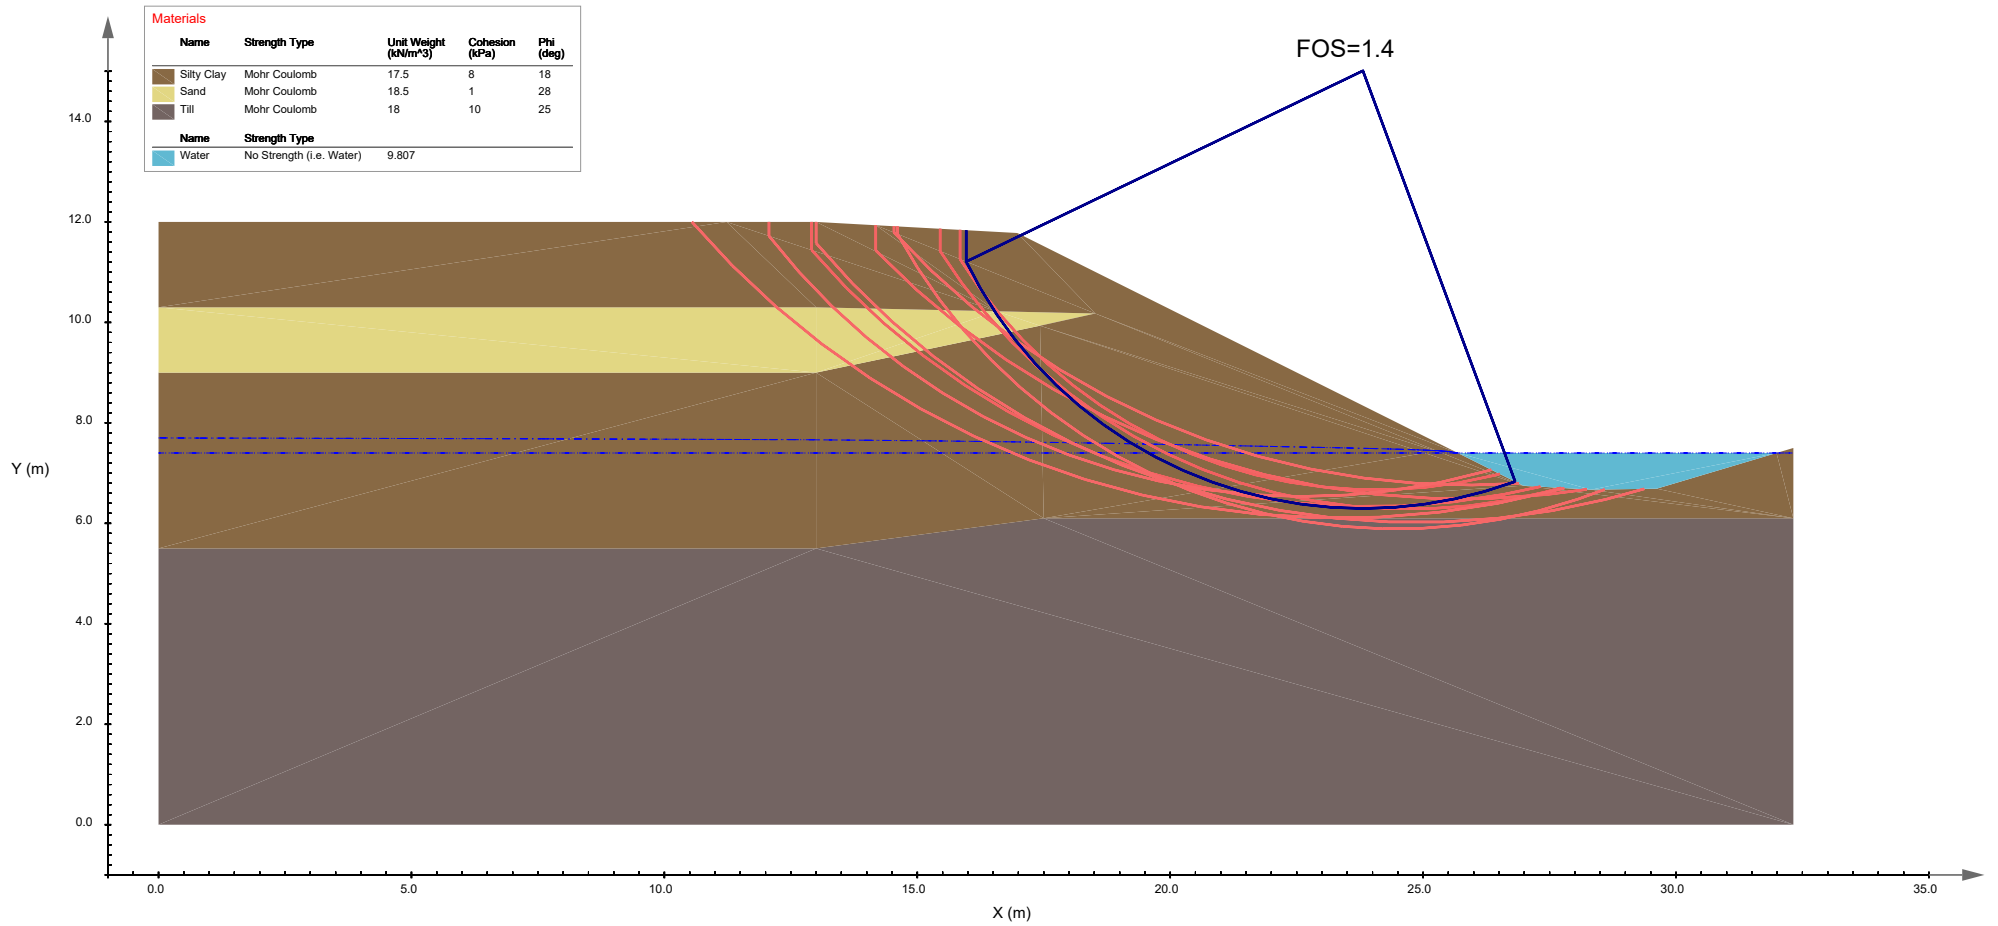
PROJECT			Carp Creek Restoration	
TITLE			Long-term Slope Stability Analysis (2H:1V)	
McINTOSH PERRY	PROJECT No.	0CM-17-429-	File No.	
	Author		FIGURE 2	
	Date	2020-08-24

- Three slope cut ratios were investigated (2H:1V, 2.5H:1V and 3H:1V). The minimum global and local factor of safety (FOS) is presented in Table 1. The global FOS of safety is for the whole slope while the local FOS is for specific zones in the slope. The soil profile at Carp Creek constituted of three soil layers, clay, sand and till. The local slope failures were observed under seismic loading within the sand (alluvial) deposit. Under certain circumstances, sand is known to exhibit liquefaction behavior when subjects to seismic loads which could be a possible reason to trigger local slope failure. Therefore, slope cut of 2.5H:1V ratio is recommended. Also, any steeper slope is not recommended from a surface erosion perspective.

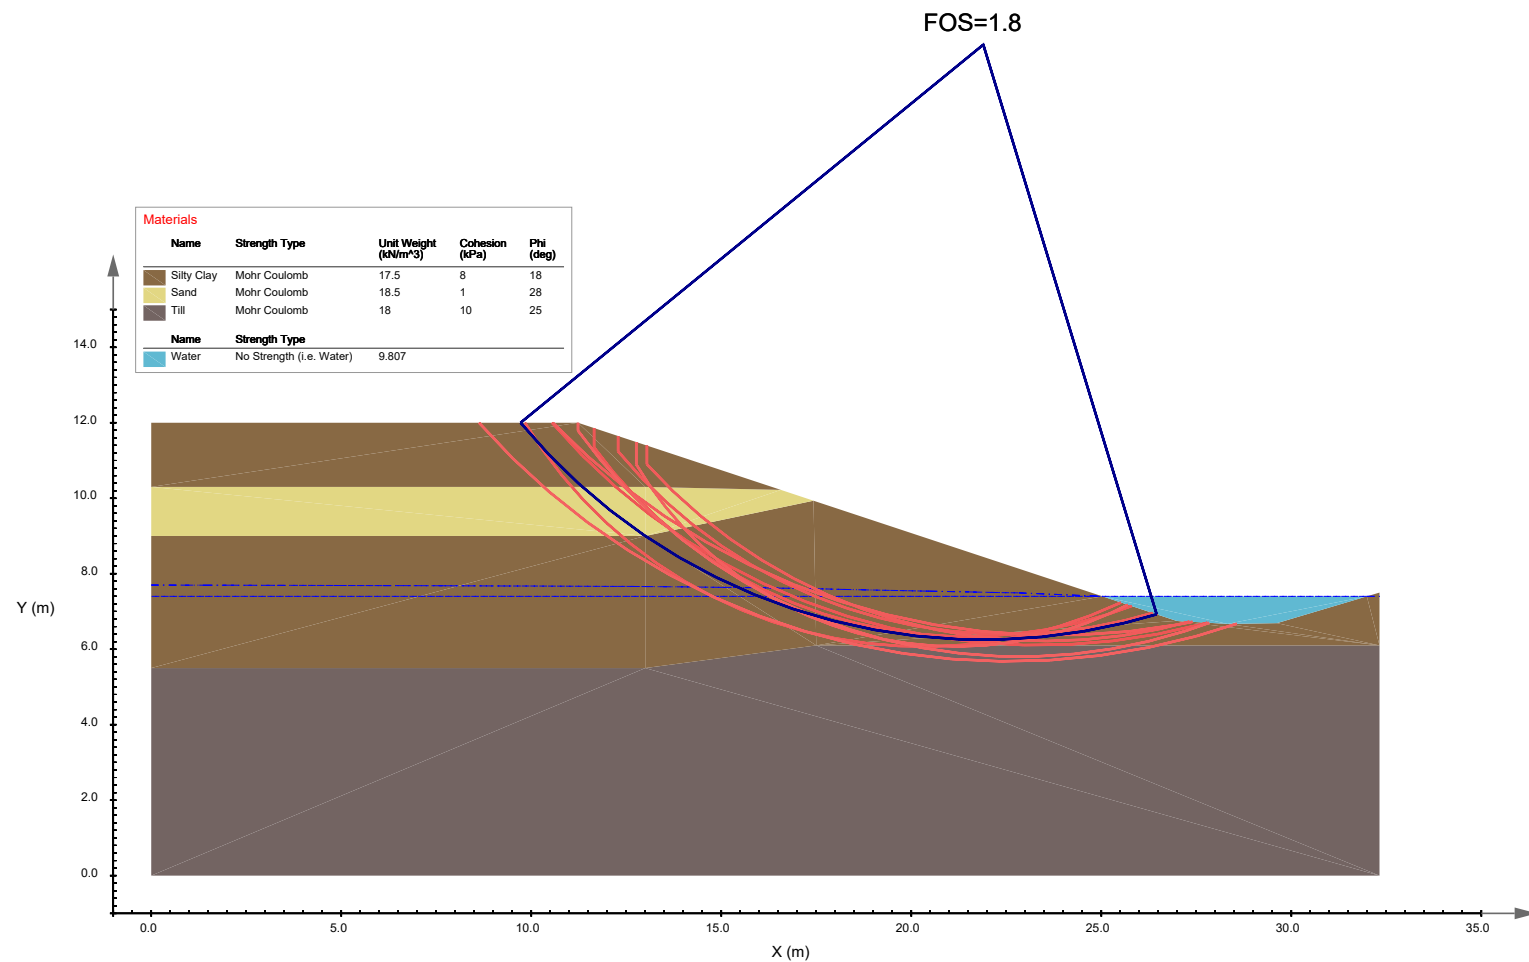
PROJECT			Carp Creek Restoration	
TITLE			Long-term Slope Stability Analysis (3H:1V)	
McINTOSH PERRY	PROJECT No.	0CM-17-429-	File No.	
	Author		FIGURE 4	
	Date	2020-08-24

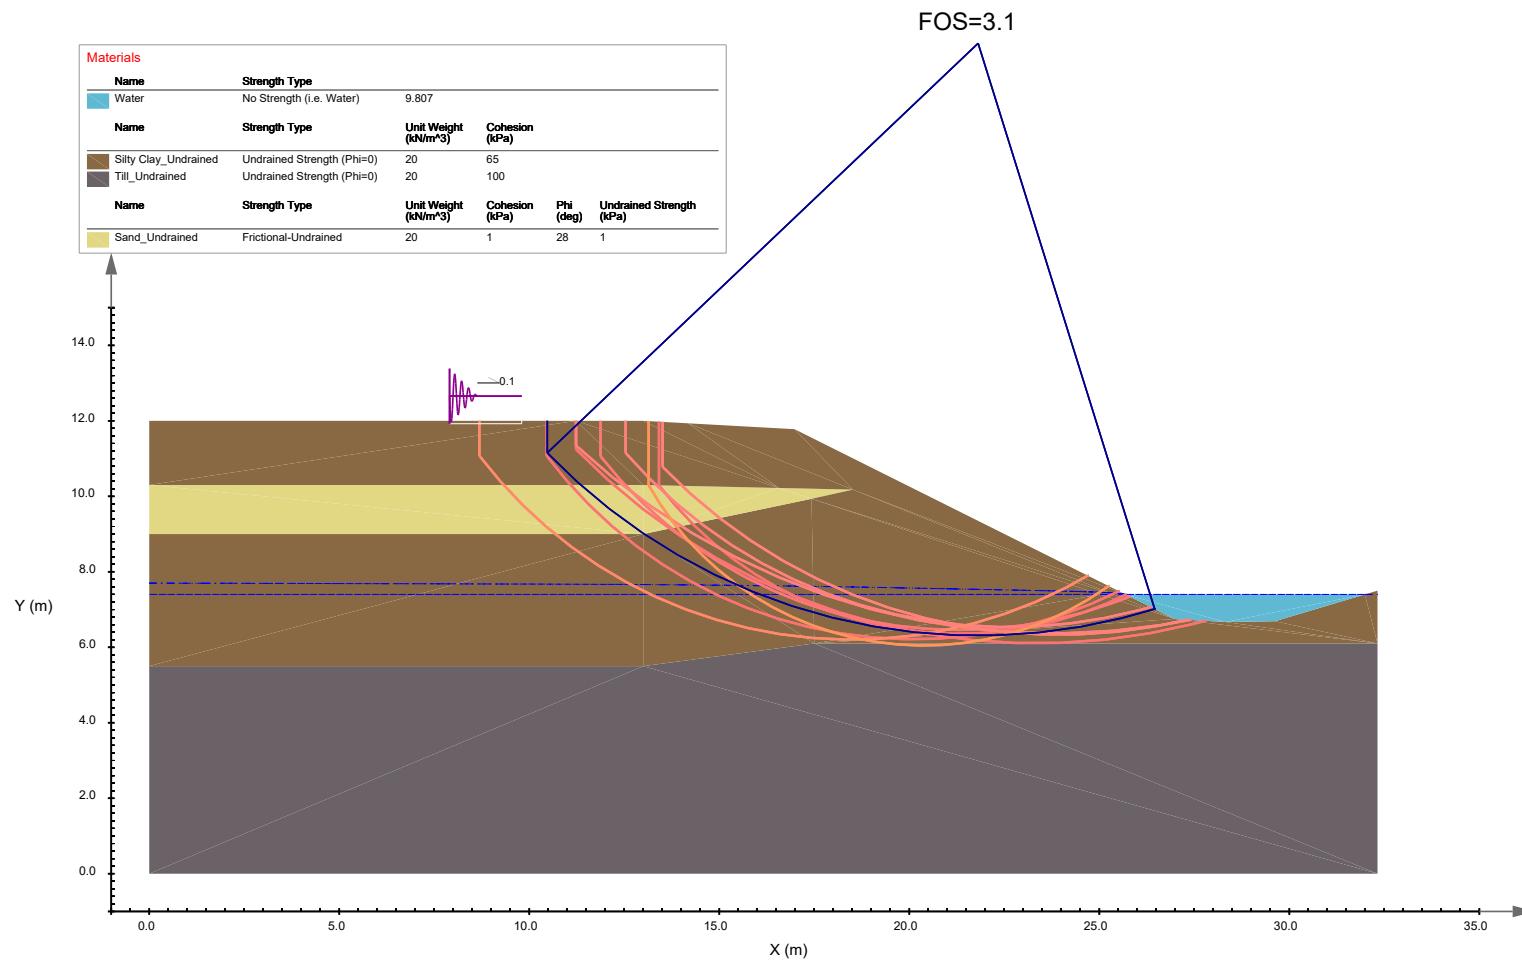
PROJECT		Carp Creek Restoration	
TITLE		Short-term Slope Stability Analysis (2H:1V)	
McINTOSH PERRY	PROJECT No.	0CM-17-429-	File No.
	Author		
	Date	2020-08-24	
			FIGURE 5

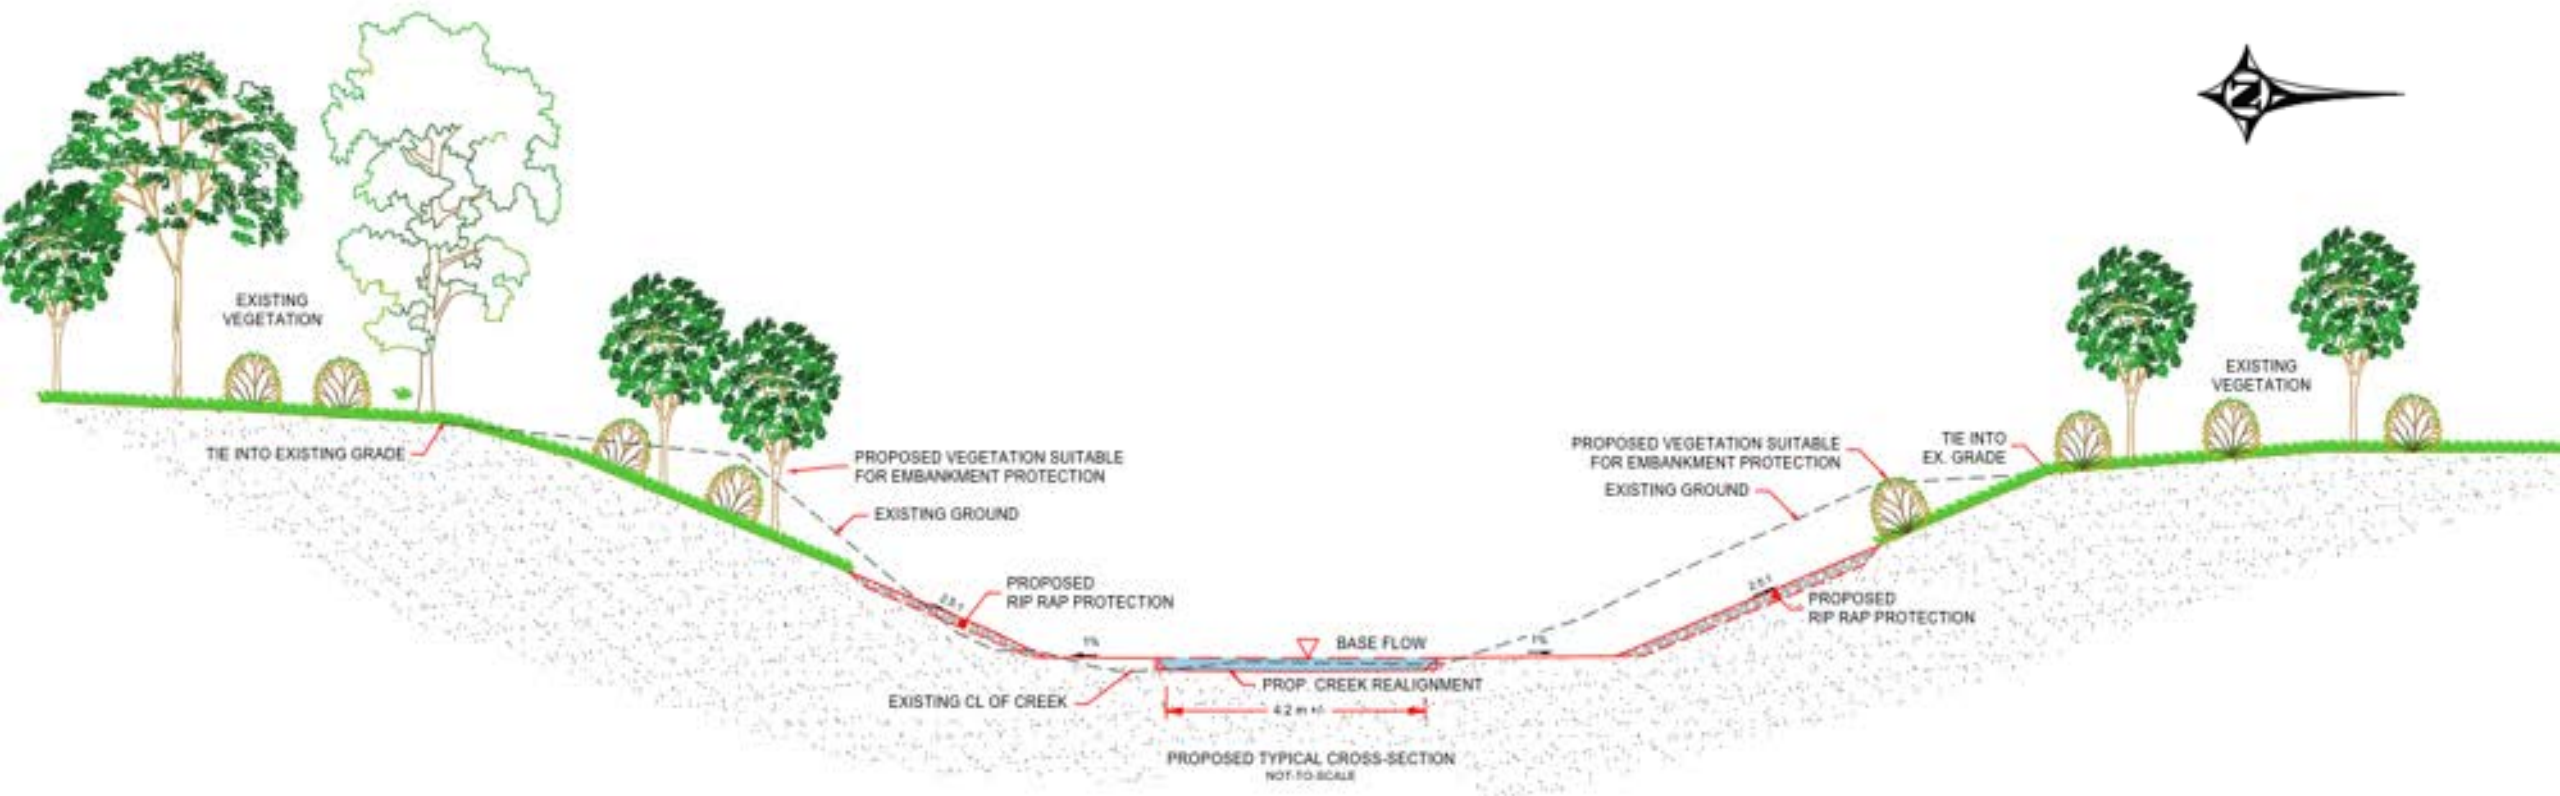
# PRELIMINARY TECHNICALLY PREFERRED ALTERNATIVE TYPICAL CROSS-SECTION
