STATE OF THE LAKE Environment Report 2014

CROTCH LAKE

A lake monitoring program of the Mississippi Valley Conservation Authority

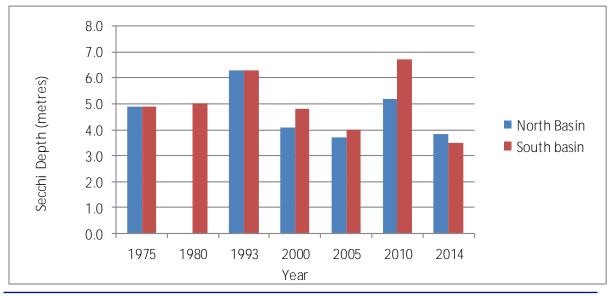
CROTCH LAKE — ALL BASINS ANNUAL MEAN SECCHI DISC DEPTHS (metres)

A Secchi Disc is a black and white coloured disc used to determine water clarity. The disc is lowered into the water. The point at which you can no longer distinguish the black and white is called the Secchi depth. The higher the Secchi Disc measurement, the more clear your lake.

Interpreting SECCHI DISC Results				
Secchi Depth	Lake Nutrient Status			
Over 5 metres	Oligotrophic – unenriched, few nutrients			
3.0 to 4.9 metres	Mesotrophic – moderately enriched, some nutrients			
Less than 2.9 metres	Eutrophic – enriched, higher levels of nutrients

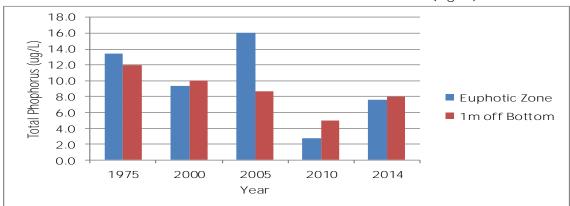
CROTCH LAKE - NORTH BASIN ANNUAL MEAN TOTAL PHOSPHORUS RESULTS (ug/L)

Interpreting TOTAL PHOSPHORUS Results				
Total Phosphorus Lake Nutrient Status				
10 ug/L or less Oligotrophic – unenriched, few nutrients				
11 to 20 ug/L	Mesotrophic – moderately enriched, some nutrients			
21 ug/L or more Eutrophic – enriched, higher levels of nutrients

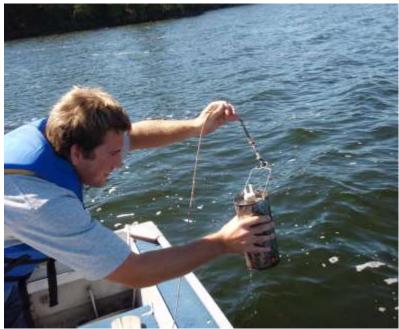
A Composite Sampler (pictured above) is used by dropping the tin container into the water. When it reaches the required depth it is slowly pulled back to the surface. The tin is filled as water enters one tube and air escapes the other. Some air remains in the tin to ensure collection throughout the haul to the surface.

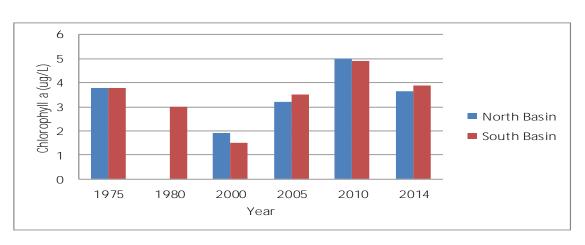
CROTCH LAKE - ALL BASINS ANNUAL MEAN CHLOROPHYLL <u>a</u> RESULTS (ug/L)

Interpreting CHLOROPHYLL a Results				
Chlorophyll <u>a</u> Reading Lake Nutrient Status				
Up to 2 ug/L – low algal density	Oligotrophic – unenriched, few nutrients			
2-4 ug/L-moderate algal density Mesotrophic-moderately enriched, some nutri				
More than 4 ug/L – high algal density Eutrophic – enriched, higher levels of nutrients

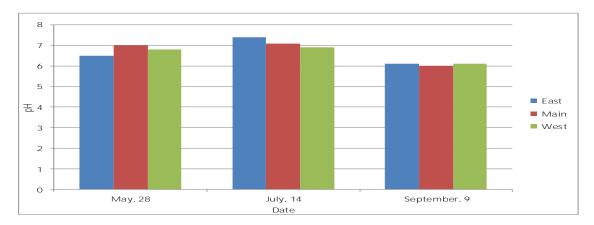
BIG GULL LAKE - EAST AND WEST BASINS 2014 pH LEVELS

Lake with pH's lower than 7.3 are less prone to zebra mussel invasion.

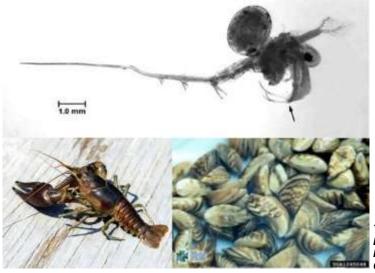
The plankton haul net (pictured right) looks like a wind sock with a plastic cup attached to the end. The mesh size of the net is 63 microns, which can filter microscopic organisms (plankton) like spiny water flea and zebra mussel veligers from the water. The plastic cup portion of the net is called the cod end. It collects the plankton sample as water passes through the net.

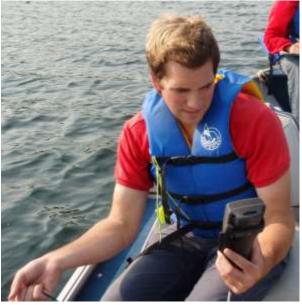
The Dissolved Oxygen Metre is used to gather DO and temperature readings. The probe is lowered into the lake and readings are taken at every metre from the hand-held screen.

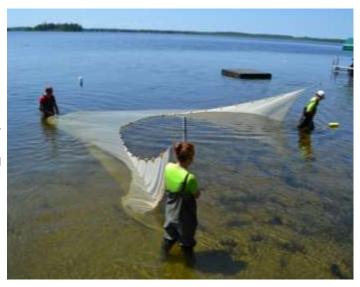
Seine netting by hand is a way of sampling fish species that may live or visit the near shore areas of a waterbody. A seine net is a type of fishing net that has floats along one edge and weights along the other edge, to keep it upright in the water. It is then dragged through a section of water, encircling it, thus collecting all the fish within that area. The depth of the testing area is limited to areas wadeable by the field crew. This method has a very limited impact on the health of the fish sampled and is affordable, easy to do, and portable.
