**Class Environmental  
Assessment for Shabomeka  
Lake Dam Rehabilitation and  
Erosion Control Projects**

Project Plan Report

Prepared for:  
Mississippi Valley Conservation  
Authority

Prepared by:  
Stantec Consulting Ltd.

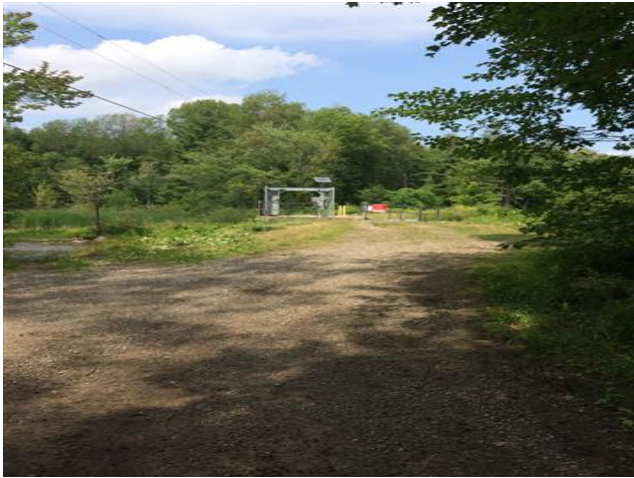
Berm south of sluice structure.

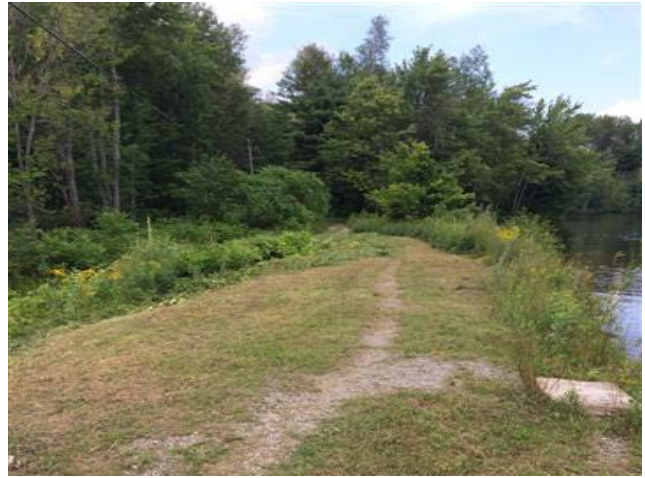
Berm north of sluice structure.

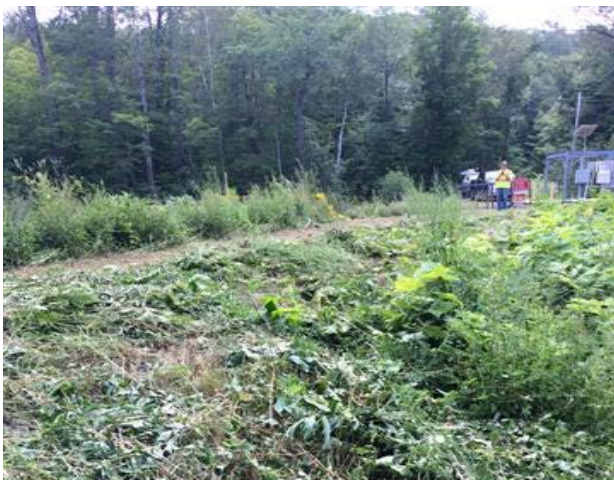
Cut vegetation on berm north of sluice structure.

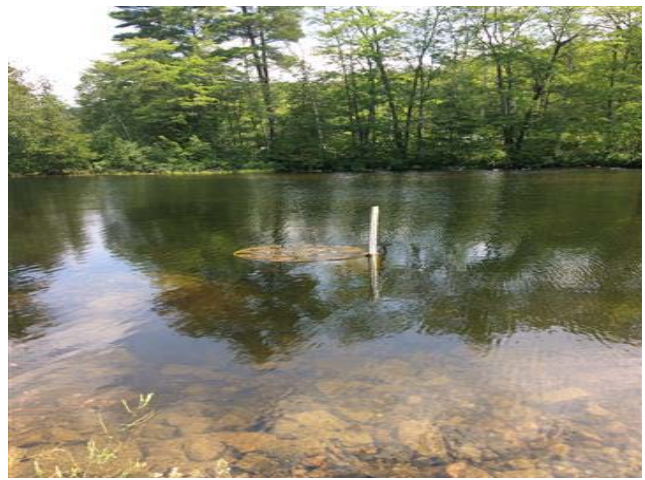
Shoreline substrates looking at staff gauge in lake.

During the August 4 site visit, water levels in Shabomeka Lake were slightly elevated due to recent heavy rains. In the immediate area of the embankment and control structure, the shoreline is characterized by an approximate 3 m wide shallow shelf ranging in depth from 10 cm near the shore and slope gradually to 40 cm at the extent of the shelf, where depth gradually drops off to 3 m in the central area approximately 15 m in front of the dam. In the shelf area, substrates consist of large fractured rock, smaller rounded cobbles and interspersed gravels. Off the south end of the embankment exists an embayment where the shallow shelf extends approximately 15 m from the shoreline and deposition provides substrates suitable for the establishment of submerged and emergent aquatic vegetation.

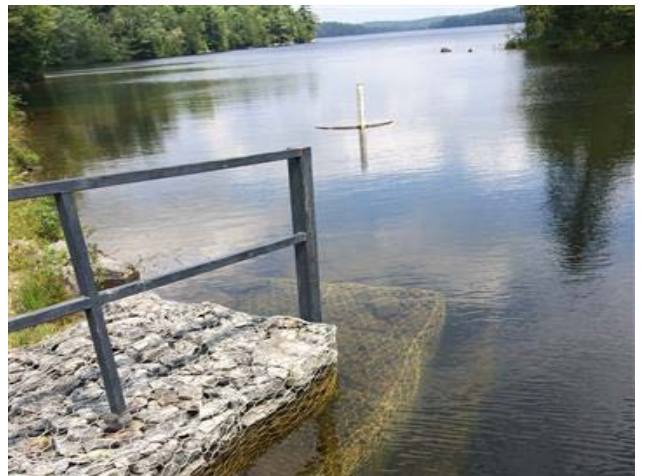
Entrance to sluice.

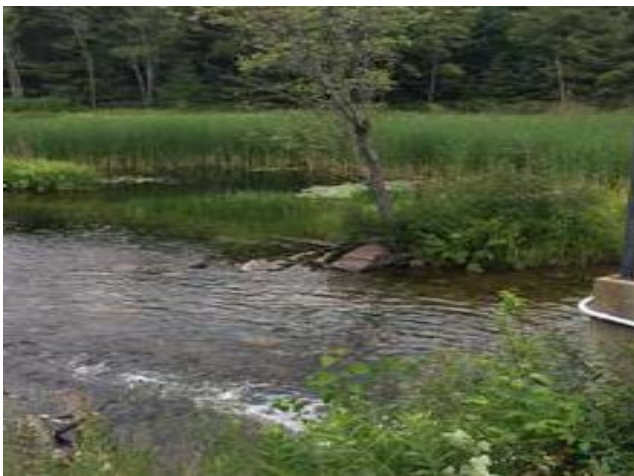
Semicircle Creek immediately downstream of sluice.

No fish were observed in the creek during the August 4 assessment, however it is expected that a typical assemblage of baitfish would utilize the area immediately downstream of the dam for feeding, particularly given that dam discharges produce turbulent waters with high oxygen content. Smaller fish that feed on plankton would also be attracted to the discharge to feed on floating organisms in the current from the tailrace.
