# Watts Creek 2023 Catchment Report

## Monitoring Activity in the City of Ottawa

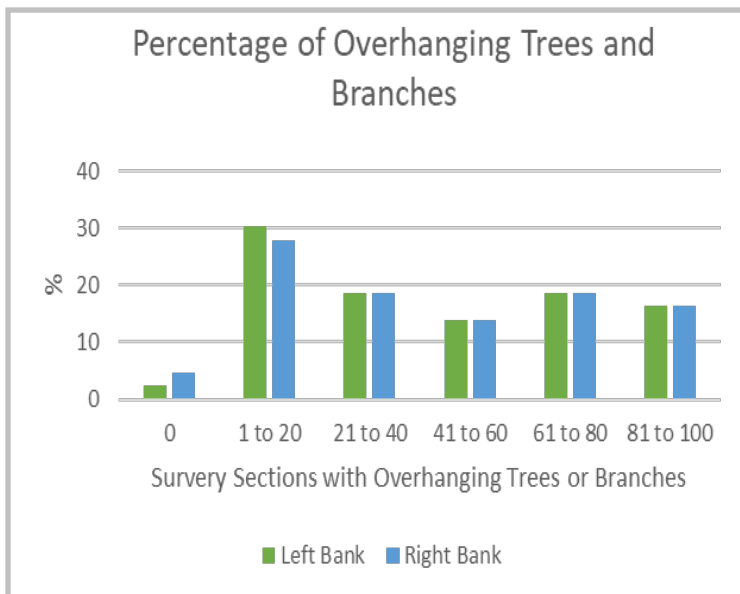
**Figure 9: Percentage of each surveyed section of Watts Creek with overhanging trees and branches**

Figure 9 shows the data quantified as the percent of creek sections classified according to the various amounts of overhanging trees and branches. For example, 5% of the 43 surveyed stream sections on the right bank were classified as having zero overhanging trees and branches. 51% of the surveyed stream was found to have less than 40% overhanging branches.

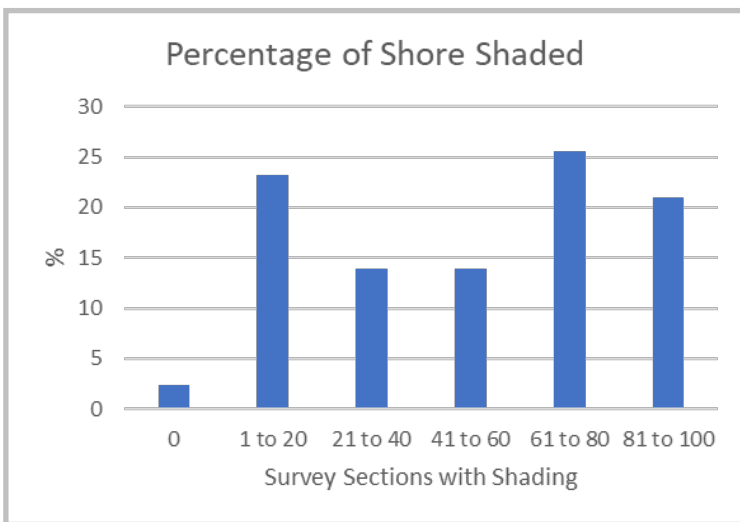
Figure 11: Shading along Watts Creek

Figure 11 shows the data quantified as the percent of creek sections classified according to the various levels of shading. With 2% at zero shading, 23% at 1 to 20 percent, and 14% at 21 to 40 percent, 40% of the surveyed stream has less than 40% shading. The area of highest shading was in the thickly forested area downstream of Eagleson Road shown in bright green in Figure 10.

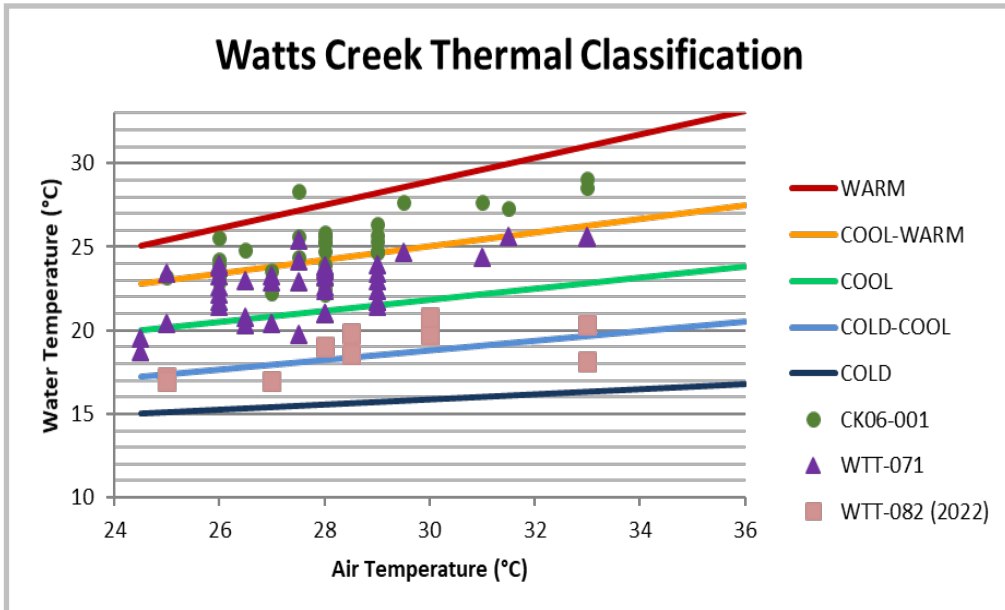
**Figure 25:** Thermal classification of Watts Creek

Many factors can influence fluctuations in stream temperature; including springs, tributaries, precipitation runoff, discharge pipes and stream shading from riparian vegetation. Water temperature is used along with the maximum air temperature (using the revised Stoneman and Jones method by Cindy Chu *et al*) to classify a water-course as either warm, cool-warm, cool, cold-cool, or cold water. Figure 25 shows the thermal classifications of Watts Creek for 2023.

Analysis of the data collected indicates that Watts Creek should be classified as a cool-cold stream. This is likely due to the primary source of water flowing into Watts Creek originates from cool underground storm water and agricultural drains. The stream starts cool-cold in the headwater area (2022 data) and is classified as a cool water in the mid-reach (WTT-071). The water continues to warm into the cool-warm range downstream of the Kizell drain junction (CK6-001).

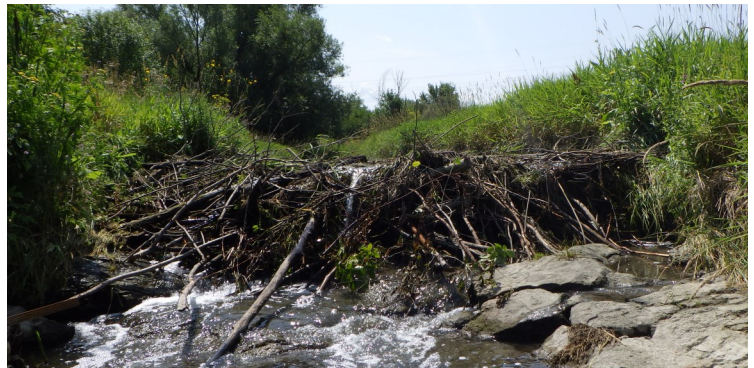
Figure 26 Map of migratory obstructions on Watts Creek, 2023

As seen in Figure 26 there were many obstructions noted, most were debris dams related to the recent aggressive floods. There was also one large beaver dam noted, pictured below.

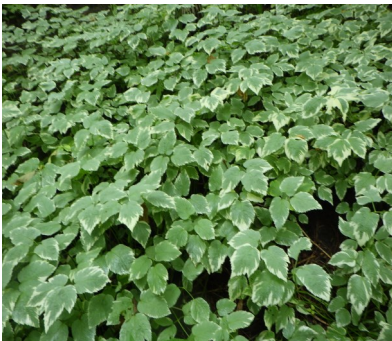
Invasive species found shown to the right (clockwise): Himalayan Balsam, Purple Loosestrife, Flowering Rush, Common Buckthorn and Garlic Mustard. Left is Goutweed found in an urban section and likely escaped from a garden.
