City Stream Watch 2023 Summary Report

City Stream Watch 2023 Summary Report MVCA RVCA

Aquatic Resource Technician
Rideau Valley Conservation Authority

Aquatic Biologist
Mississippi Valley Conservation Authority

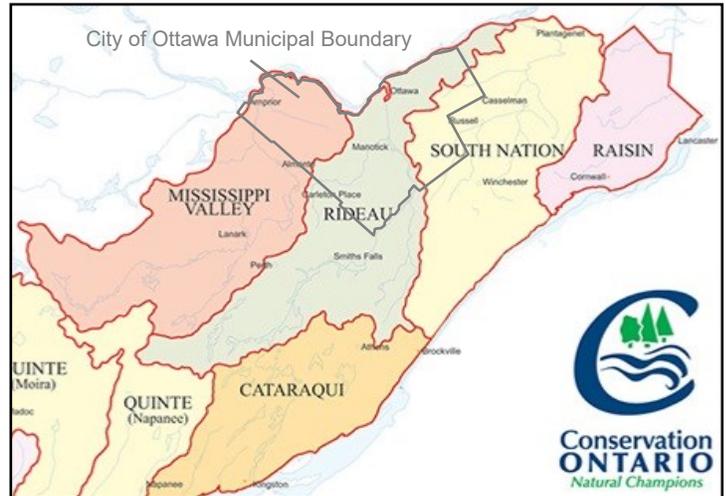
Figure 1 Area monitored by City Stream Watch. Photo courtesy of South Nation Conservation (modified).

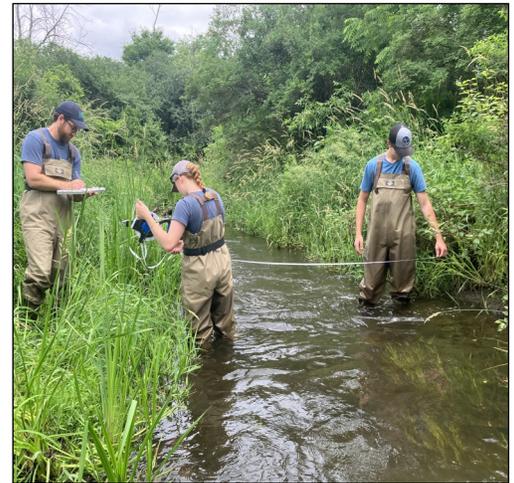
RVCA staff measuring wetted width during a stream survey.

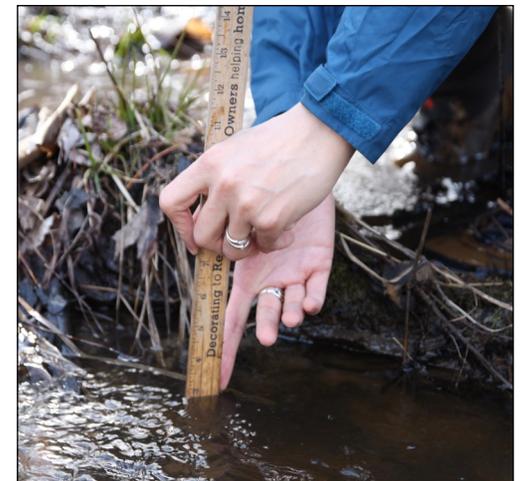
CSW volunteer measuring hydraulic head, a measurement of surface flow velocity.

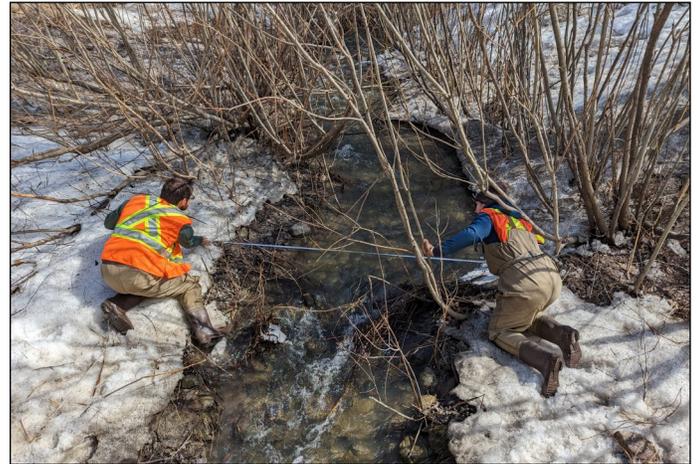
RVCA staff members measuring the wetted width of a headwater drainage feature

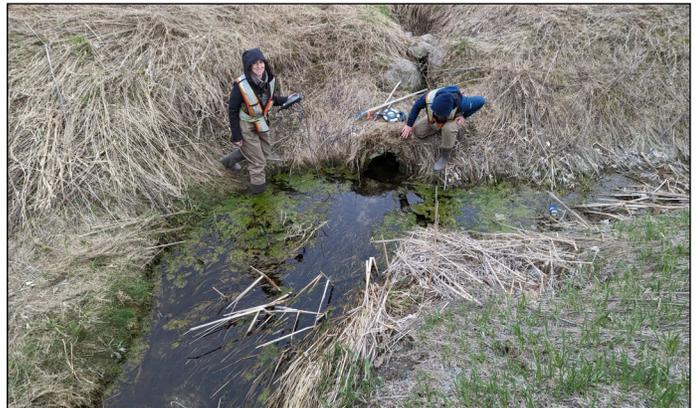
Volunteers using a multiparameter YSI probe to measure the water chemistry of a headwater drainage feature during a spring site visit

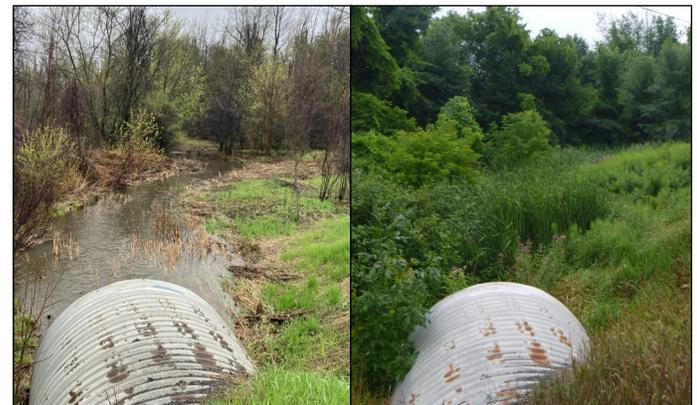
Difference between seasons for an HDF site in the Mud Creek catchment.

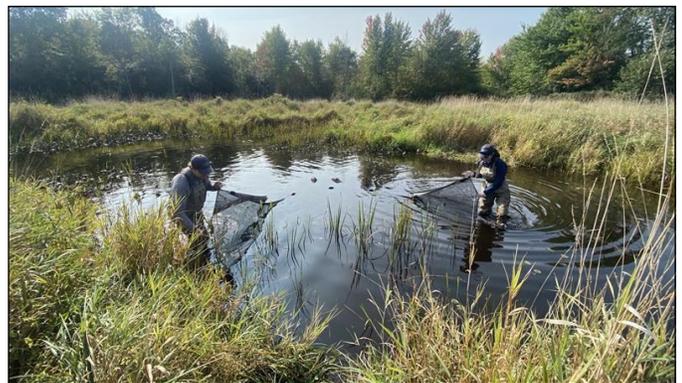
RVCA staff members sampling fish community using a seine net

- Rectangular, with a three-dimensional box, or “purse” in the middle;
- The net is actively moved through the water, creating a wall;
- Fish are directed toward the purse in the middle and collect there;
- Ideal for pool habitat.

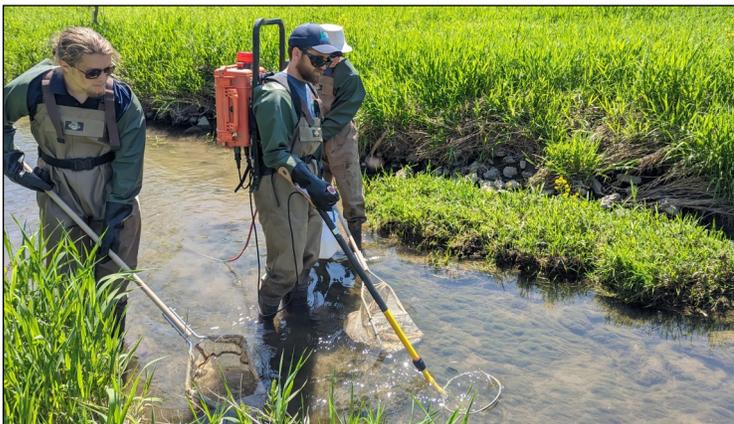
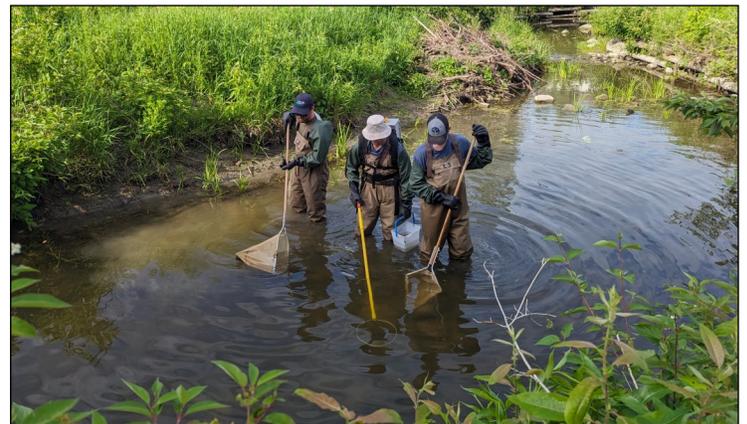
RVCA staff members sampling fish community via backpack electrofishing.

- Effective way to sample fish in a variety of habitats;
- Using an electrofishing “backpack”, the crew leader creates an electrical field in the water which causes a muscle response in fish, temporarily stunning them;
- Netters collect these fish using dip nets and place them in a recovery bucket;
- Electrofishing very seldom kills fish if the correct procedures are used;
- Electrofishing is completed by staff that have been certified according to provincial standards.

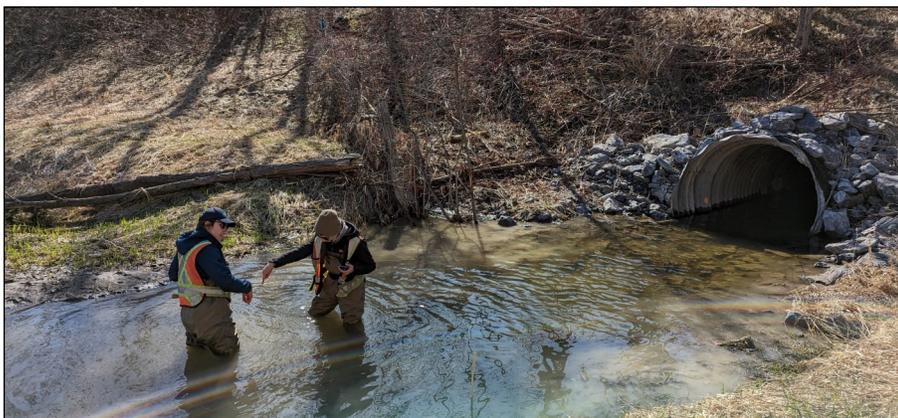
RVCA staff members installing a temperature logger in Stillwater Creek in April.

Temperature is an important parameter in streams as it influences many aspects of physical, chemical, and biological health. Temperature data loggers are deployed in each of the monitored streams for the sample year from April to late October to give a representative evaluation of how water temperature fluctuates. Many factors can influence fluctuations in stream temperature, including: springs, tributaries, precipitation runoff, discharge pipes, land use change and stream shading from riparian vegetation. Water temperature is used along with the maximum air temperature (using the revised method in Stoneman and Jones, 1996) to classify a watercourse as either warm water, cool-warm water, cool water, cold-cool water or cold water.

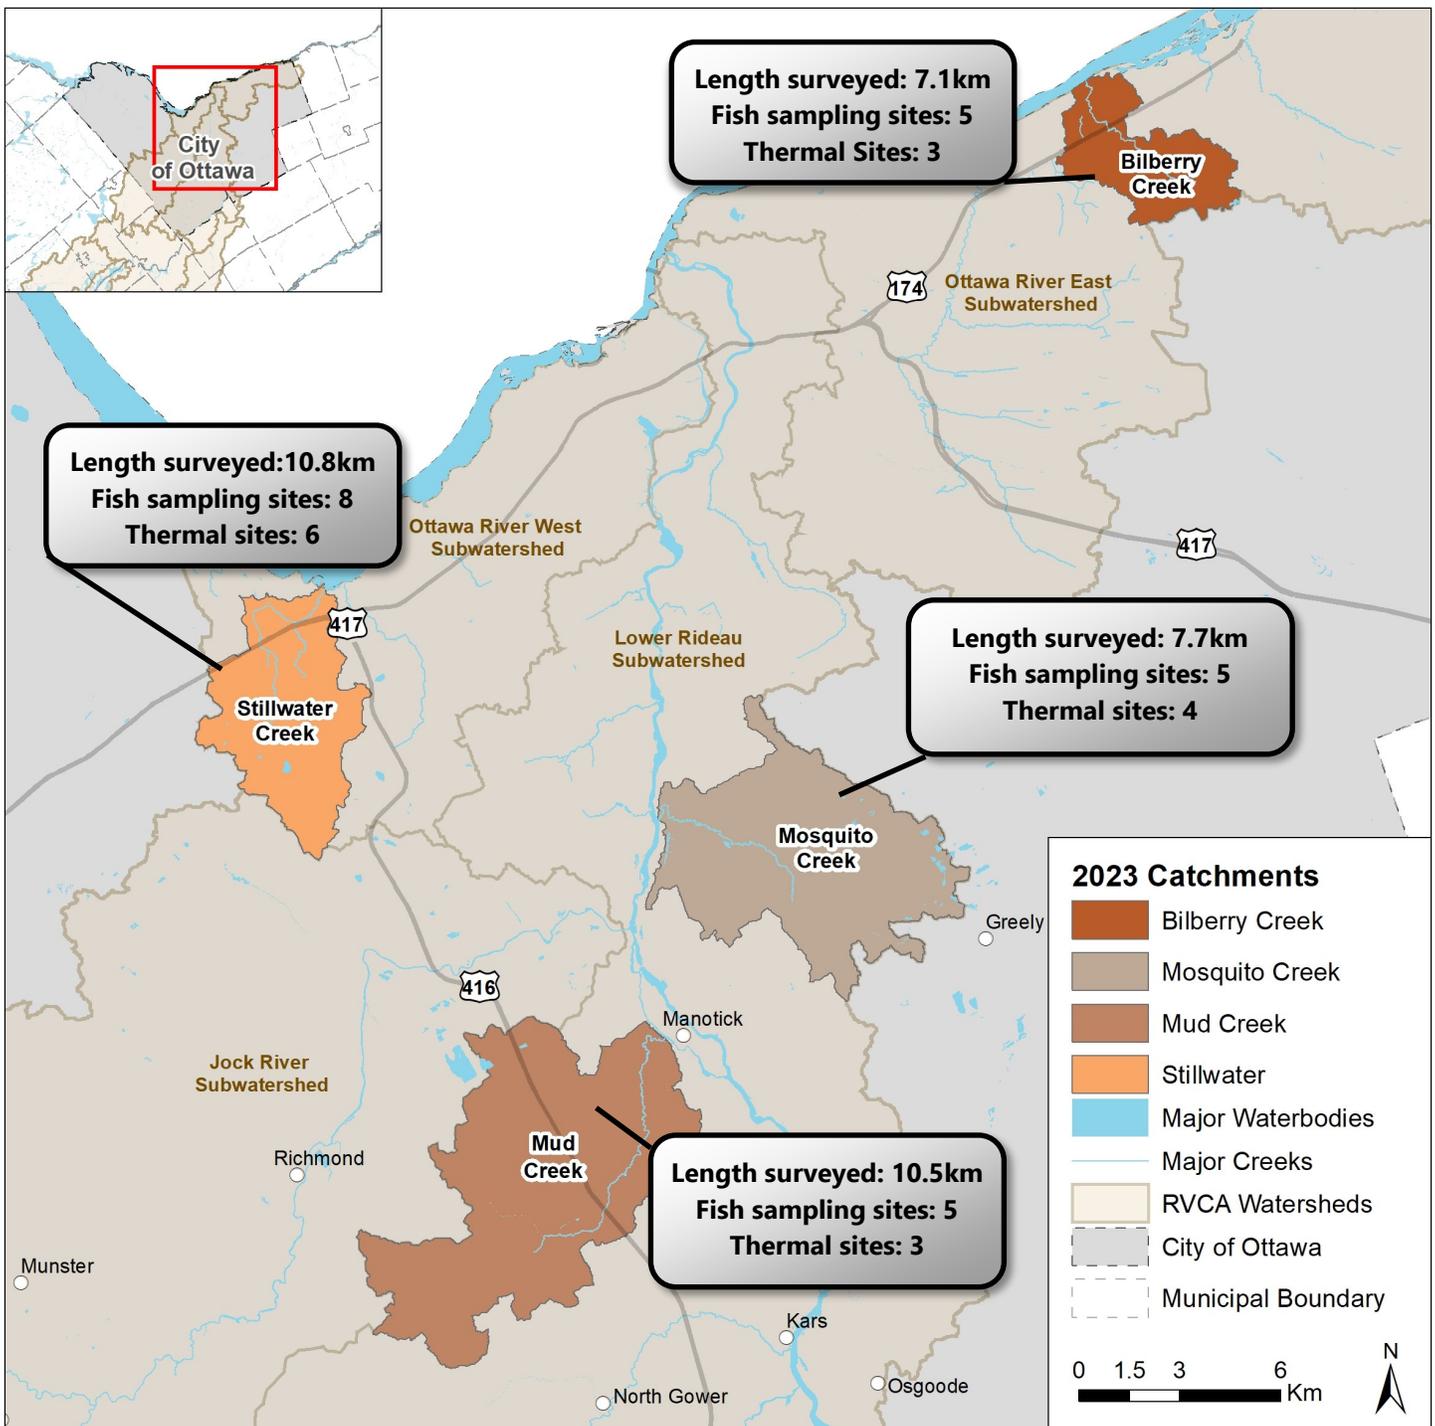
Figure 2 2023 RVCA CSW creek catchment areas with summary monitoring statistics.

The RVCA City Stream Watch program monitors 25 tributaries of the Rideau and Ottawa Rivers on a 6 year cycle. Approximately 36.1 kilometers of streams were surveyed and 29 fish sampling sites were assessed as part of the 2023 cycle on Mud Creek, Bilberry Creek, Stillwater Creek and Mosquito Creek. In addition, a total of 16 sites on these systems were surveyed for thermal regime. For more detailed findings for each catchment area monitored in 2023, please see their individual catchment reports that are shared on our website at rvca.ca (Monitoring & Reporting > Reporting > City Stream Watch Reports).

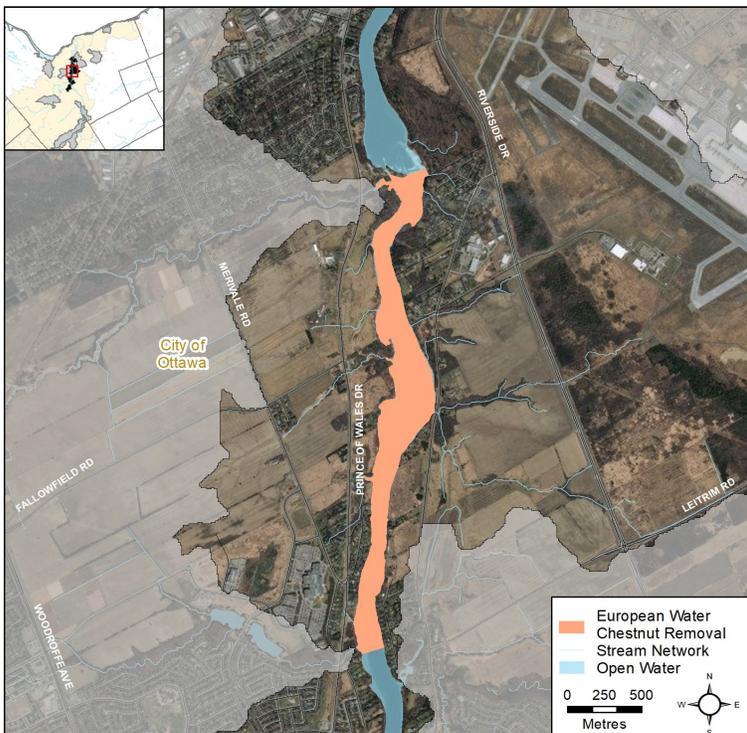
Figure 3 Area along the Rideau that was inspected for European water chestnut.

RVCA and Parks Canada joined forces once again this year to prevent the spread of European water chestnut (EWC) on the Rideau River. The invasive plant was first found along the Rideau in 2014. The next few summers, City Stream Watch assembled staff to help pull out as many plants as possible. By 2018, there was a noticeable decline in the number of plants found along this section of the Rideau River. This year, the trend continued and fewer plants were found compared to 2018. On July 13th, staff members in canoes scoured the river and cleared any remaining plants. On August 24th, staff members returned to the site, however no plants were found during the second site visit. EWC has significantly declined within the original target area.

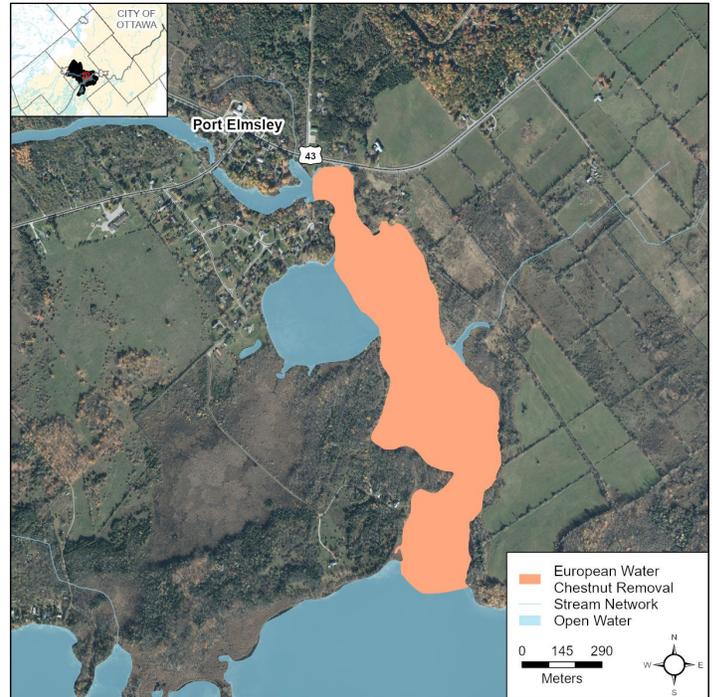
Figure 4 Area along the Tay River that was inspected for European water chestnut.

While completing shoreline surveys in 2022, Parks Canada observed a new sighting of the invasive plant upstream near Lower Rideau Lake. Thus, the mouth of Tay River, which feeds into the Lower Rideau, was targeted this year for monitoring and removal of EWC.

On July 5th 2023, about 146000 m² was surveyed using canoes and boats, where 20.73 kg of EWC rosettes were pulled from the river. On August 2nd 2023, staff members returned to the site to clear any remaining plants, however they found various new patches of EWC hidden among other native plants. This removal collected an additional 583 EWC rosettes weighing 51.56 kg over an area of 185000 m². City Stream Watch will have to continue monitoring this new targeted area in 2024.

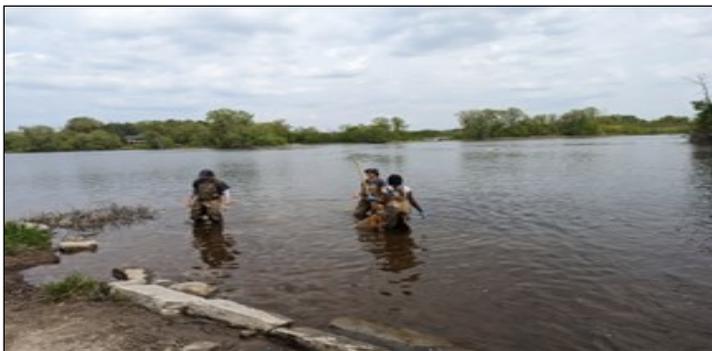
RVCA staff member giving a live demonstration of the 'kick and sweep' method of OBBN collection.

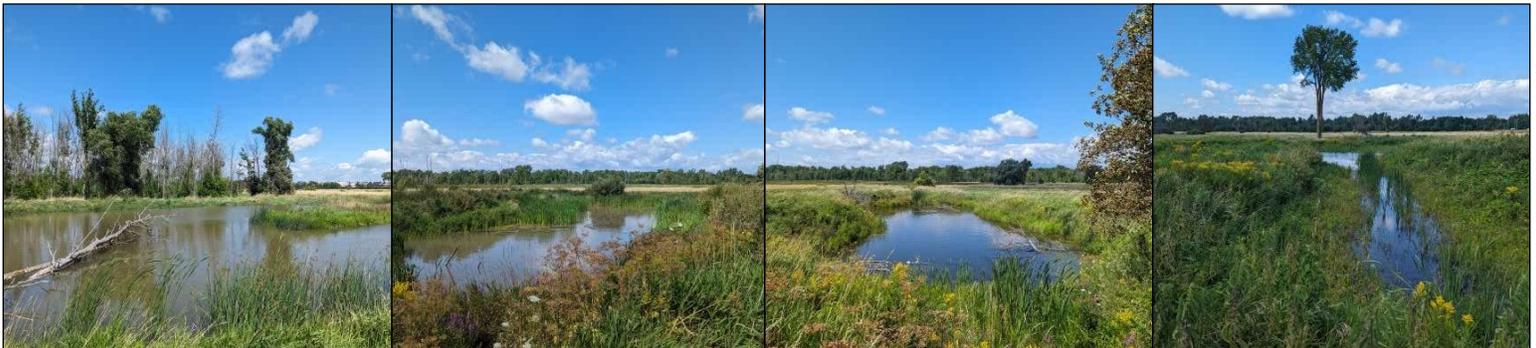
Stillwater Creek Wetland, August 2023; (a) West, (b) Willow (c) Central and (d) East cells

In the fall of 2018, the Rideau Valley Conservation Authority (RVCA) partnered with the National Capital Commission (NCC) and created 10 000 square meters of wetland habitat in the Stillwater Creek catchment area, just south of the new DND headquarters off Moodie Drive and Highway 417. The Ottawa-Carleton Wildlife Centre, which is located nearby, observed that the wetland habitat in the area was suffering annually from extreme low water conditions. The project involved expanding the previous habitat by creating three large, wetland cells and installing wood structure within them. The project constructed three wetland cells (West, Central, and East Cell) along the Watts Creek pathway system in the fall of 2018. In the fall of 2022, an additional cell (Willow Cell) was constructed and the East Cell underwent an expansion.

This year was the third year of post-effective monitoring for the project. Stillwater Creek wetland is visited once a month by RVCA staff. Monitoring for wildlife observations, amphibian surveys and the collection of water chemistry data is conducted for each of the four wetland cells. Although the wetlands are only about 5 years old, animal and plant species have quickly started to establish. The wetland is currently home to several species of birds, fish, amphibians, and pollinators. This year, a turtle (midland painted turtle) was observed for the first time since starting this project in 2018.

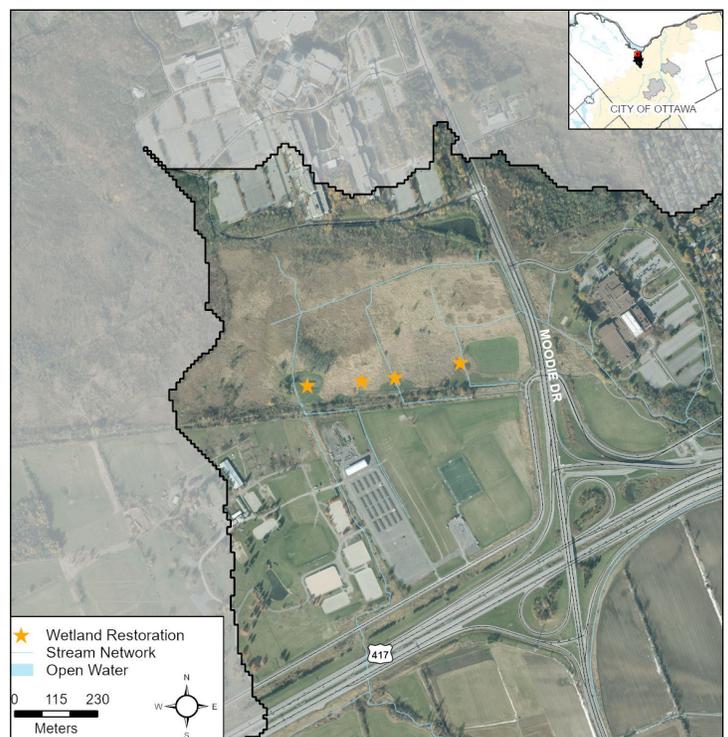
Figure 5 Location of Stillwater Creek wetland cells

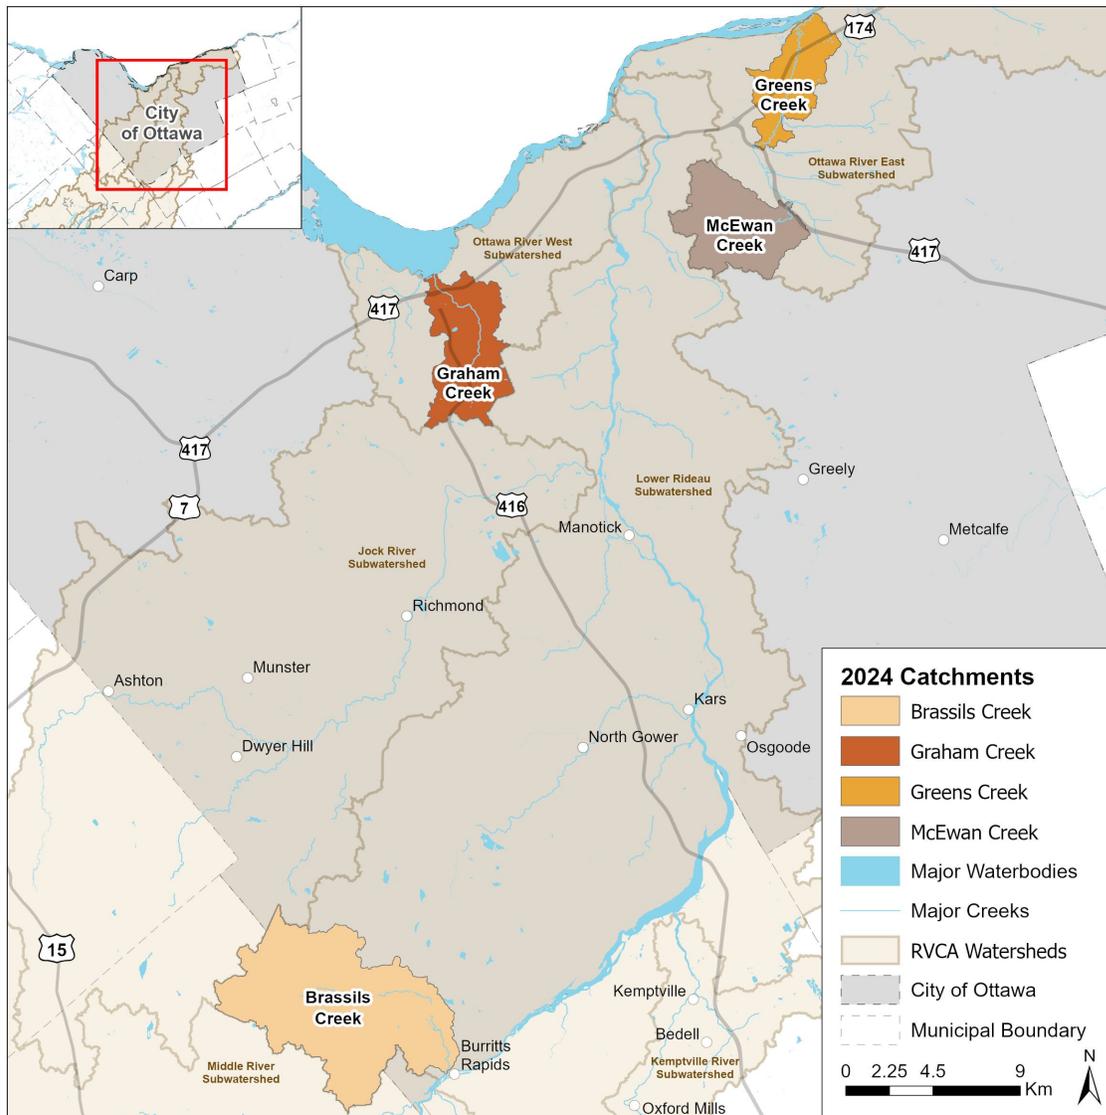
Figure 6 Catchments to be monitored by RVCA City Stream Watch in 2024.

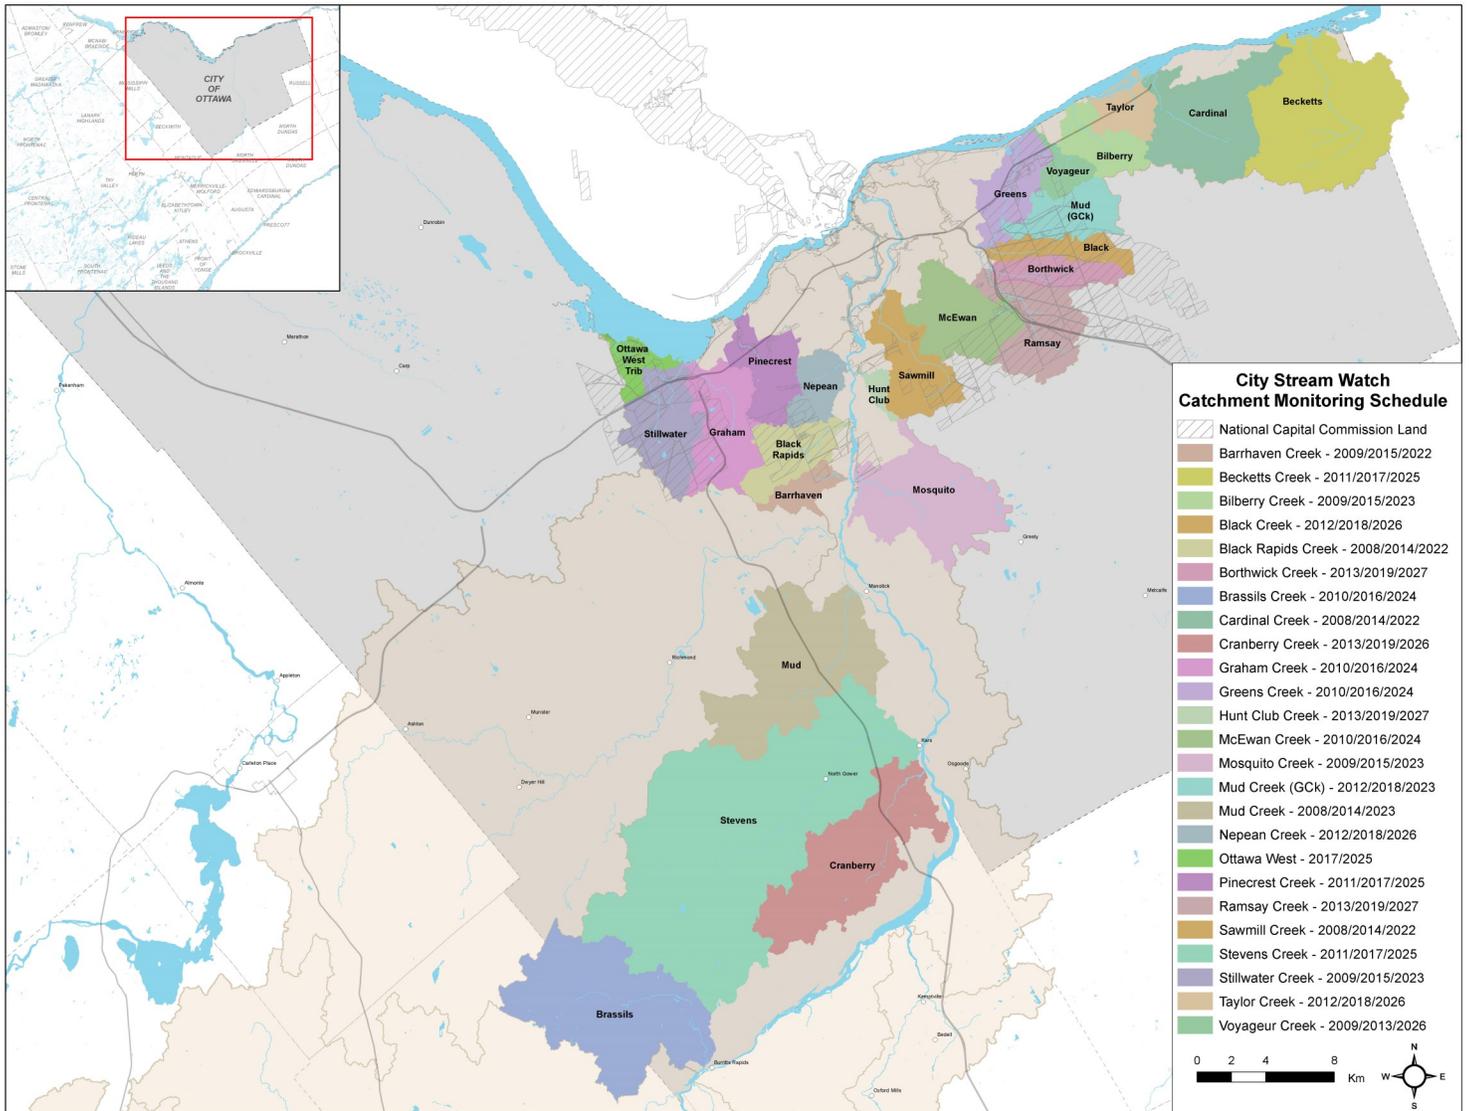
Figure 7 RVCA City Stream Watch catchment locations and monitoring schedule.

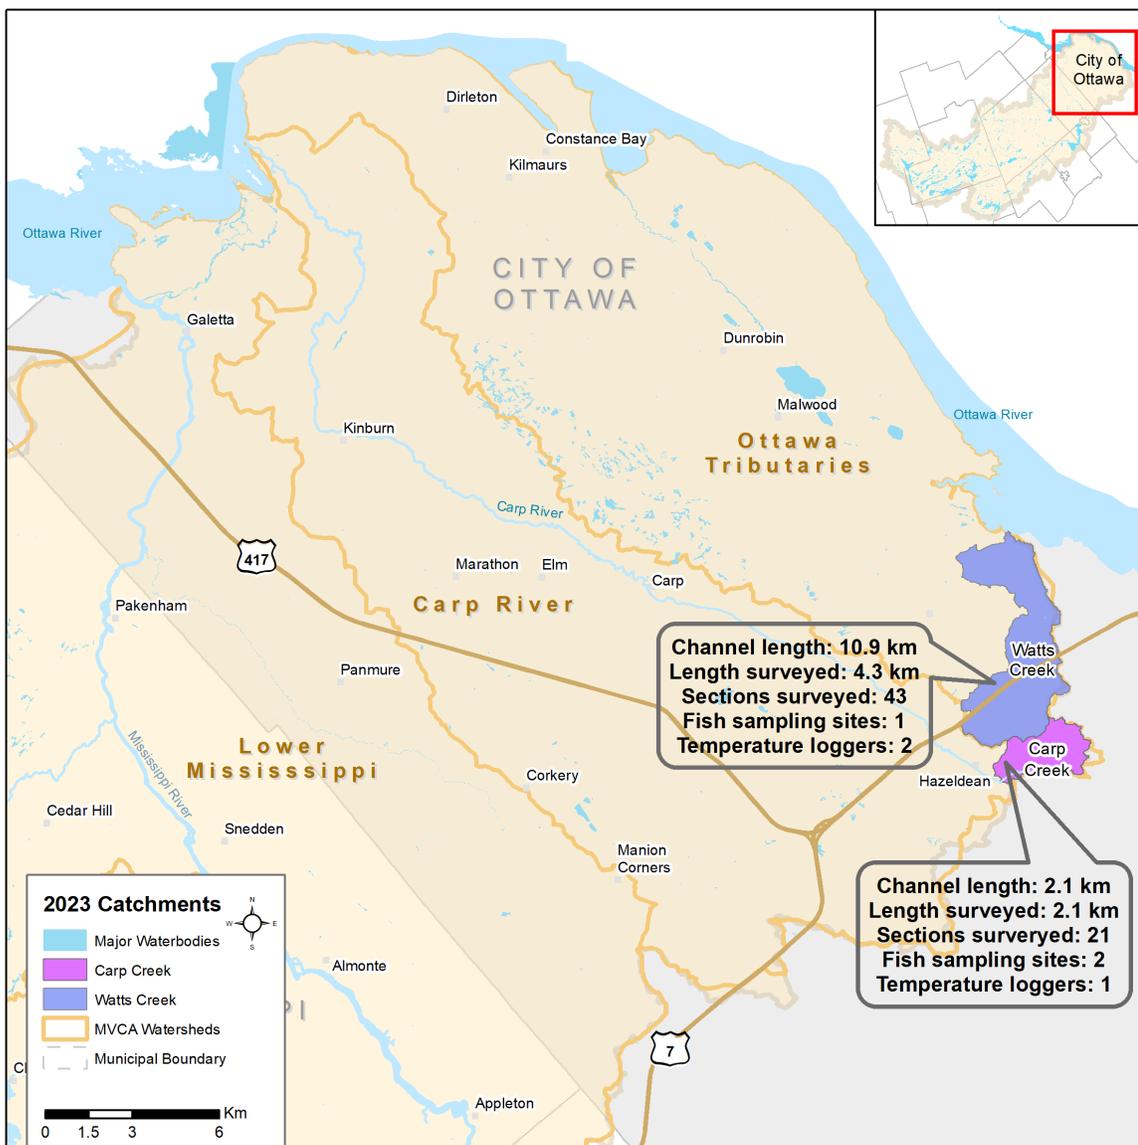
Figure 8 2023 MVCA CSW creek catchment areas with summary monitoring statistics.

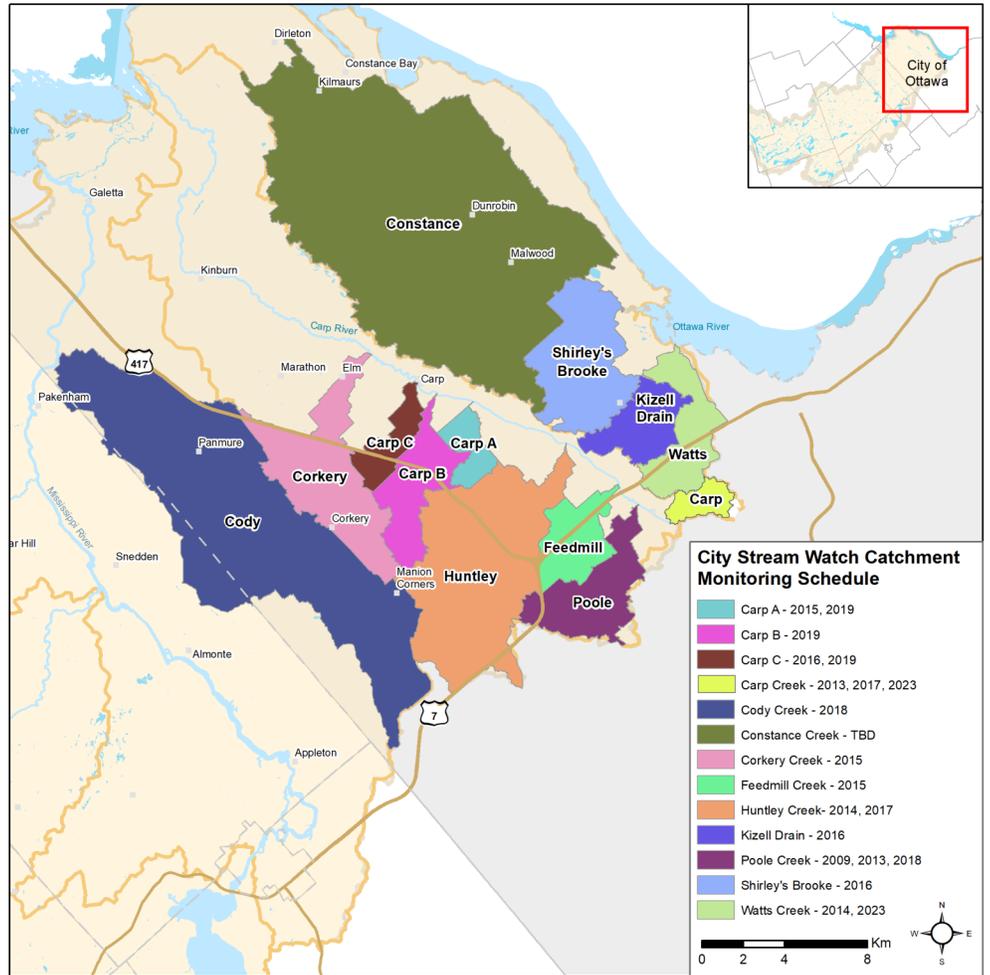
Figure 9 MVCA's past CSW catchment monitoring cycle.

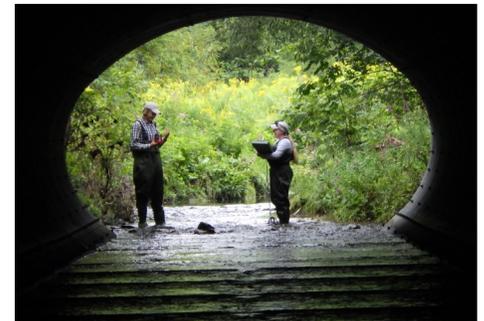
MVCA staff taking YSI measurements.
