CULTURAL HERITAGE EVALUATION REPORT

Kashwakamak Lake Dam, Mississippi River, Township of North Frontenac

MP Project No.: CCO-23-3603

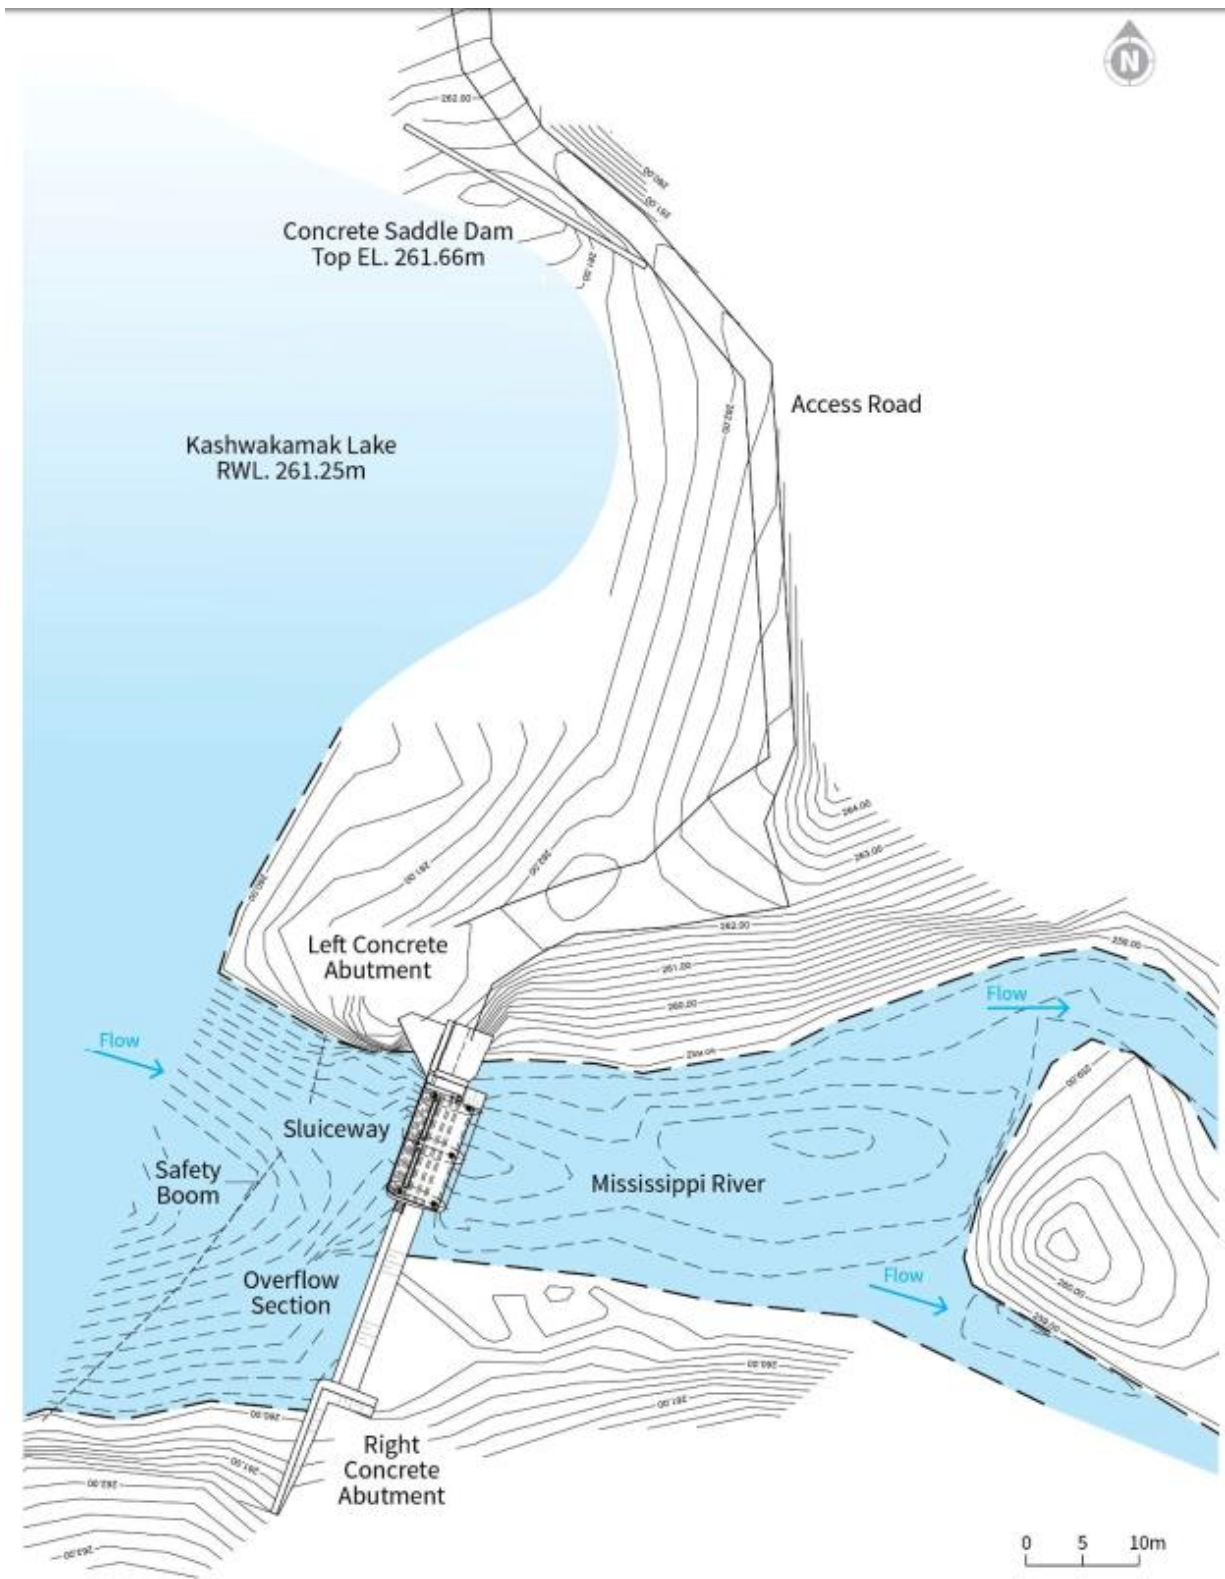
Figure 2: Detailed Site Layout – Kashwakamak Lake Dam, Township of North Frontenac (Hatch, 2022)

The following descriptions of the subject property are based on a field survey conducted on June 6, 2023, by Lindsay Bennett and Alex Ploughman of McIntosh Perry. The field survey was undertaken to record any features that could enhance the understanding of the setting in the landscape and contribute to the cultural heritage evaluation process. The site visit was conducted on the entire property including landscape features. A key map of the study area is provided in **Figure 1** and a detailed map of the property boundaries and site layout is provided in **Figure 2**.

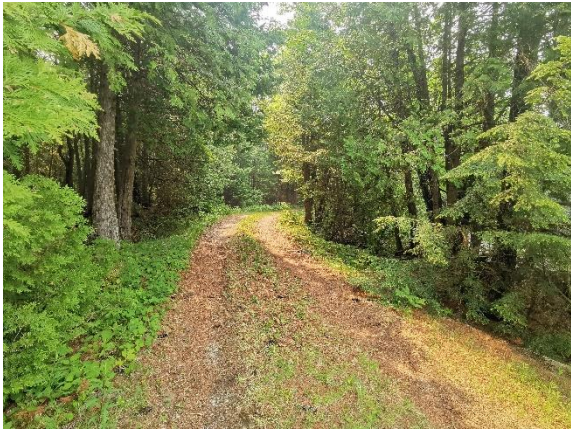
Figure 3: Study area landscape overview, approach access to dam site.

The landscape is predominantly a forested, naturalized landscape (Figures 3, 4 and 6). Recreational development along the shoreline of Kashwakamak Lake includes approximately 577 cottage residences and several marinas and resorts. Other than property on islands, there are no boat-access only dwellings on this lake. Kashwakamak Lake is one of six major lakes in the watershed. These six lakes act as spring storage reservoirs to alleviate flooding. The Kashwakamak Lake Dam is part of a system of dams that work to provide flood control for the lake and downstream areas (MVCA, 2023). The Kashwakamak Lake Dam is necessary for maintaining water levels in the lake for local recreation and tourism, as well as in assisting the spawning of fish species such as walleye and bass (MVCA, 2023).

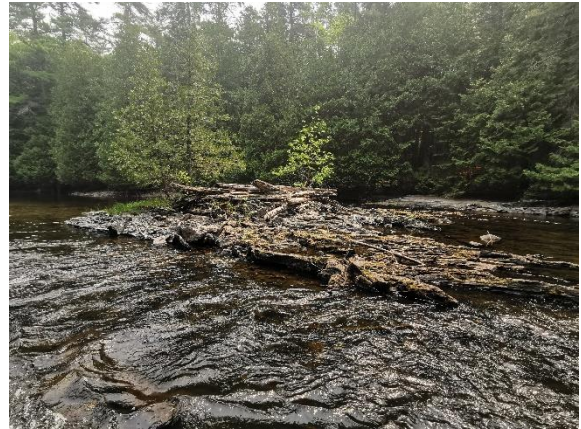
Figure 4: Study area landscape overview, Mississippi River.

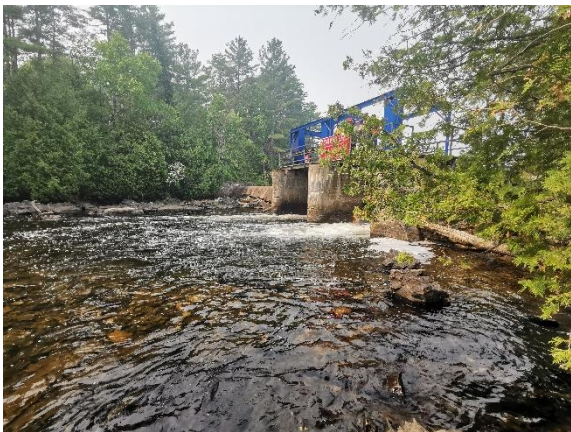
Figure 5: Kashwakamak Lake Dam, looking northwest.

Kashwakamak Lake Dam consists of two structures, the main control dam and a secondary side block dam (Figures 6 to 14). These two structures are separated by an earthen island at a distance of about 30 m (Terraprobe, 1998). The main structure consists of two bulkhead walls, three concrete piers forming the two sluiceways, and a broad crested concrete weir. The north bulkhead wall extends 5.5 m from the north bank to the north pier. The crest elevation of this wall is 261.63 m.

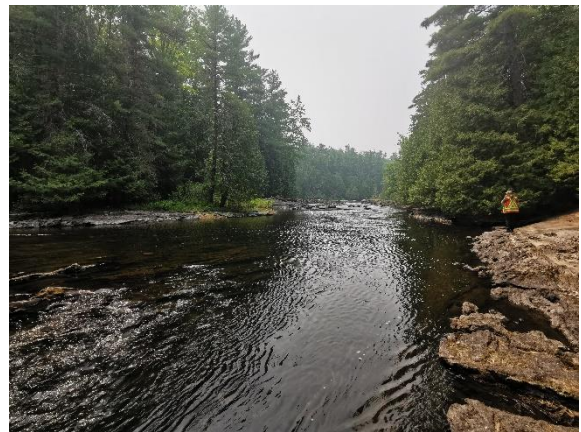
Figure 6: Mississippi River, looking west from Kashwakamak Lake Dam site.

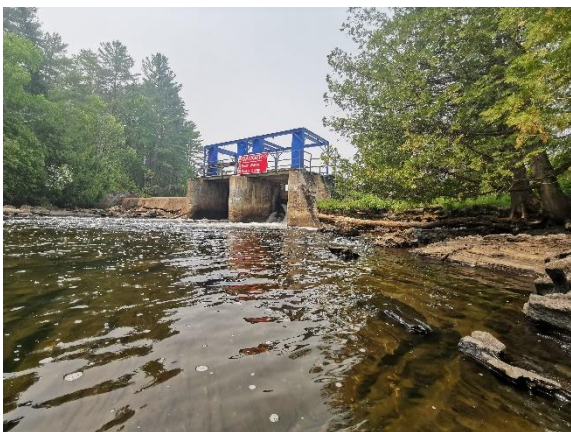
Figure 7: Kashwakamak Lake Dam, looking west.

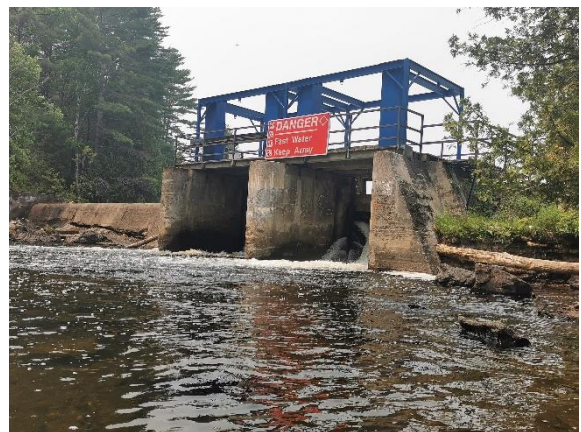
Figure 8: Kashwakamak Lake Dam, sluiceway and overflow looking west.

The north sluiceway has a clear opening width of 2.98 m and contains ten (10) 0.30 m x 0.30 m x 3.43 m stoplogs. The south sluice has a clear opening width of 2.96 m with the same number and size of stoplogs. The sill elevation for both sluiceways is 258.22 m. The broad crested weir extends 16.84 m from the south pier to the south bulkhead wall. The crest elevation is 261.06 m. The south bulkhead wall is 'L' shaped and is 5.5 m x 12.5 m long. The top of the wall is 261.65 m.

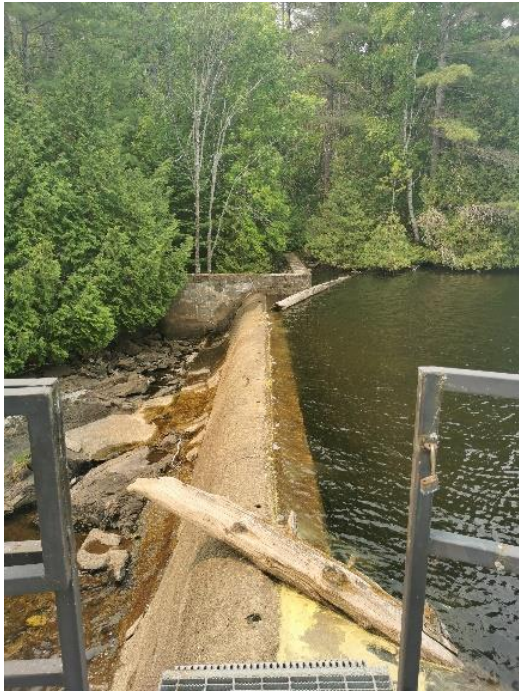
Figure 9: Kashwakamak Lake Dam, overflow spillway.

The secondary concrete side block dam is located north of the main structure and controls an emergency spillway section. This structure is approximately 25 m long and has a maximum height of 0.80 m. A wooden plank walkway has been installed below the structure. The elevation of the top of this weir is 261.67 m.

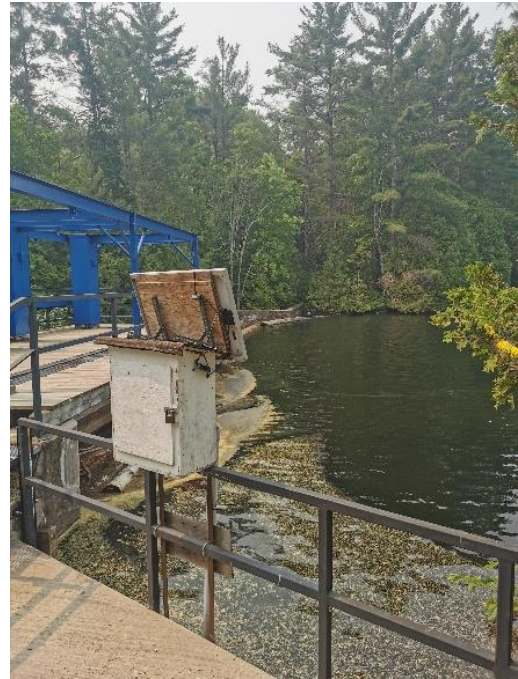
Figure 10: Kashwakamak Lake Dam, sluiceway and deck, looking north.

The three piers form the two sluiceways and support the wooden deck, metal railing and winch assembly. The elevation of the top of the piers is 262.00 m. The deck is supported by 0.20 m x 0.20 m wooden beams and has a top elevation of 262.26 m (Hatch, 2022). A solid metal railing encloses the deck. The winch assembly consists of a wheel mounted crank and a metal beam extending across the length of the deck.

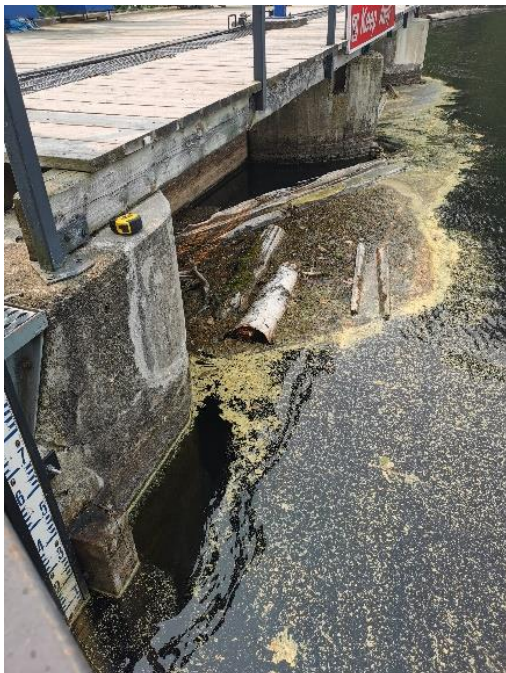
Figure 11: Kashwakamak Lake Dam, sluiceway and deck, detail.

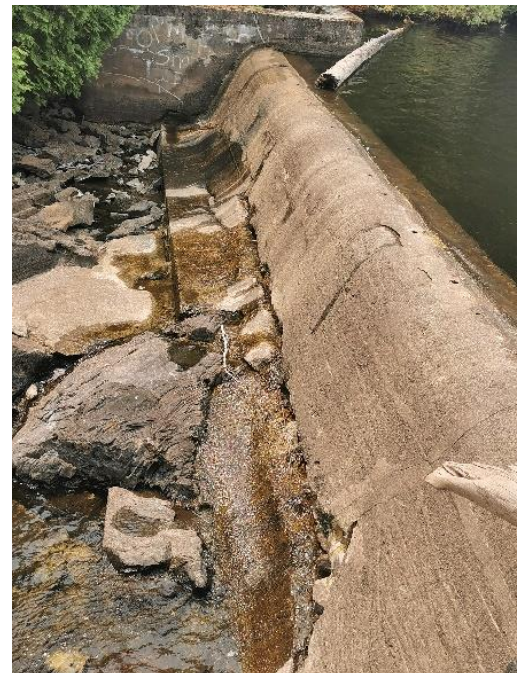
Figure 12: Kashwakamak Lake Dam, spillway detail.

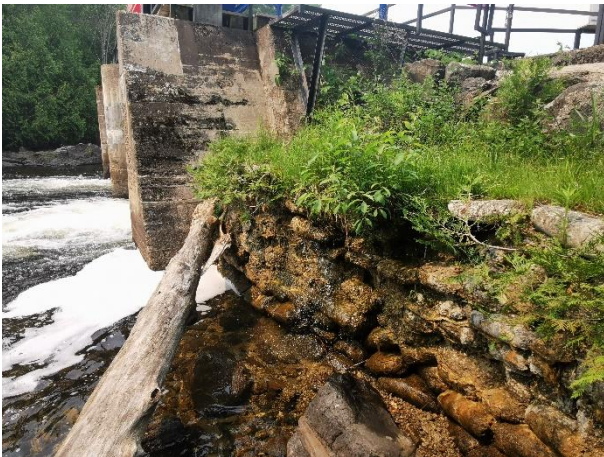
Figure 13: Kashwakamak Lake Dam, left concrete abutment and earthen embankment.

In the fall of 1995, MVCA undertook a repair program to reduce or eliminate the seepage around the earth embankment at the entrance to the dam. Pressure grouting was undertaken to try to plug the fissures in the rock.

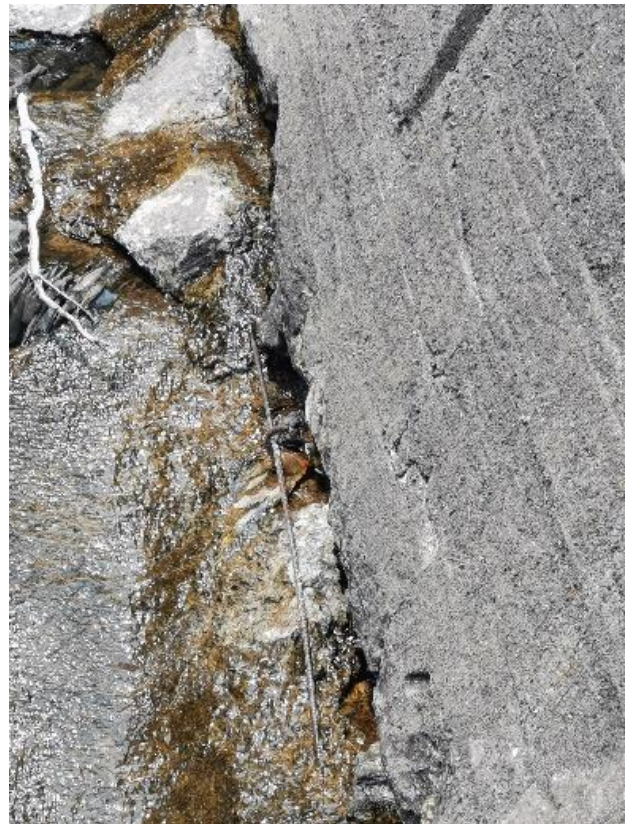
Figure 14: Kashwakamak Lake Dam, concrete detail.

In the fall of 2000, MVCA undertook a second grouting program and repairs to cracked and spalled concrete on the weir and the abutments. In 2002, the wooden deck of the dam was replaced and in 2005 an overhead steel gantry system was installed for stop log manipulation. No rehabilitation work has been completed on the dam since this time.

In 2022 a Dam Safety Review concluded that the concrete structures of the Kashwakamak Lake Dam were in a deteriorating condition and that major refurbishment or replacement should be performed within the next 5 years to ensure the continued safe operation of the dam. MVCA initiated planning for this in recognition of the necessary lead-time for design, permitting and funding processes.
