KASHWAKAMAK LAKE DAM CLASS ENVIRONMENTAL ASSESSMENT - PROJECT PLAN REPORT

Prepared for: Mississippi Valley Conservation Authority

Prepared by: Egis Canada Ltd.

November 12, 2024

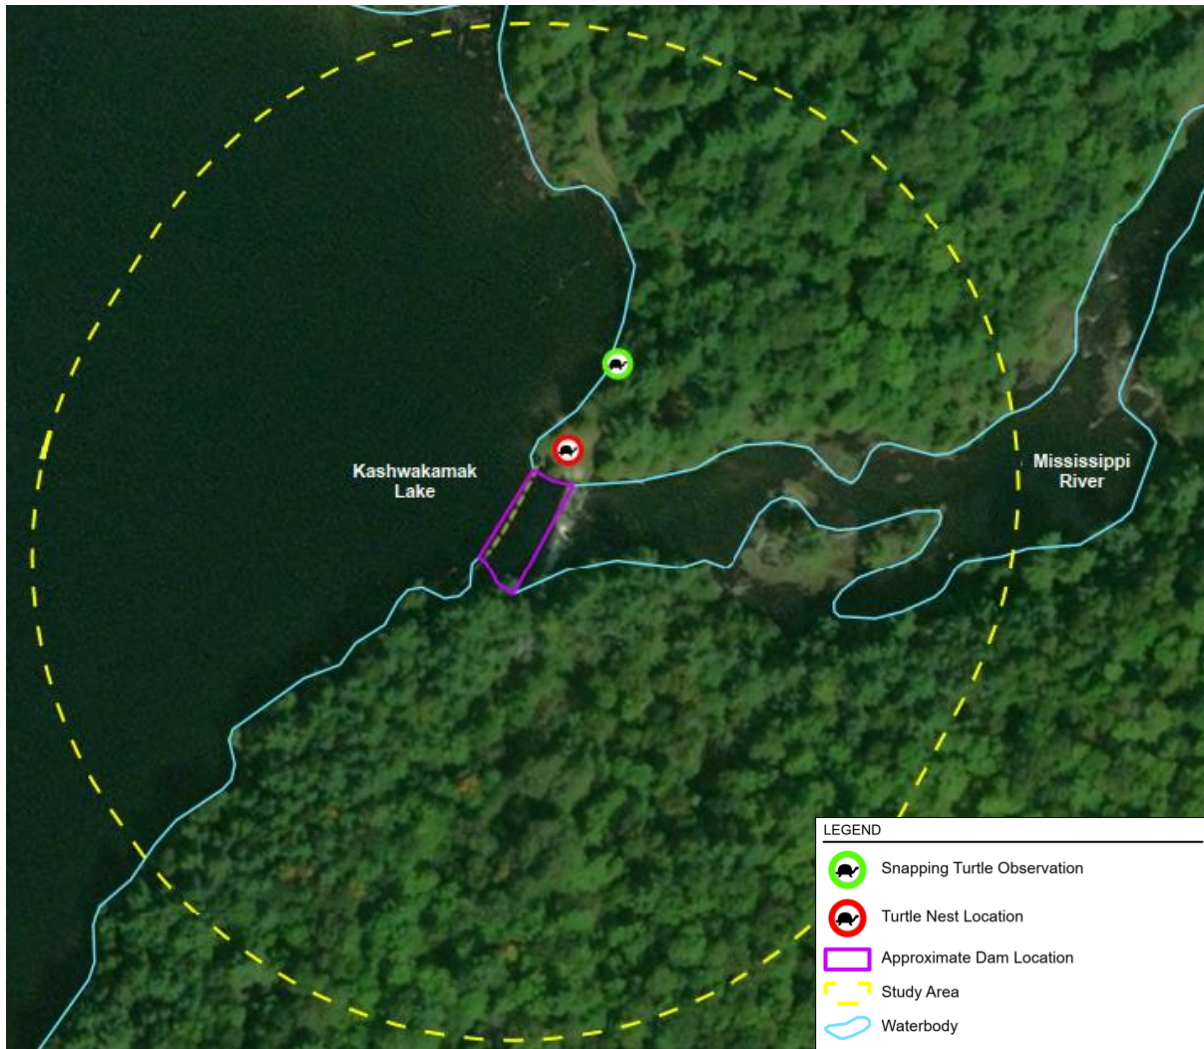
Figure 4-4: Location of Turtle Observations and Nests

The study area is located on Kashwakamak Lake where there are many observations from Ontario Nature, NHIC and iNaturalist for several SAR herptiles.

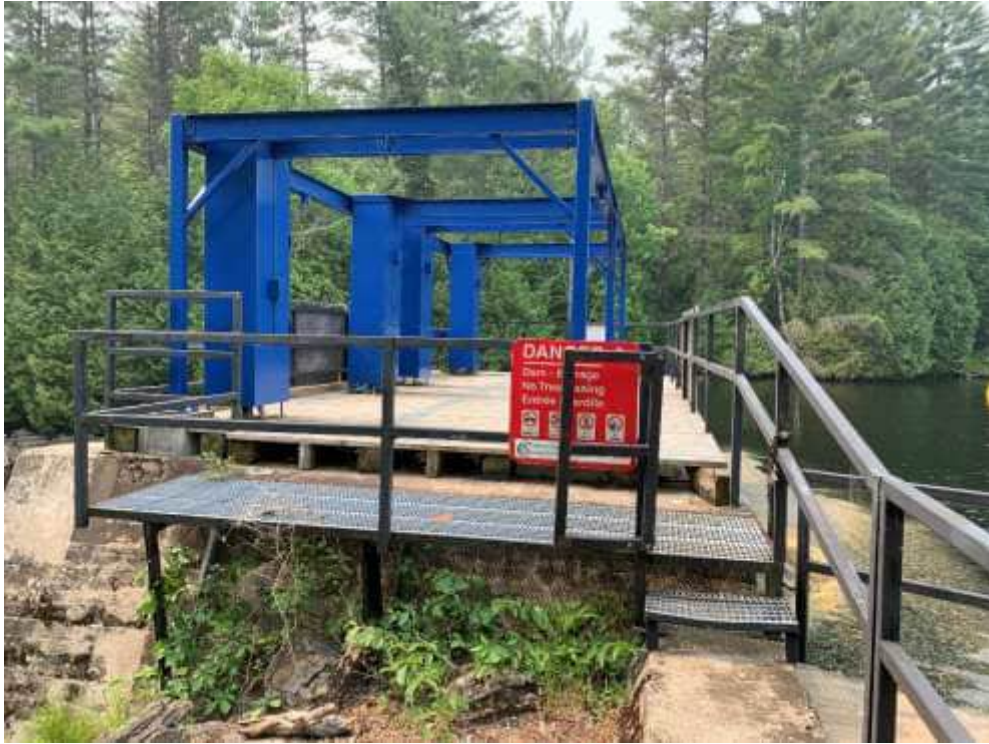
Photo 1: Existing conditions of the Kashwakamak Lake Dam structure to be replaced, facing north.

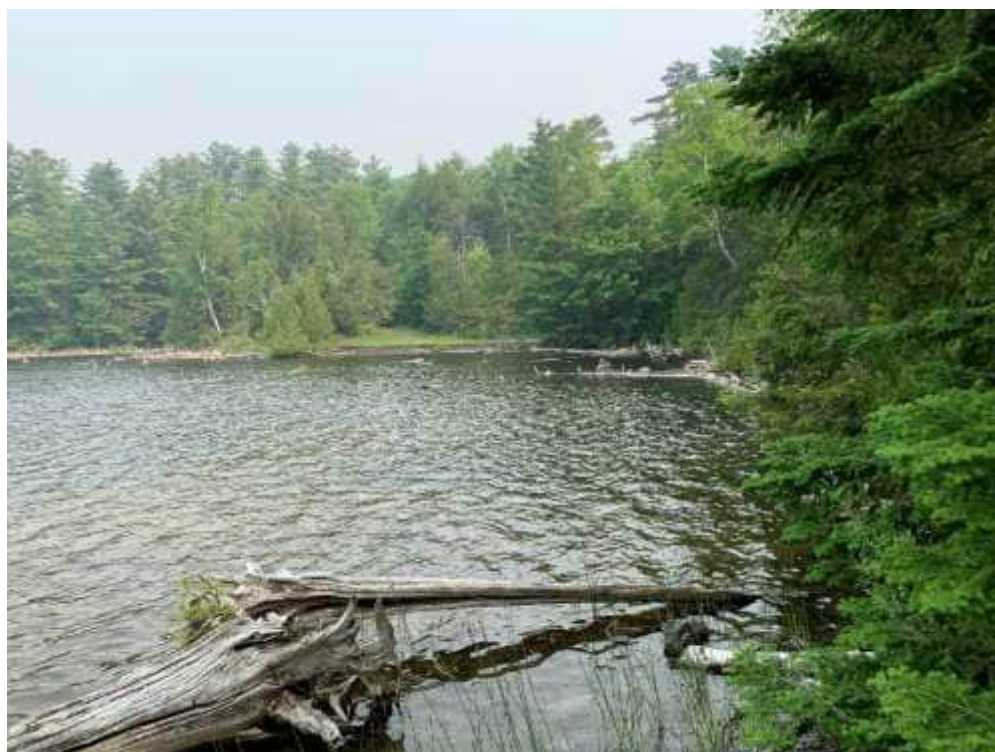
Photo 4: Existing conditions of log catchment bay, facing south.

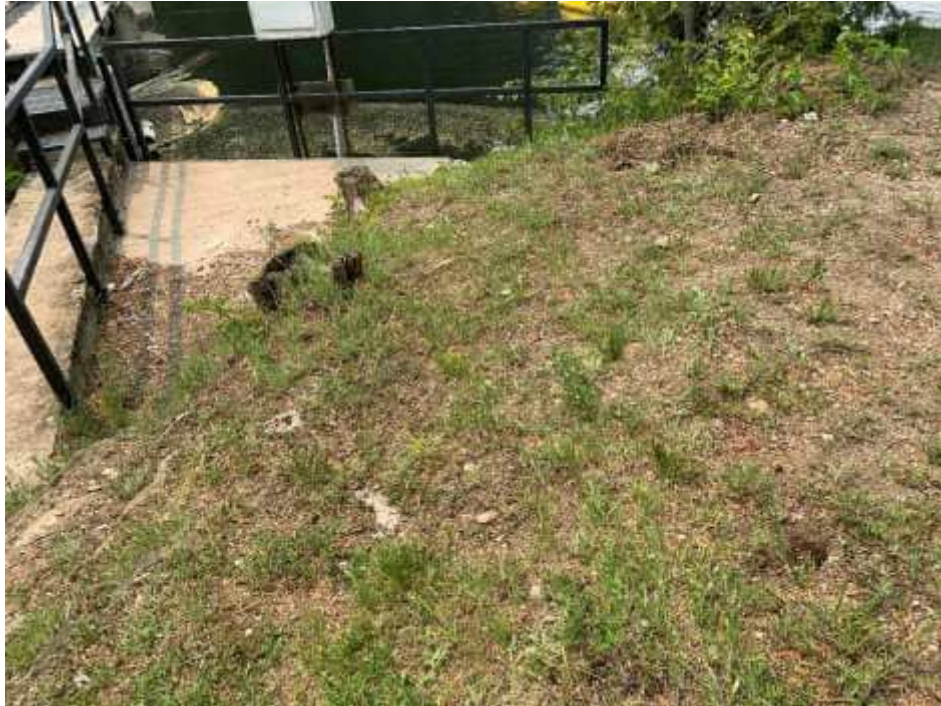
Photo 9: Existing conditions illustrating an old turtle nest within 2m of the Kashwakamak Lake dam structure. Facing south.

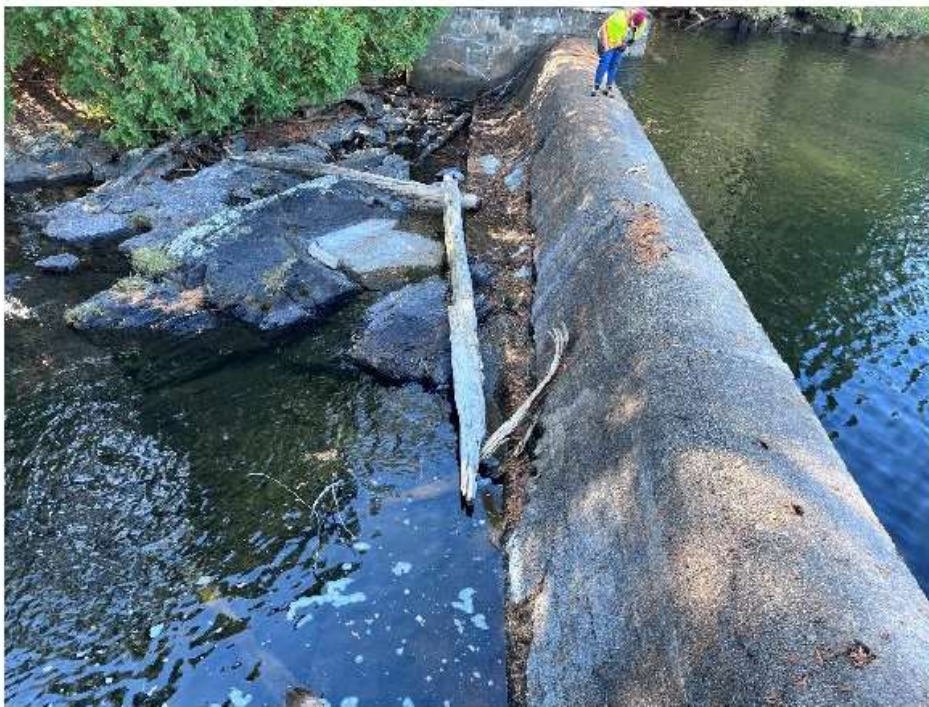
View of the overflow weir.

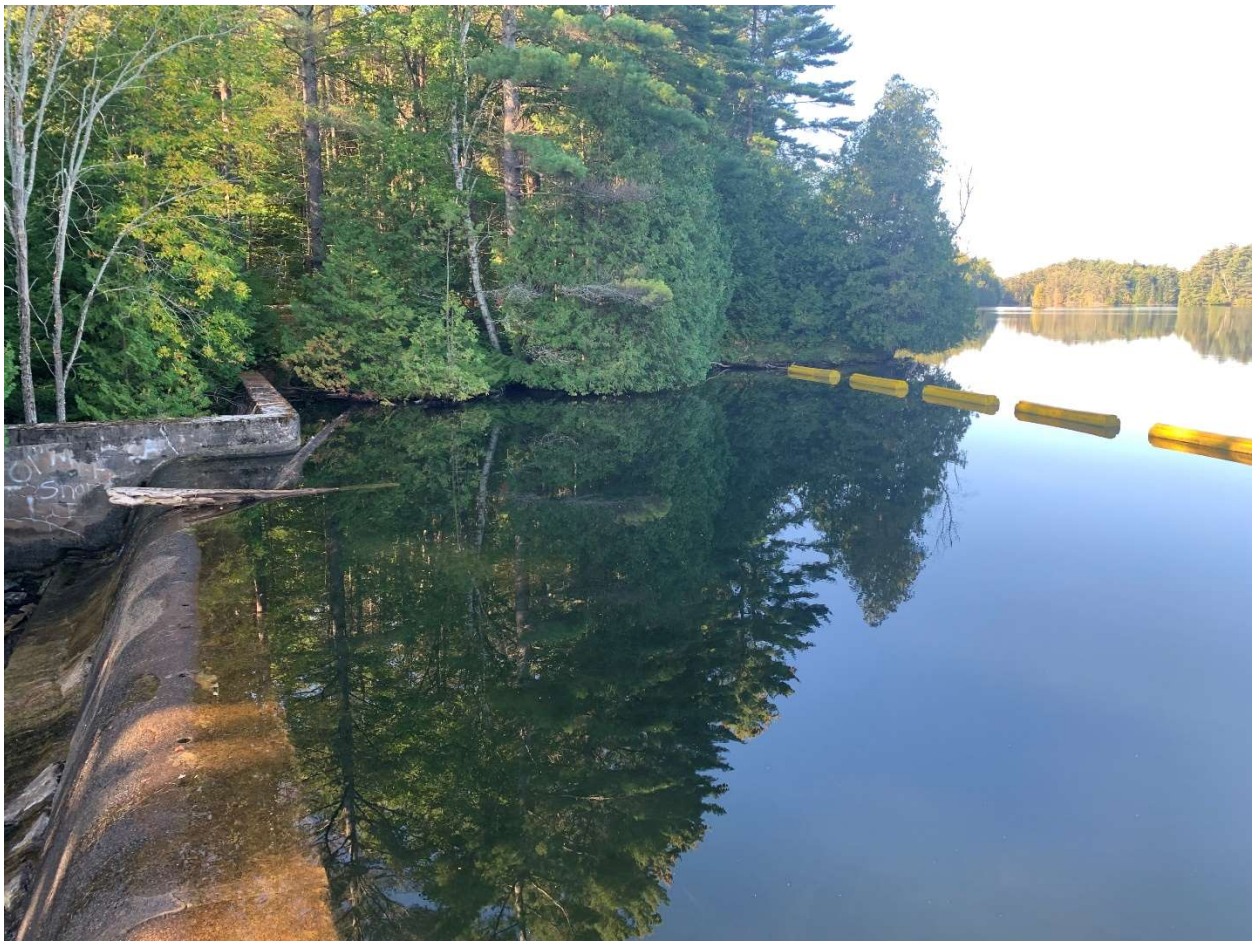
Image 4: Overflow dam and south wingwall facing southwest.

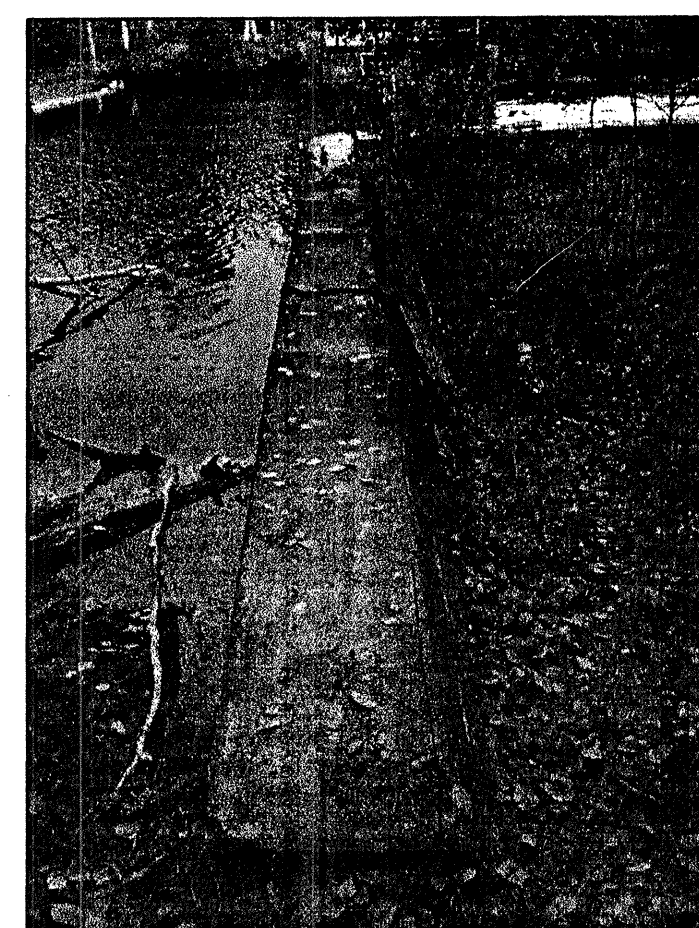
SEVERE STRUCTURAL CRACK

- LAYOUT & CONFIRM ALL CRACKS AND JOINTS TO BE REPAIRED.
- PRESSURE WASH.
- REMOVE LOOSE DELETERIOUS MATERIALS.
- SUFFICIENTLY GROUT CRACKS TO BE ABLE TO PRESSURE INJECT HILTI RM700 EP REPAIR MORTAR.
- CLEAN CONCRETE FACE OF SURPLUS REPAIR MATERIALS.

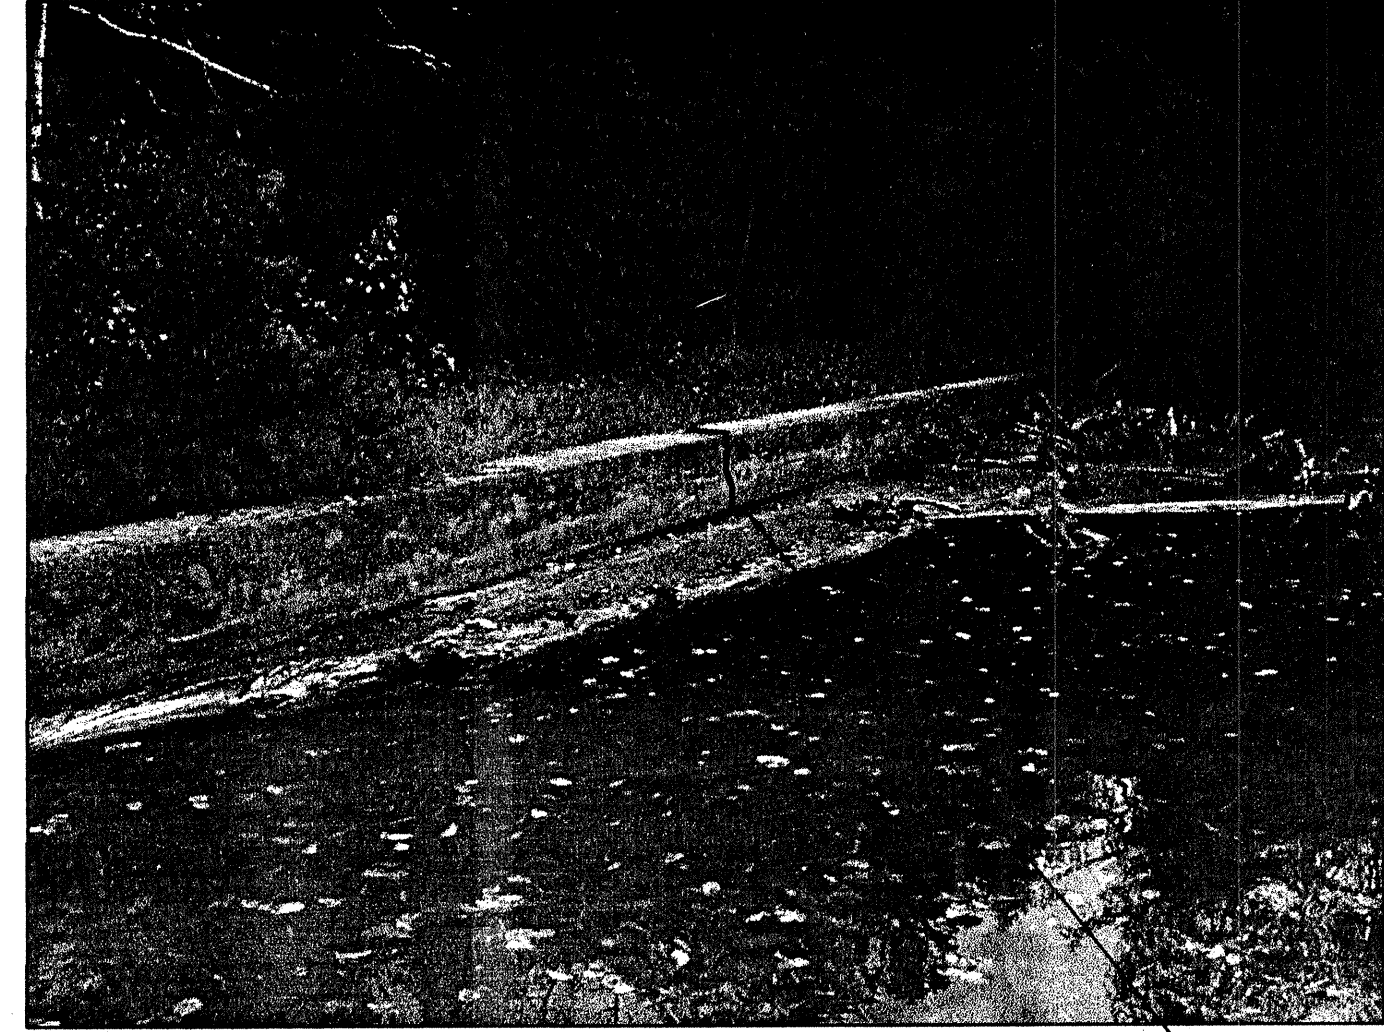
PHOTO #18 SEVERE STRUCTURAL CRACK
