Facility Assessment 2025-2026

## Mill of Kintail Conservation Area: Mill of Kintail and Gatehouse Almonte, Ontario

**Draft Report (version 2)**  
29 September 2025

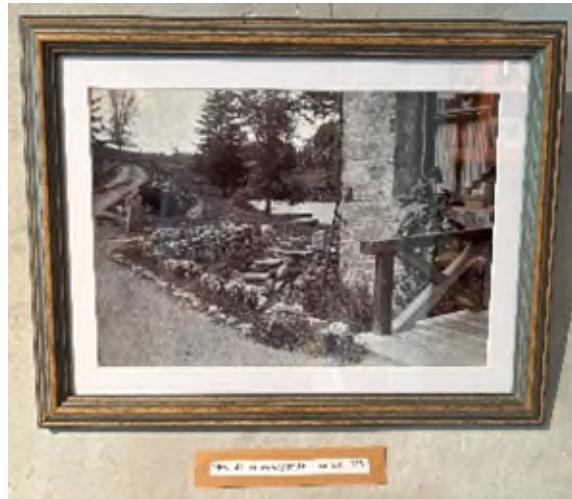
Figure 1: historic photo from 1935 on display showing the driveway and main entrance to the Mill.

In addition, historic photos of the Mill (Figure 1) show clearer grounds directly around the Mill, so FireSmart grounds may be more closely aligned with the historic appearance of the Mill.

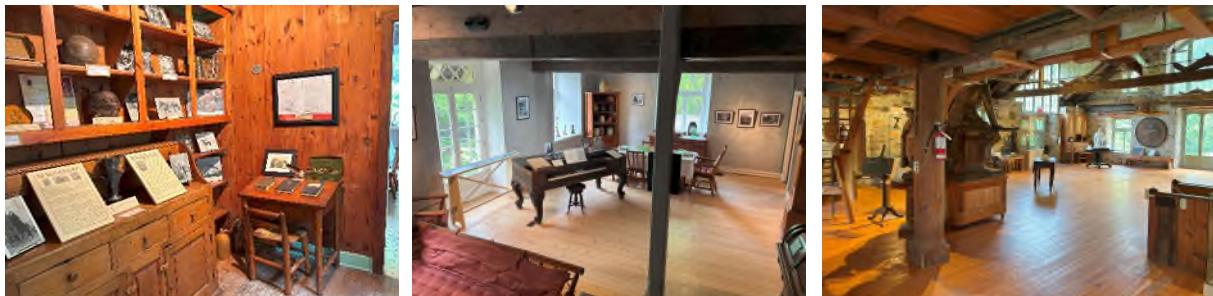
The Mill of Kintail exhibits a mixed collection consisting of artworks (including a large number of plaster casts), artifacts and archives related to R. Tait McKenzie (surgeon, sculptor, educator), Ethel O'Neil (poet and McKenzie's partner), and James Naismith (inventor of basketball, close friend of McKenzie), as well as historic tools collected by James Leys. Recently, collections from the Naismith basketball foundation were added (Figure 2).

Figure 2: Naismith artifacts on display on the main floor (left), historic entertaining rooms on the main floor (middle), R. Tait McKenzie studio on the upper floor (right).

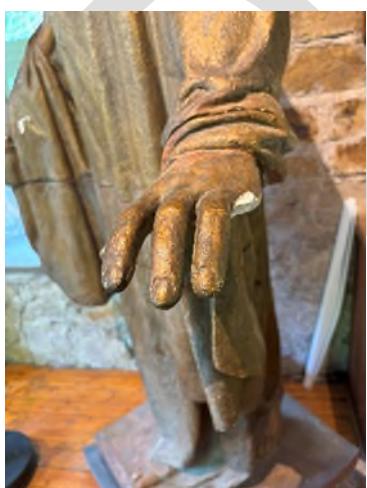
Figure 3: broken missing finger on "Mercy".

#### **Plaster is highly sensitive to physical forces.**

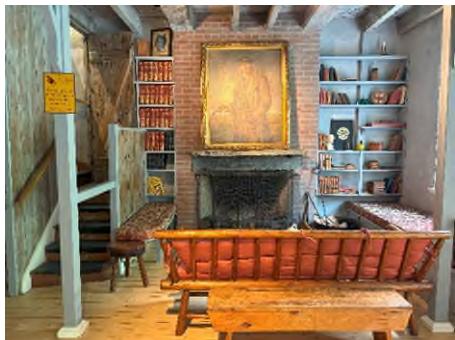
**Permanent exhibits, including some sensitive materials, are exposed to daylight year-round and some electric lighting is overbright on the main floor.**

Figure 4: Overly brightly lit painting of R. Tait McKenzie.

As is typical of historic homes, period rooms permanently display of objects and are exposed to daylight entering through the rooms' windows. Although shutters are installed on ground floor windows, these are kept open, even during the winter closure. No blinds or curtains are installed on the windows. Daylight can provide very high lux levels and includes ultraviolet radiation (UV). In addition, some halogen bulbs are in use which emit high light levels and UV levels as compared to other bulbs in use (LEDs).

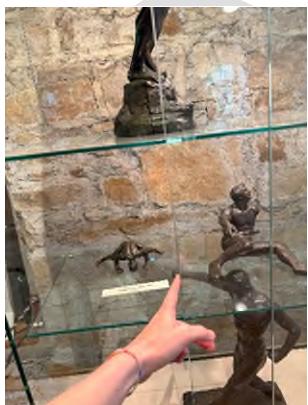
**Unsecured, small copper-based (brass and bronze) sculptures are vulnerable to theft.**

Figure 5: Unsecured display case in the R. Tait McKenzie studio.

Several smaller brass and bronze sculptures are displayed in the studio. Many of these are displayed in display cases, with unsecured sliding doors, or on open display (Figure 5). Due to the commodity value for copper, brass and bronze sculptures are targeted by thieves. The small, portable unsecured sculptures could be easily stolen during open hours.

A number of sliding jewellery case locks were found in display case drawers, suggesting that these locks were used in the past; it is unclear why the use of locks was discontinued.

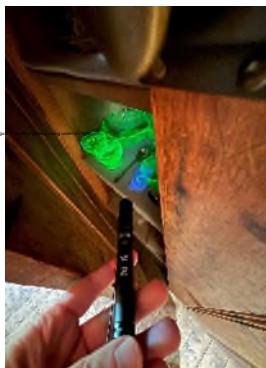
Figure 6: uranium glass glowing under UV light.

**Many uranium glass artifacts are displayed and stored in the Mill, which may concern some who are aware of potential radiation from this type of glass.**

- Uranium glass will glow bright green when lit by a UV light.
- Approach health and safety officials, or a college or university to confirm that radiation levels are acceptably low, using a radiation detector.
- Document the potential radiation hazard in the catalogue records for these objects.
- Do not use uranium glass objects for food or drink.

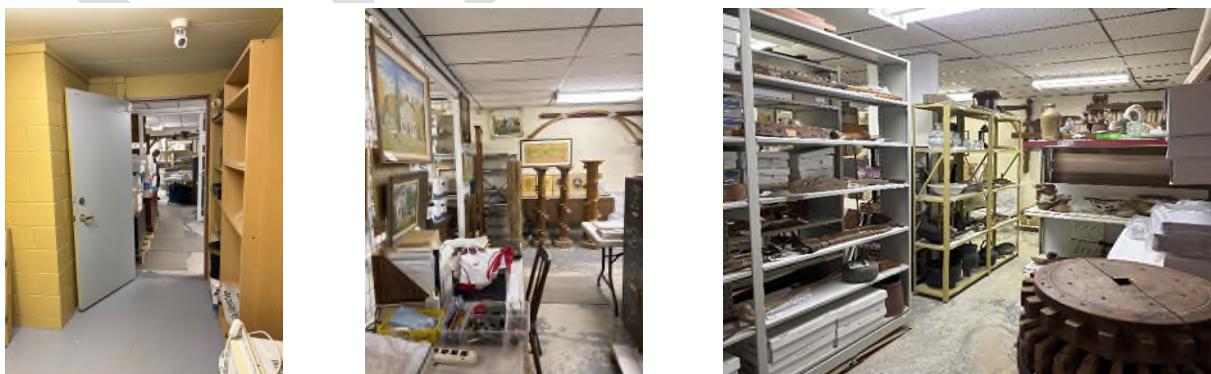
The collection is stored in the artifact storage room, located in the basement of the Gatehouse's extension (Figure 7).

Figure 7: entrance into artifact storage (left), artifact storage room (middle and right)
