Catchment Report:

Poole Creek 2024

Introduction

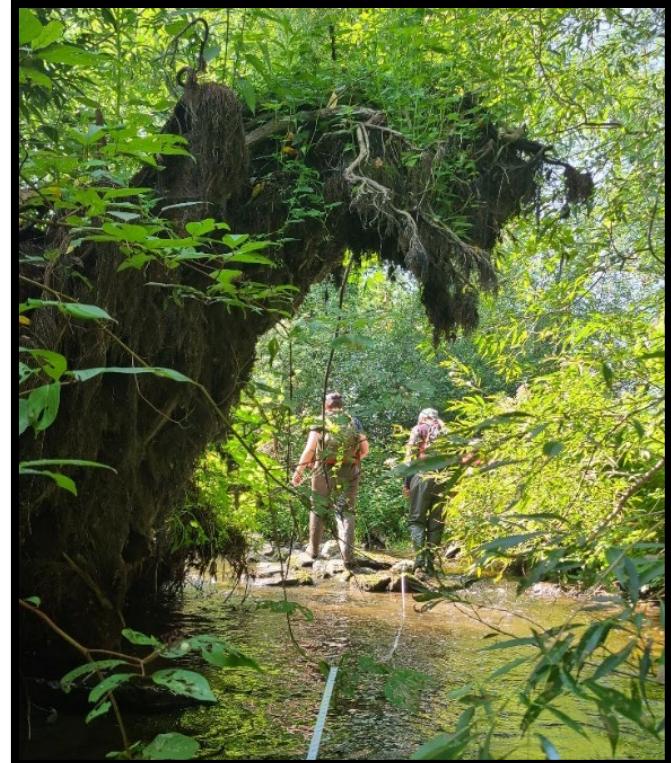
Image 1. Upturned tree roots shading a section of Poole Creek near Stittsville.

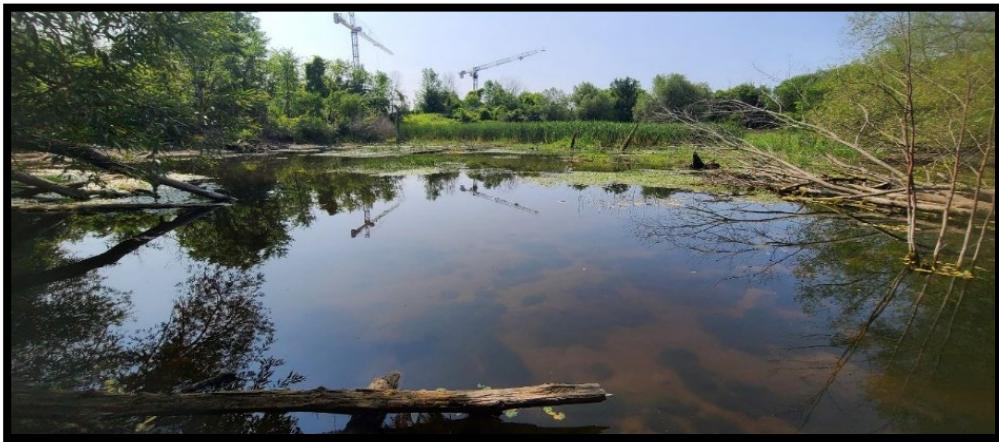
Image 2. Beaver pond and wetland area along Poole Creek in Stittsville.

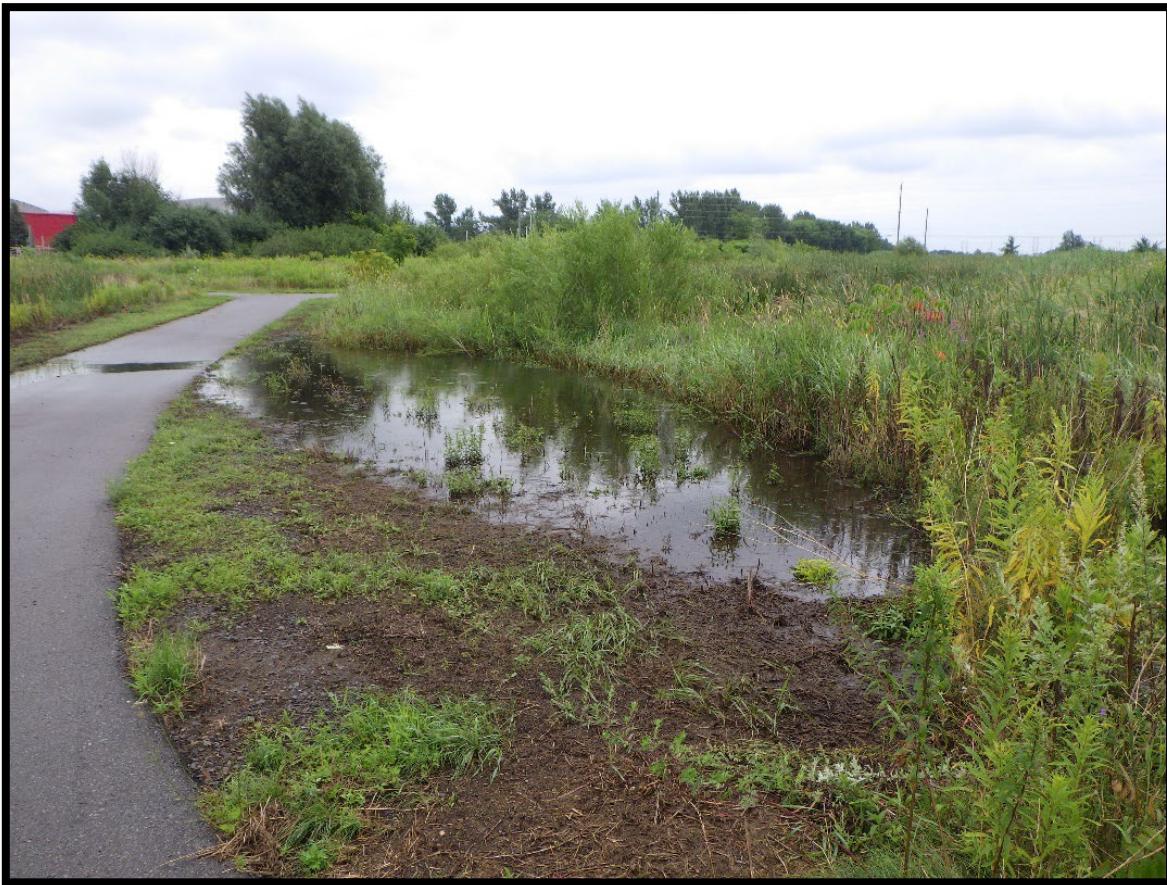
Image 1. Flooding within the area that Poole Creek intersects the Carp River.

Seasonal weather conditions were very wet in 2024 with sustained high-water conditions for most of the season due to frequent rain events. Field surveys of sections were impacted as the water was too deep or fast for wading. However, with the perseverance of the crew and volunteers, 50 sections were assessed. Given the atypical conditions, all assessments were subjected to the effects of high water; therefore, they may not reflect the overall long-term health of the system.

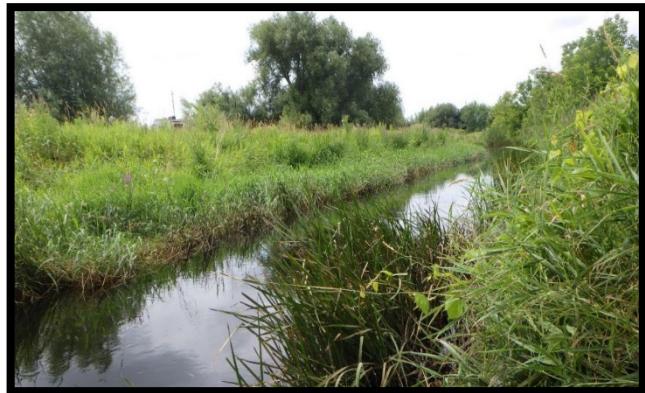
Image 2. Section along Poole Creek with a vegetated buffer of approximately 10 to 15 meters wide.

The Riparian buffer width evaluation for Poole Creek is shown in Table 5 and Figure 2. Only 2% of the left bank had greater than 30 meters of buffer – while the right bank had no sections greater than 30 meters. A 15 to 30 meter buffer was present along 6% of the left bank and 8% of the right bank. A 5 to 15 meter buffer was present along 31 % of the left bank and 34% of the right bank. A buffer of 5 meters or less was observed along 62% of the left bank and 58% of the right bank. Overall, evaluations of the buffer width for all sections surveyed were determined to be below the recommendations of Environment and Climate Change Canada (2013).

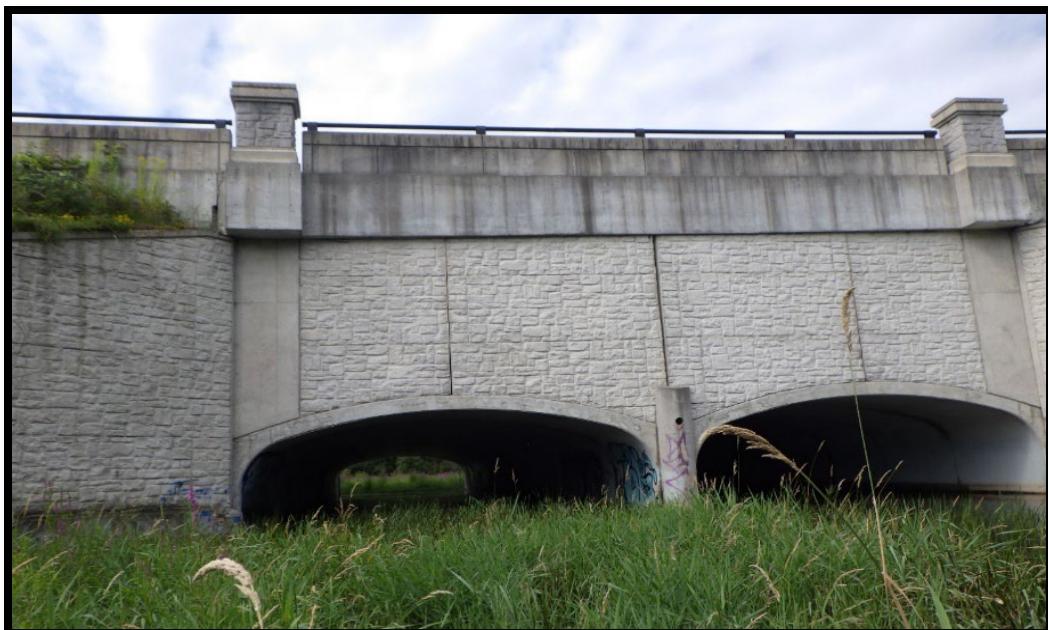
Image 5. Poole Creek flows under Huntmar Drive with a vegetated buffer less than 5 meters wide.

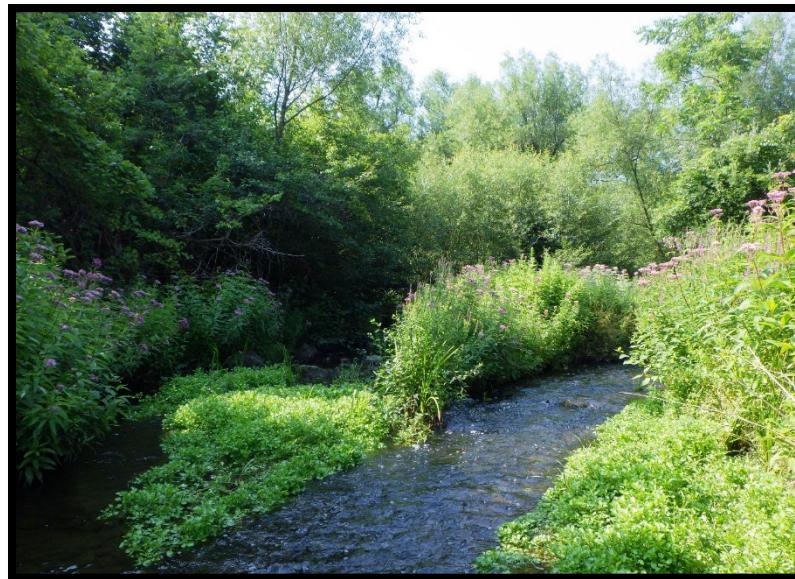
Image 3. Section along Poole Creek with forest, scrubland, and meadow land areas.

Table 7 and Figure 4 summarize the percentage of adjacent land use identified along the surveyed sections. Poole Creek catchment is naturally composed of scrublands with 15% of the surveyed areas containing this land type. These areas transition into forest in 12% of the areas, wetlands in 10%, and meadow in 8% of the adjacent lands. Aside from the natural areas; recreational and residential areas dominate the landscape at 22 and 19% of the landscape respectively. Industrial uses were noted in 8% of areas and infrastructure identified as 6% of adjacent lands.

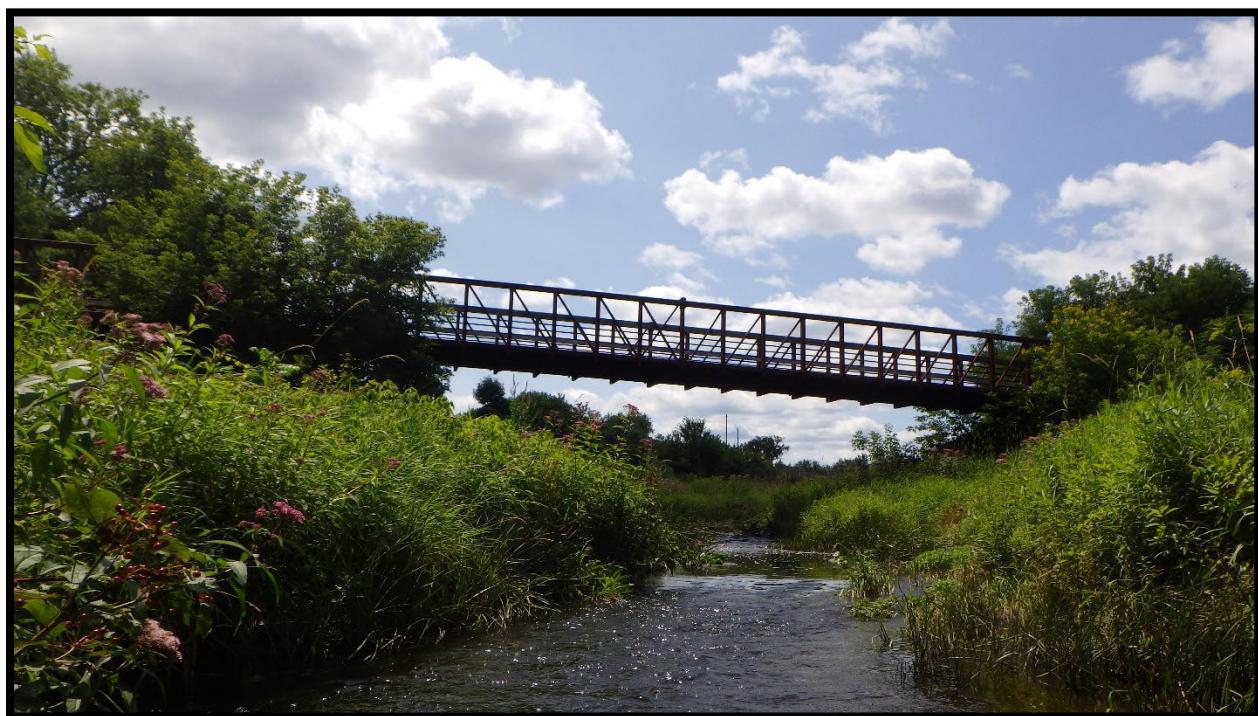
Image 4. Section of Poole Creek with a recreational bridge in Stittsville.

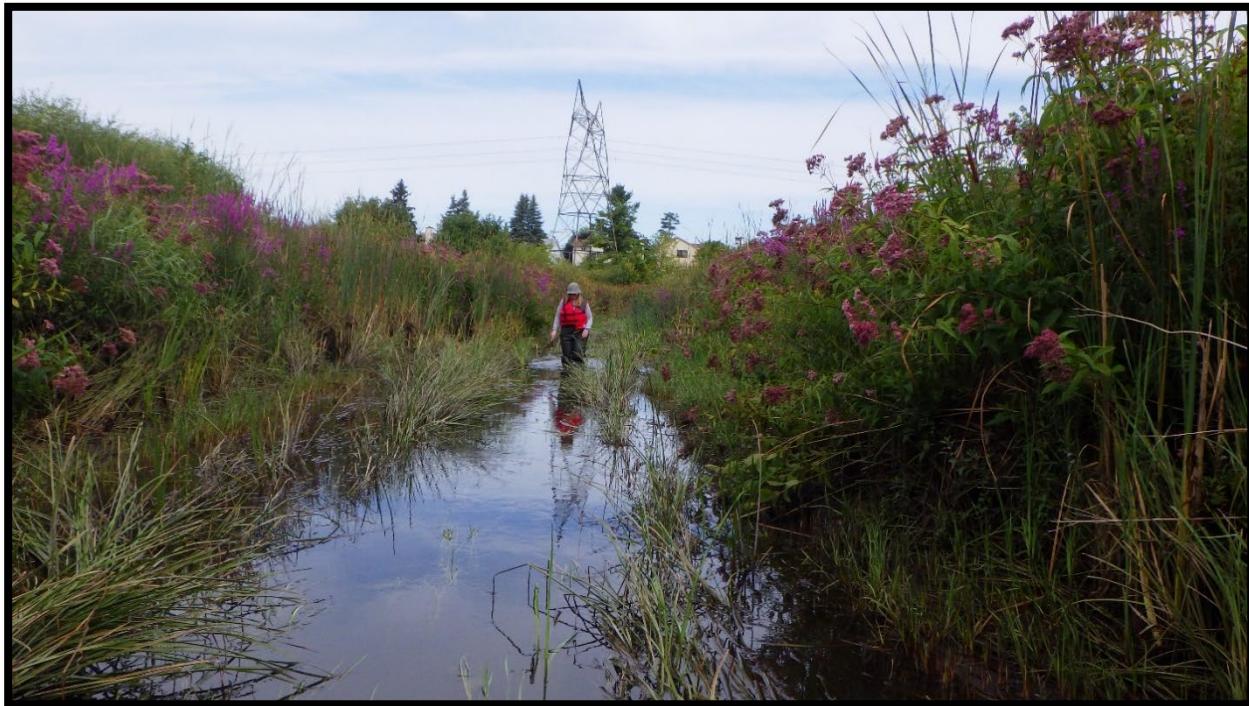
Image 5. Section of Poole Creek depicting natural levels of anthropogenic alterations, most of this section was wetland.

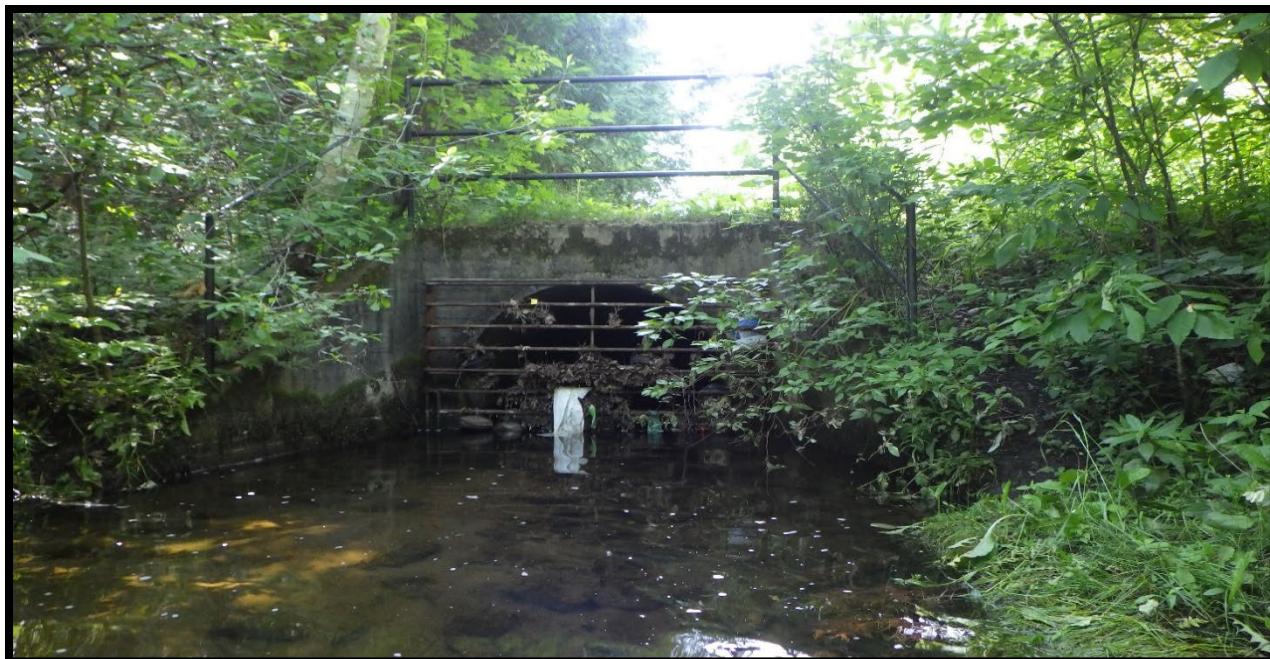
Image 6. Section along Poole Creek with high levels of anthropogenic alterations. Multiple stormwater outlets are visible throughout Poole Creek's urban areas.

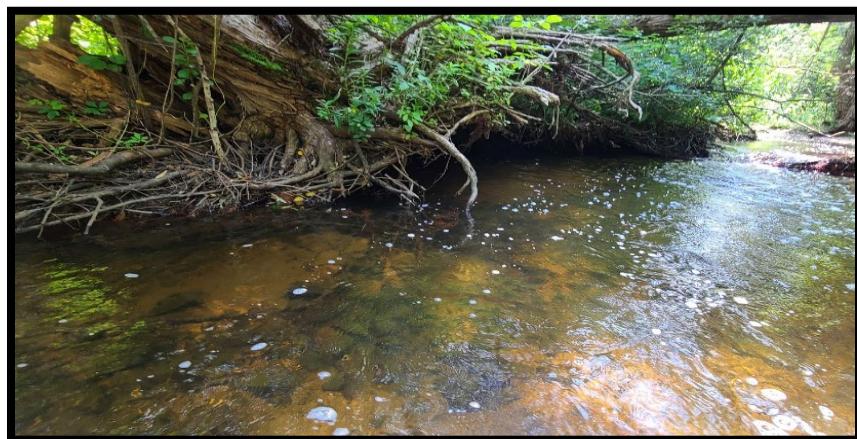
Image 7. Undercut bank along a section of Poole Creek, creating habitat for fish and wildlife.

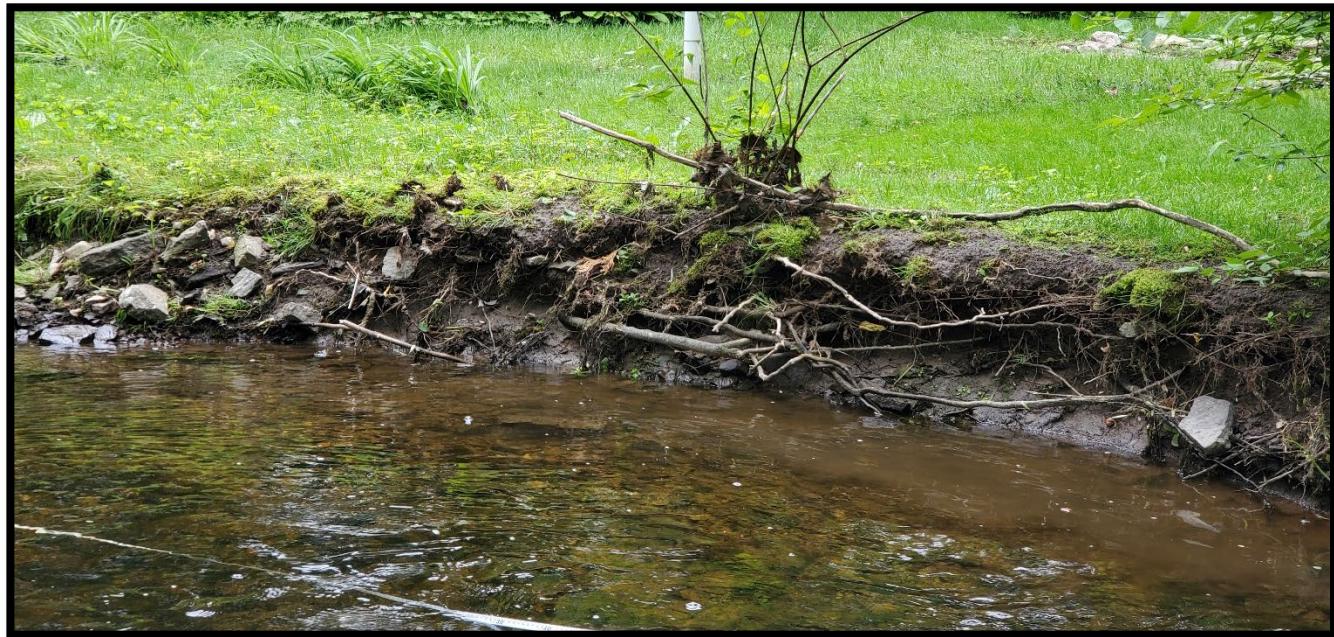
Image 8. Erosion along a section of Poole Creek in a residential area where the shoreline lacks a natural riparian buffer.

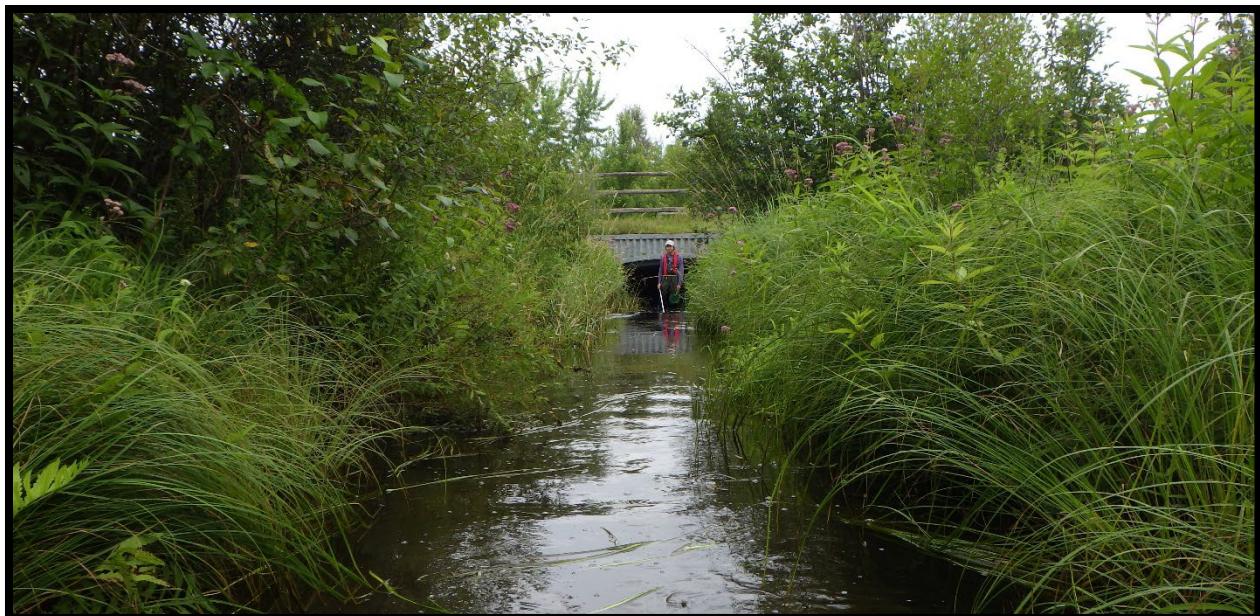
Image 9. Section of Poole Creek with low overhead shading but has abundant close to the water shading from tall grasses.

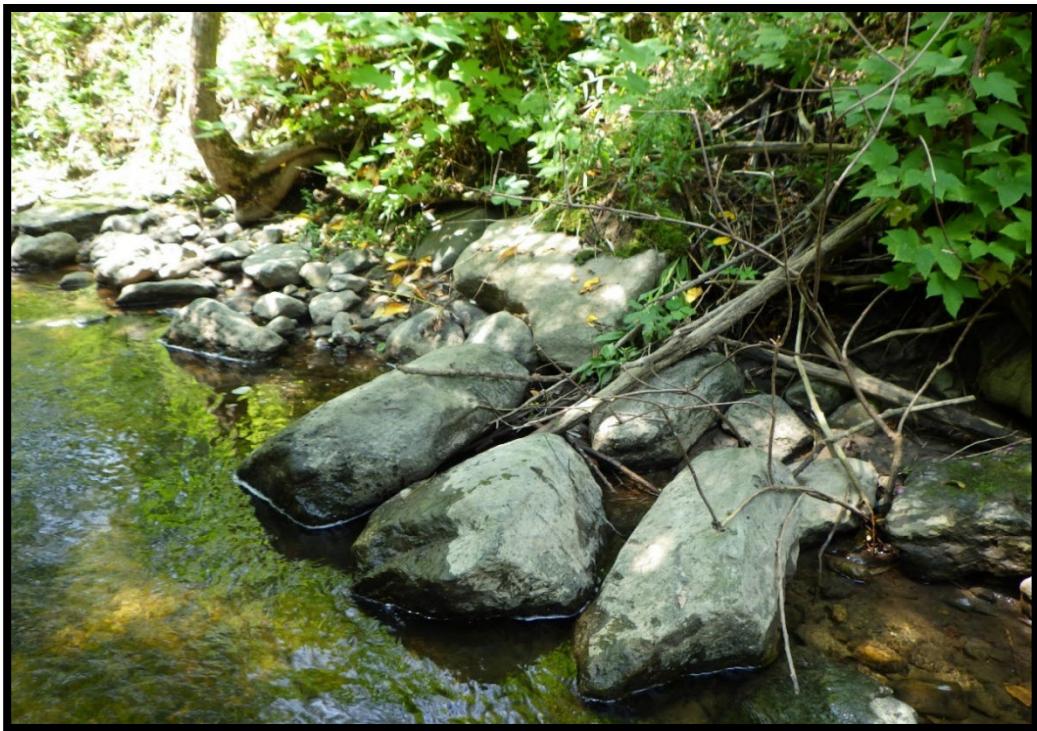
Image 12. Section of Poole Creek with high habitat complexity featuring boulders, cobble, gravel, and in-stream wood structures.

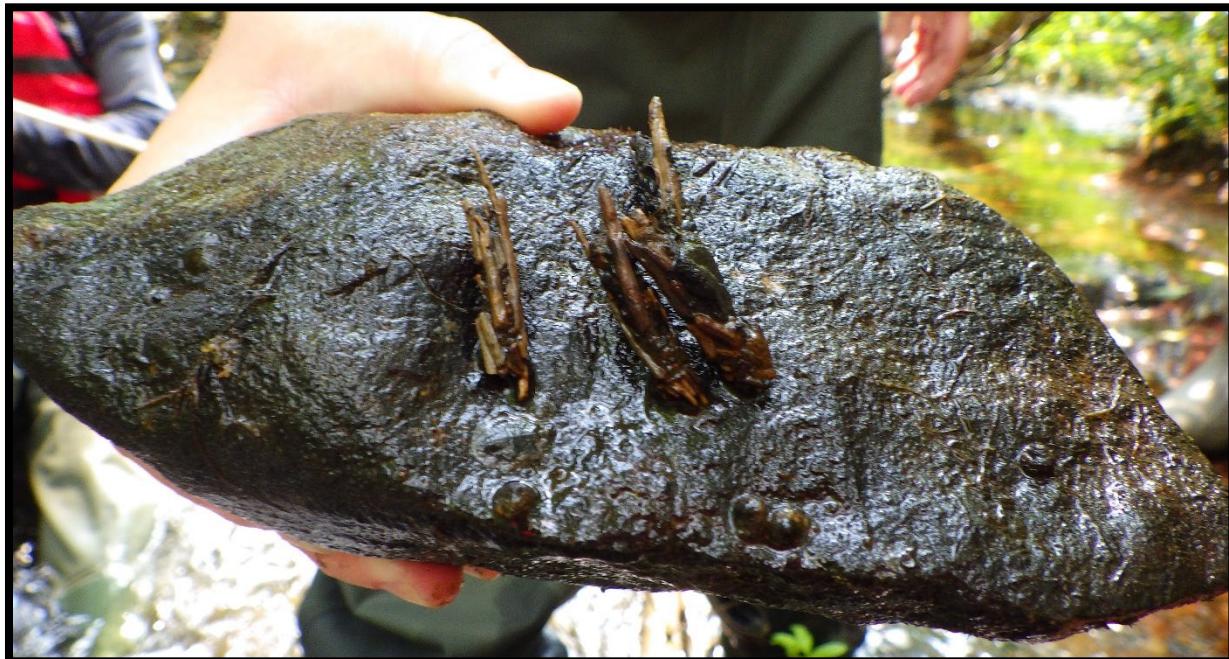
Image 16. Rocks and woody debris provide a diverse habitat for not only fish but benthic invertebrates as well. In this photo caddisfly casings made of twigs are attached to a rock – sampled from an area of faster flowing water in Poole Creek.

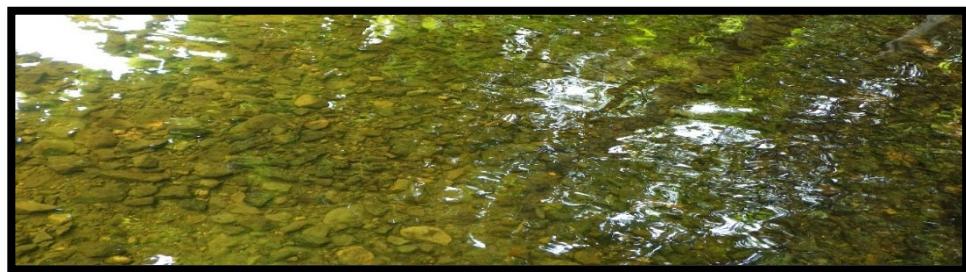
Image 13. Areas of mixed substrate types of cobble, gravel, and sand can be found along sections of Poole Creek.

Substrate complexity along Poole Creek was observed to be heterogenous in 92% of sections surveyed; meaning a very diverse substrate composition throughout the creek, and homogenous in the remaining 8%. Table 11 and Figure 11 show the substrate types observed. It is a system dominated by cobble, with this substrate identified in 26% of sections. Other substrate types included bedrock (2%), boulder (6%), gravel (12%), sand (16%), silt (17%) and Clay (22%).

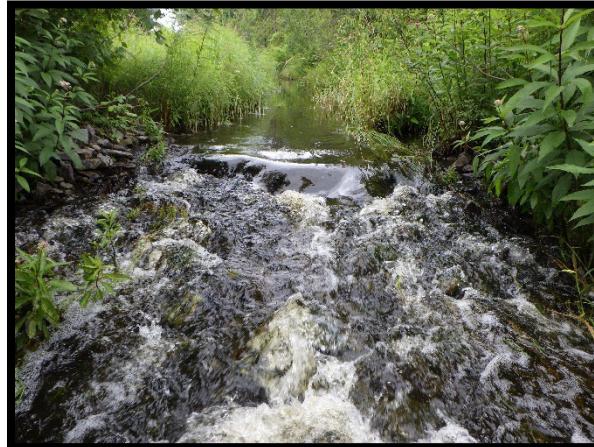
Image 14.
Run, pool,
riffle
sequence
found in a
section of
Poole Creek.

the temperatures increase. Riffles are sections of agitated and fast-moving water that help to provide dissolved oxygen to the stream; they also provide spawning habitat for some species of fish. Runs are areas along a creek that are typically shallow and have unagitated water surfaces. Table 12 and Figure 13 show that the surveyed portions of Poole Creek have a moderate to low diversity of morphological conditions. Poole Creek is made up of mostly runs (66% of surveyed sections), and only 20% riffles, and 14% pools. Although there is a low occurrence of pools and riffles, the ones present contribute to healthy habitat for aquatic species of different life stages.

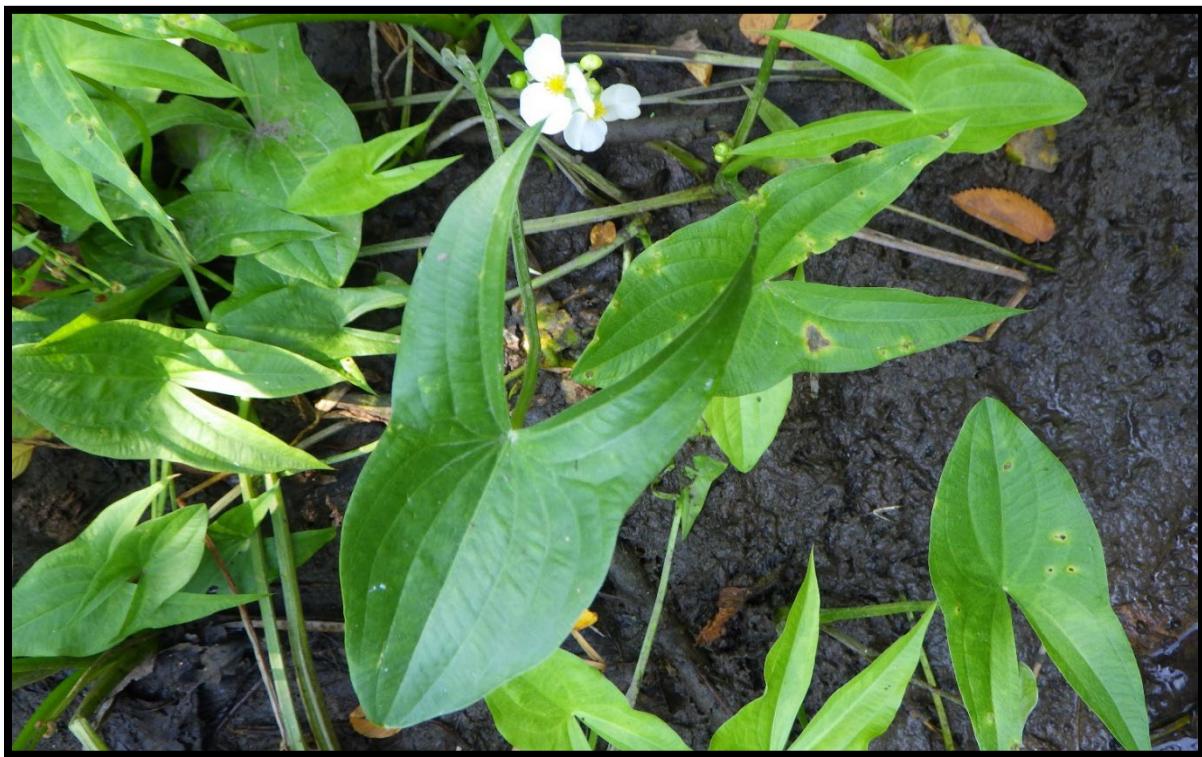
Image 20. Broad-leaved emergent plants such as Broad-leaf Arrowhead can be found in the wetland areas of Poole Creek.

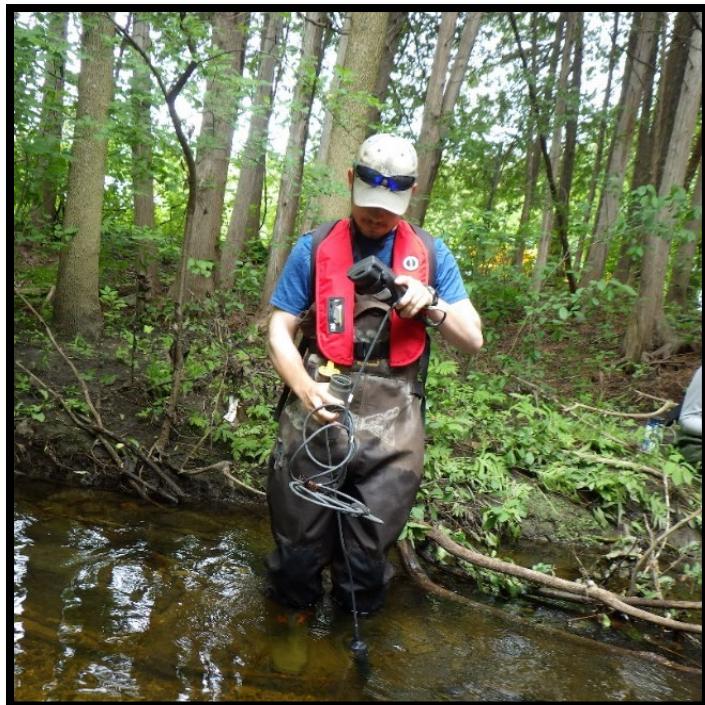
Image 15. MVCA staff collecting water chemistry readings in Poole Creek using a YSI Water Quality Meter.

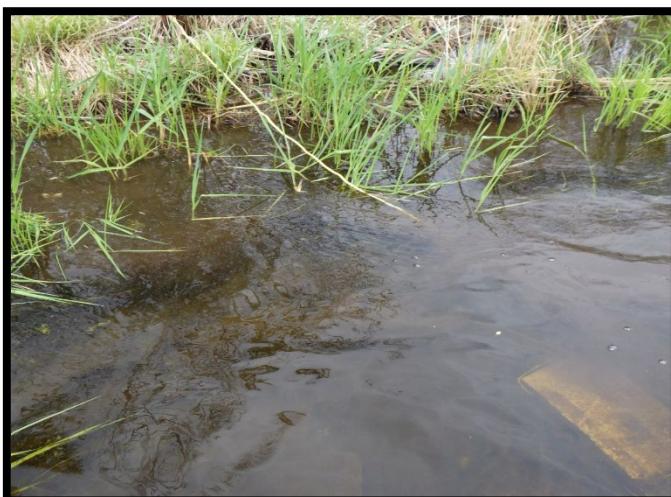
Image 22.
Temperature
Logger placed
in Poole Creek
by Westridge
Drive from
May to
September.

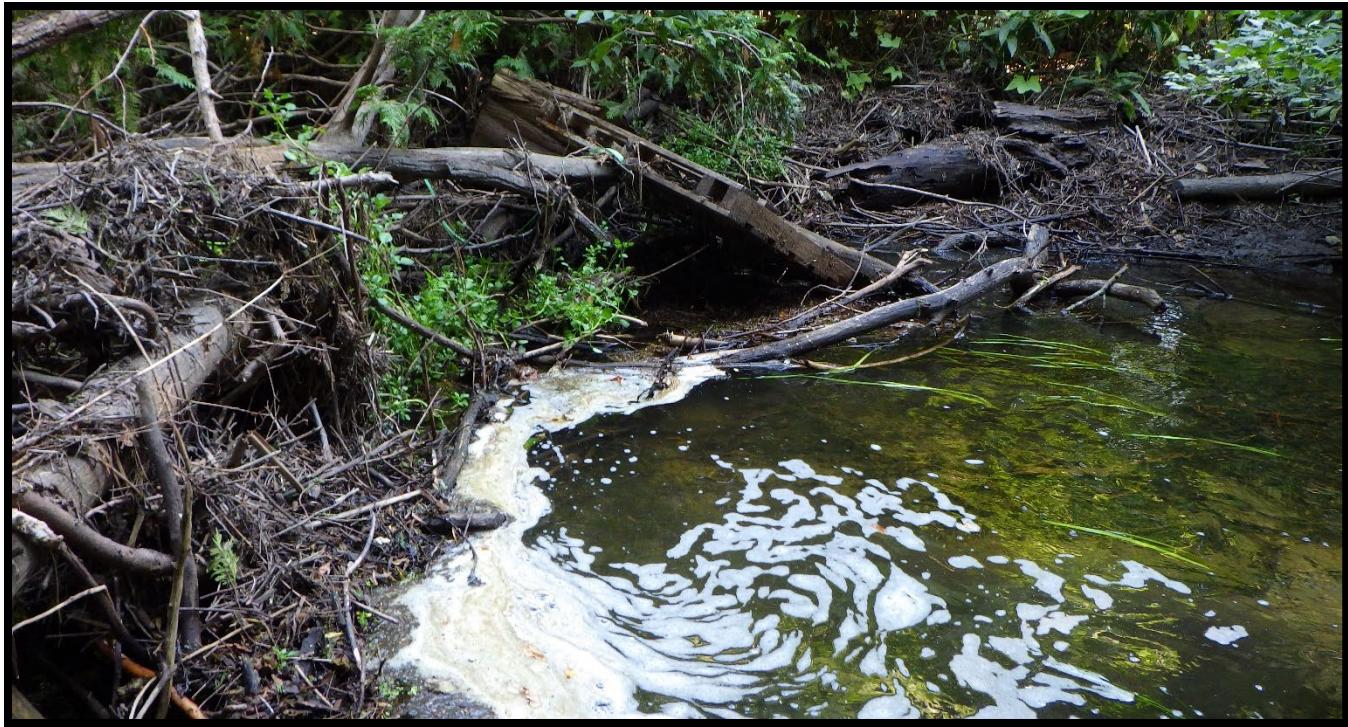
Image 26. Significant debris dam causing a change in flow in Poole Creek.

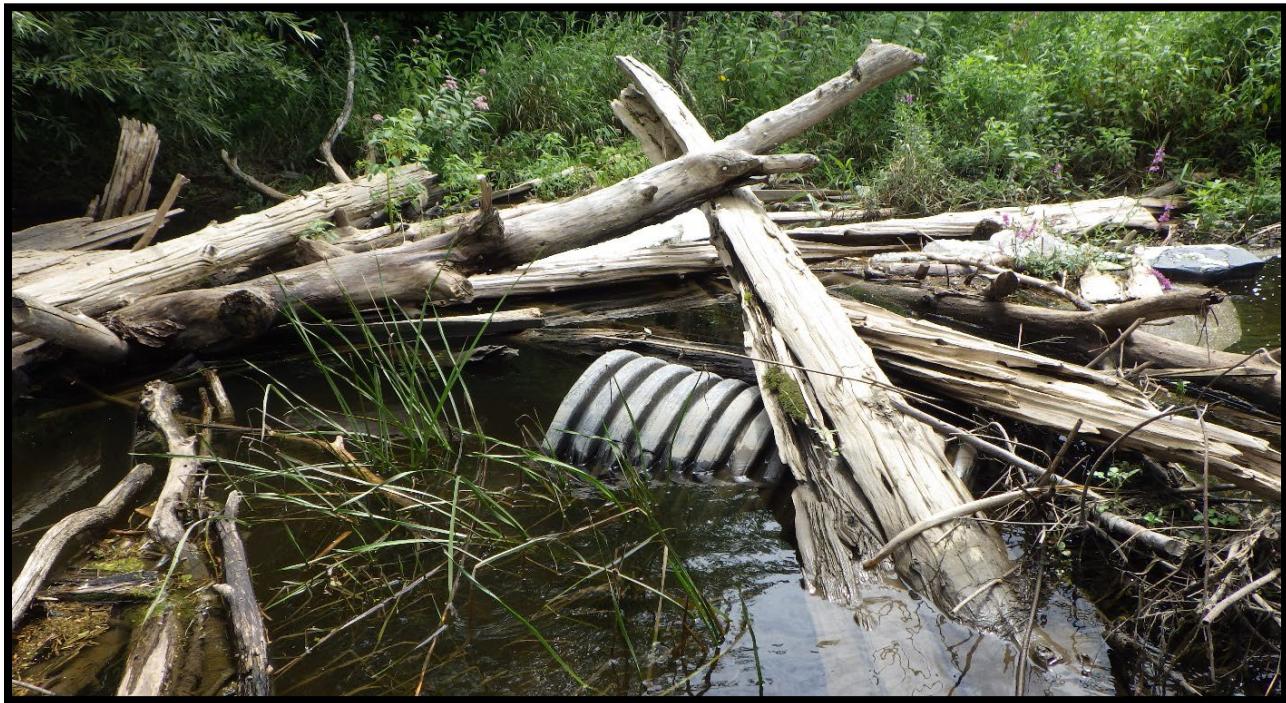
Image 167. Debris dam causing a migratory obstruction in Poole Creek near Maple Grove Road.

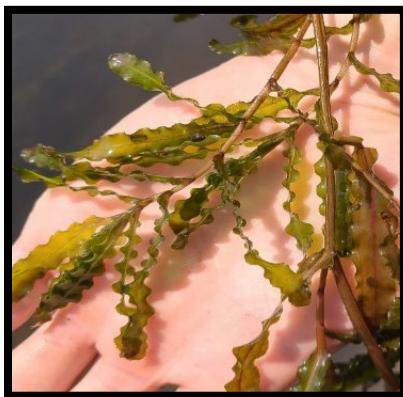
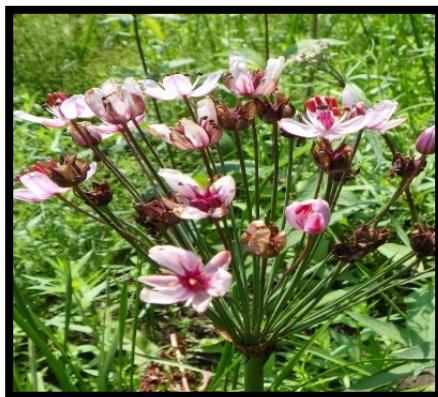
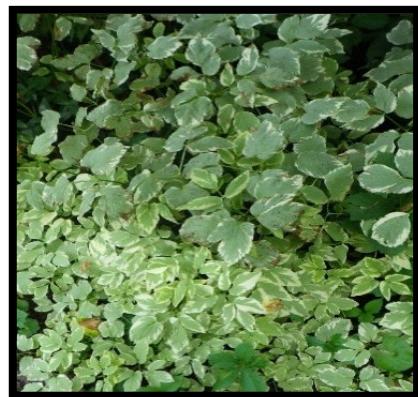
Image 29. Invasive species observed along Poole Creek from left to right: Curly Leaved Pondweed, Flowering Rush, and Goutweed which likely escaped from a nearby garden.

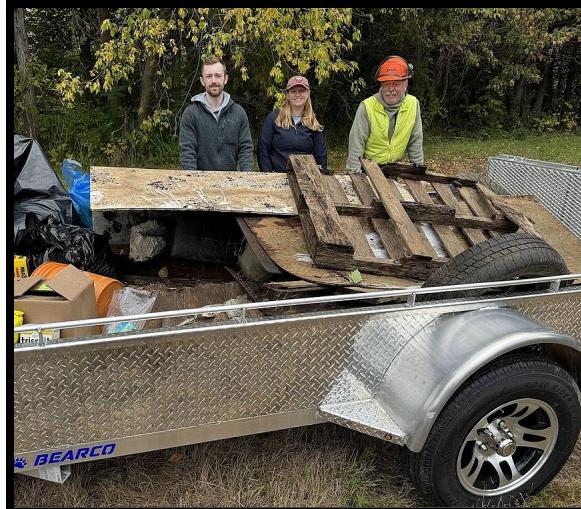
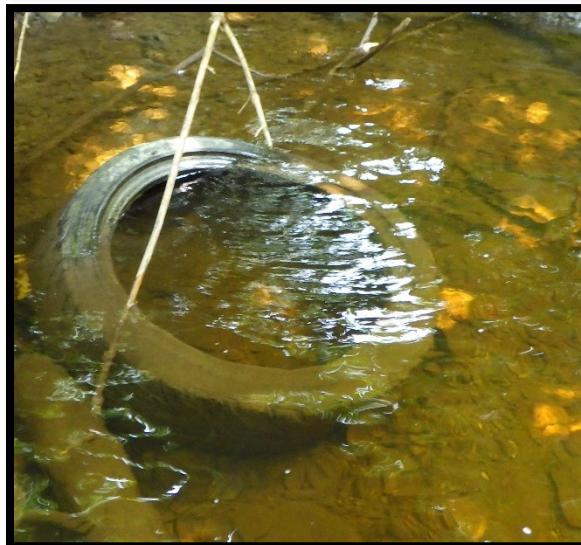
Image 30. Photos showing garbage removed from Poole Creek during a volunteer clean up day.

In the fall of 2024, a stream garbage clean-up event was held at the Sweetnam Drive area of Poole Creek; over 180 kg of garbage was removed, additional activities are planned for 2025.
