# GEOTECHNICAL INVESTIGATION AND DESIGN REPORT KASHWAKAMAK LAKE DAM REPLACEMENT, TOWNSHIP OF NORTH FRONTENAC, ONTARIO

Project No.: CCO-23-3603

Revision 2 – June 2024

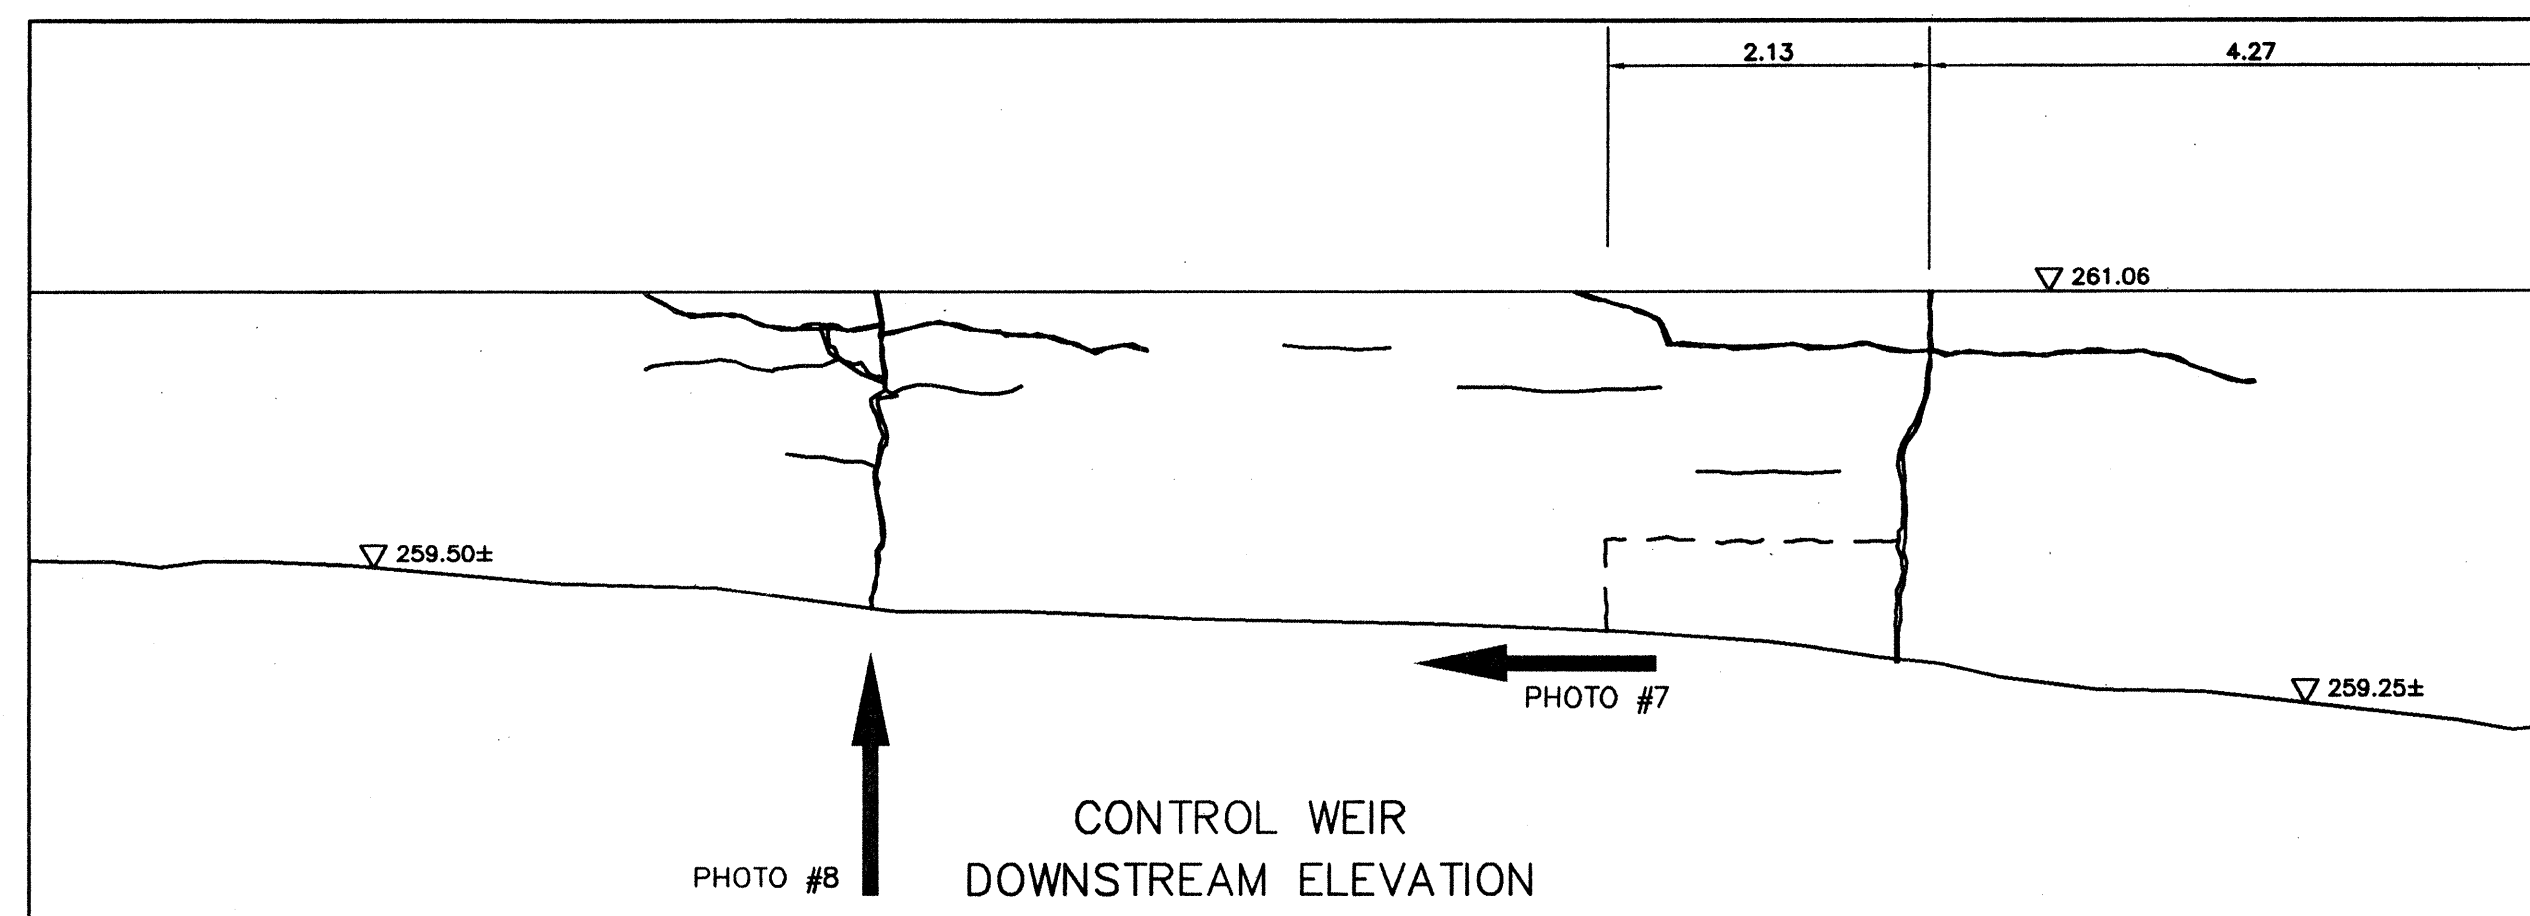
SEVERE STRUCTURAL CRACK

- PRESSURE WASH.
- REMOVE LOOSE DELETERIOUS MATERIALS.
- SUFFICIENTLY GROUT CRACKS TO BE ABLE TO PRESSURE INJECT HILTI RM700 EP REPAIR MORTAR.
- CLEAN CONCRETE FACE OF SURPLUS REPAIR MATERIALS.

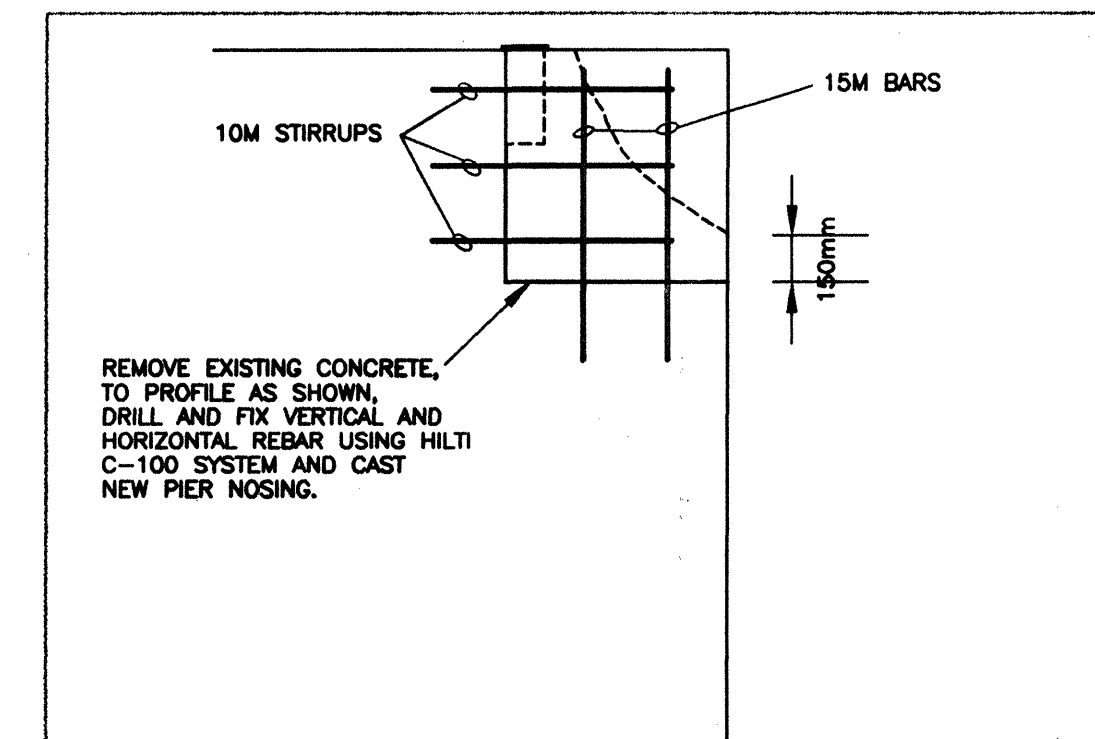
PLAN VIEW

UPSTREAM NORTH PIER SEVERE CONCRETE SPALLING

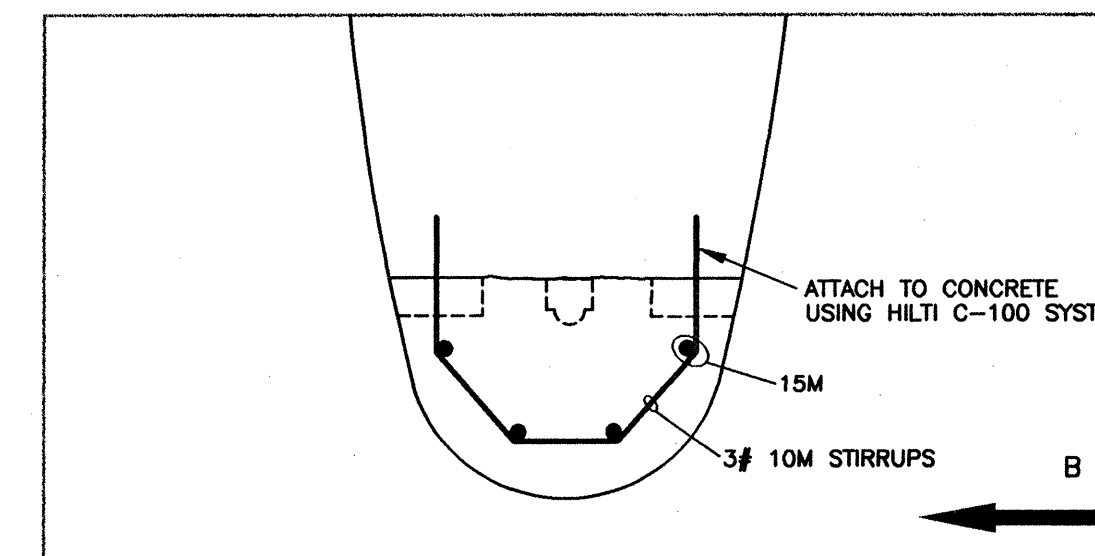
PLAN VIEW

DOWNSTREAM NORTH PIER SEVERE STRUCTURAL CRACK
