# Shabomeka Lake Dam Rehabilitation Design Report

Mississippi Valley Conservation Authority (MVCA)  
June 2021  
Project: 159100826

Prepared by:  
Stantec Consulting Ltd.

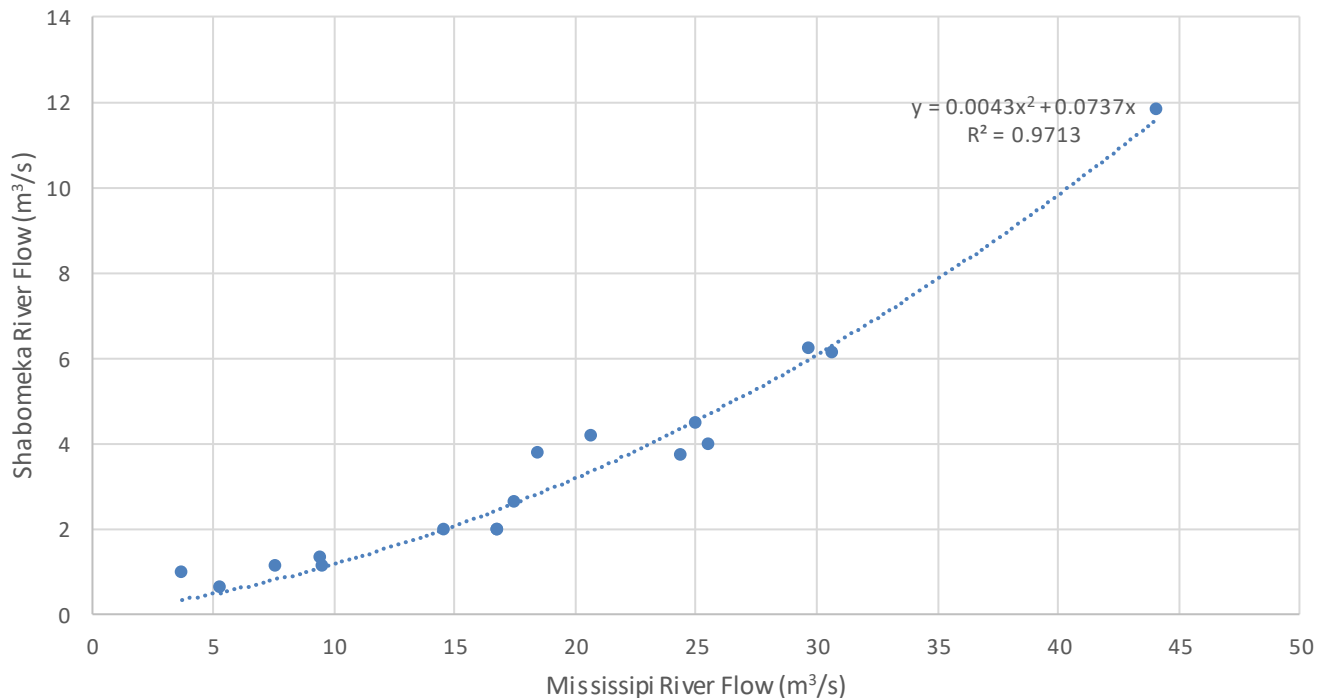
It was chosen a second order polynomial regression as the best fit. The following regression equation was extracted from **Figure 2-1**.

$$Q_{Shabomeka} = 0.0043Q_{Mississippi}^2 + 0.0737Q_{Mississippi}$$

This regression analysis is valid for flows in Shabomeka Lake between 0 m<sup>3</sup>/s and 12 m<sup>3</sup>/s. An extrapolation of this regression analysis is performed for flows over 12 m<sup>3</sup>/s.

**Figure 2-1: Shabomeka Lake Inflow vs Mississippi River**

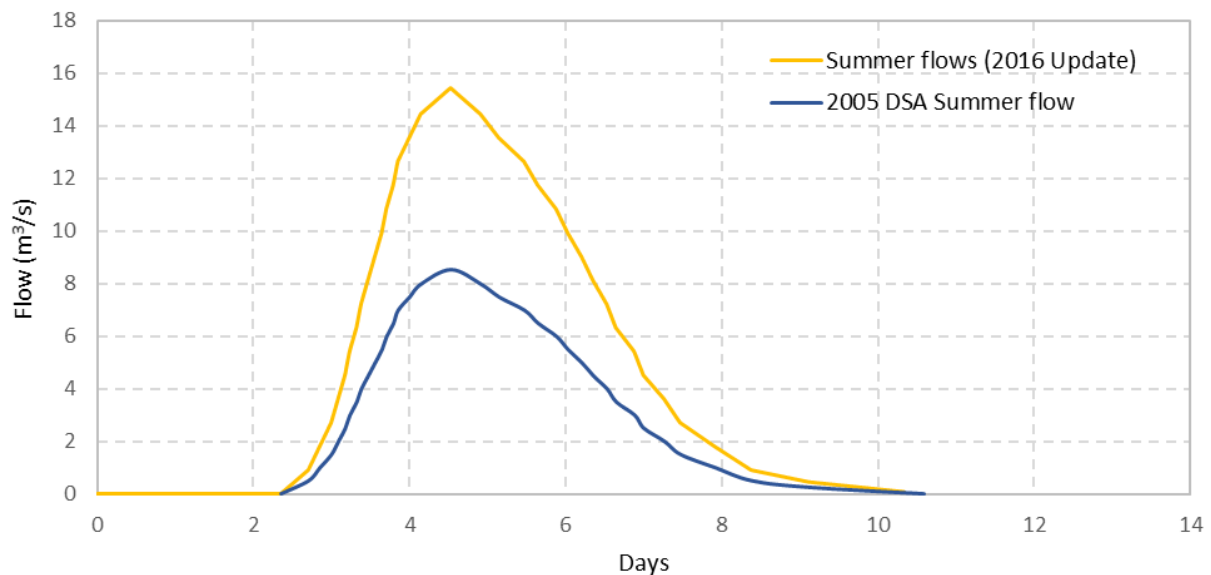
A calibrated hydrograph shape was developed in the 2005 DSA using the 2002 exceptional rain event in the OTTHYMO simulation. Stantec used the shape of this hydrograph (3-day rainfall) plotted on page 4-9 of the 2005 DSA report.

**Figure 2-2** below shows the hydrograph with the 2016 updated peak flow of 15.45 m<sup>3</sup>/s.

**Figure 2-2: Shabomeka Lake Inflow Summer Hydrograph**

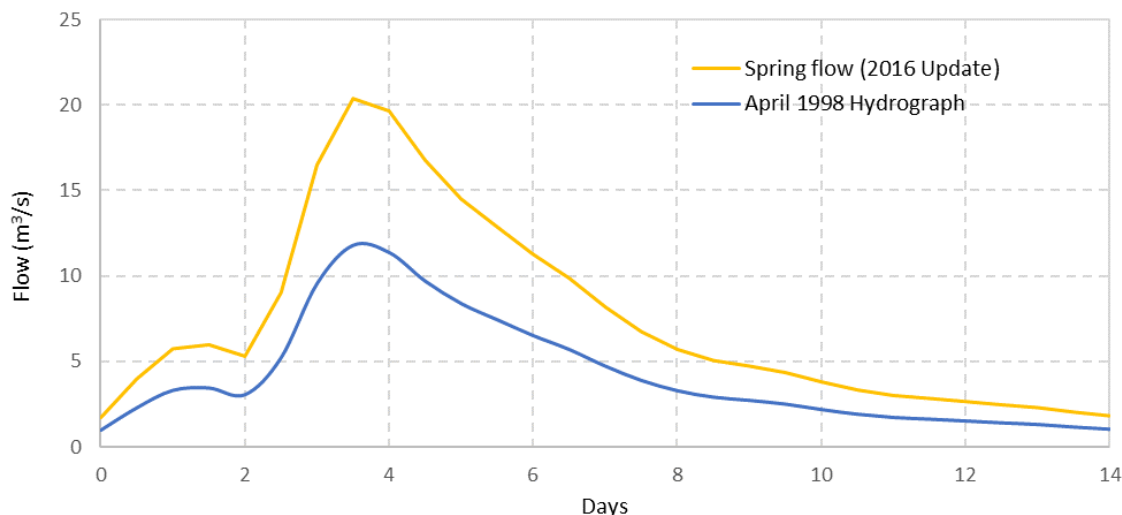
The spring hydrograph of the 2005 DSA used the largest snowmelt event occurring over the 11 years of inflow generated by the Method 1-Mass Balance Analysis. This event occurred in April 1998. The 2005 DSA report does not plot the winter hydrograph, so the results of the mass balance analysis were used to extract the shape of the hydrograph. **Figure 2-3** shows the hydrograph with the 2016 updated peak flow of 20.4 m<sup>3</sup>/s.

**Figure 2-3: Shabomeka Lake Inflow Spring Hydrograph**

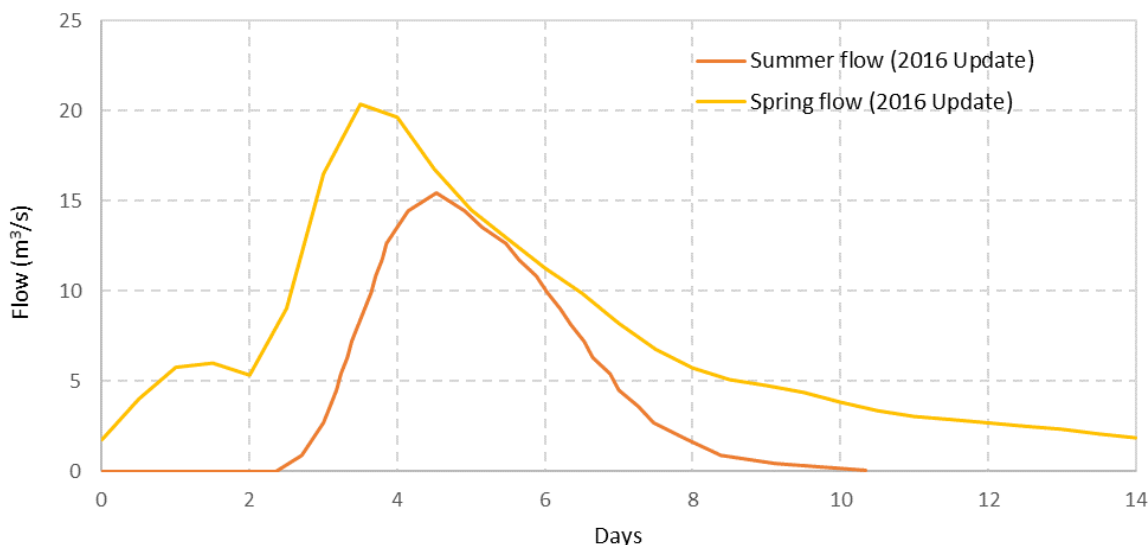
The spring and the summer hydrographs previously computed in this 2016 update are shown on **Figure 2-4** below for comparison purposes.

**Figure 2-4: Summer and Spring Hydrograph Comparison**

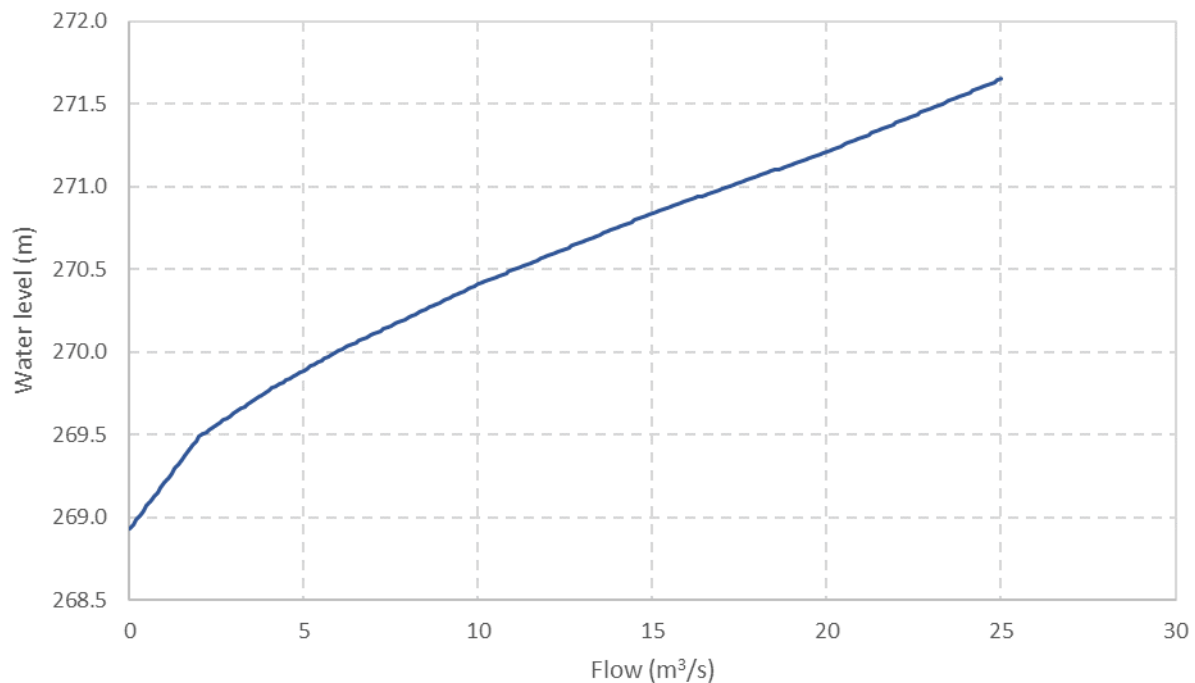
The 2005 DSA performed a backwater analysis (presented on page 4-13 of the 2005 DSA Report). The backwater curve on the downstream side of the dam was taken from the 2005 DSA report. It is plotted in **Figure 3-1** below.

**Figure 3-1: Backwater Curve Downstream the Dam**

The apron effect relationship described in the Design of Small Dams (USBR, 1987) is used to reduce the discharge coefficient when a downstream influence is observed. The backwater curve shown in Section 3.1 is used to identify the downstream water level for each discharge. The reduction factor of the discharge coefficient varies from 1 to 0.77 depending on the downstream water level.

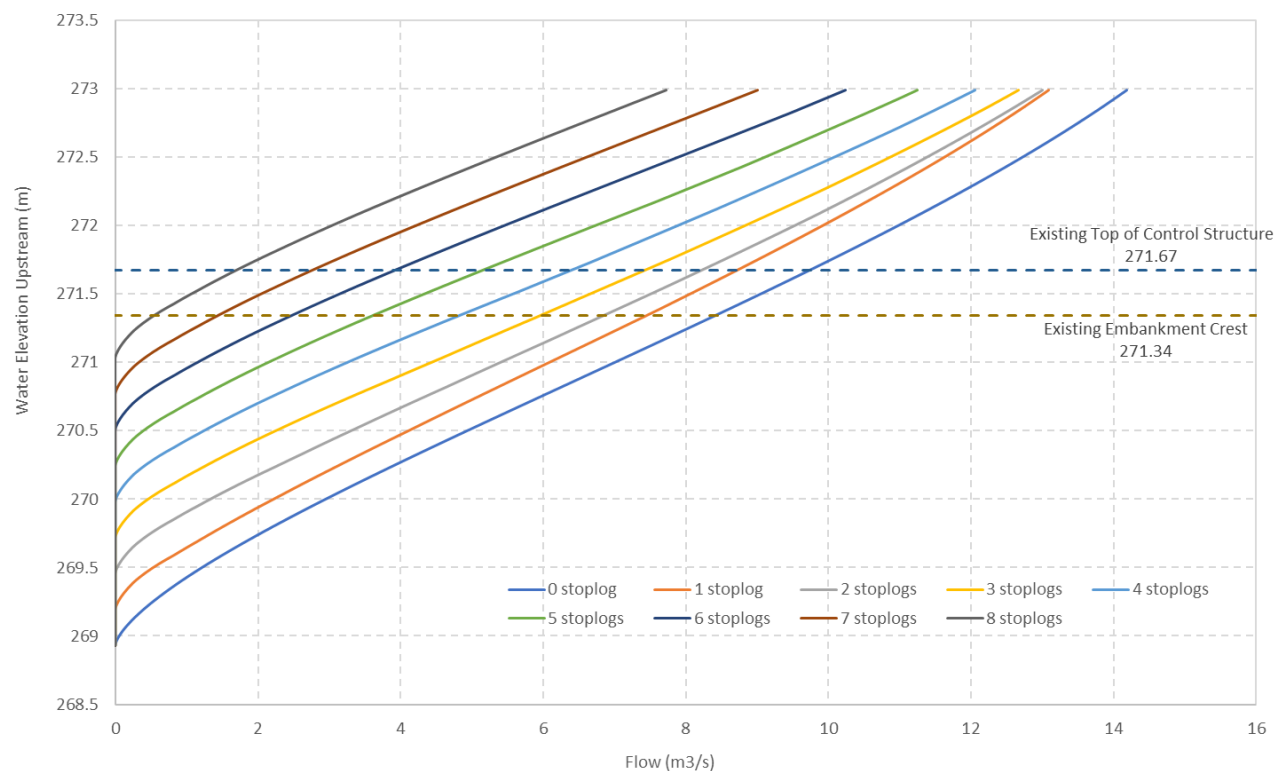
Figure 3-2 shows the discharge curves for all the possible cases (0 to 8 stoplogs).

Figure 3-2: Discharge Rule Curve

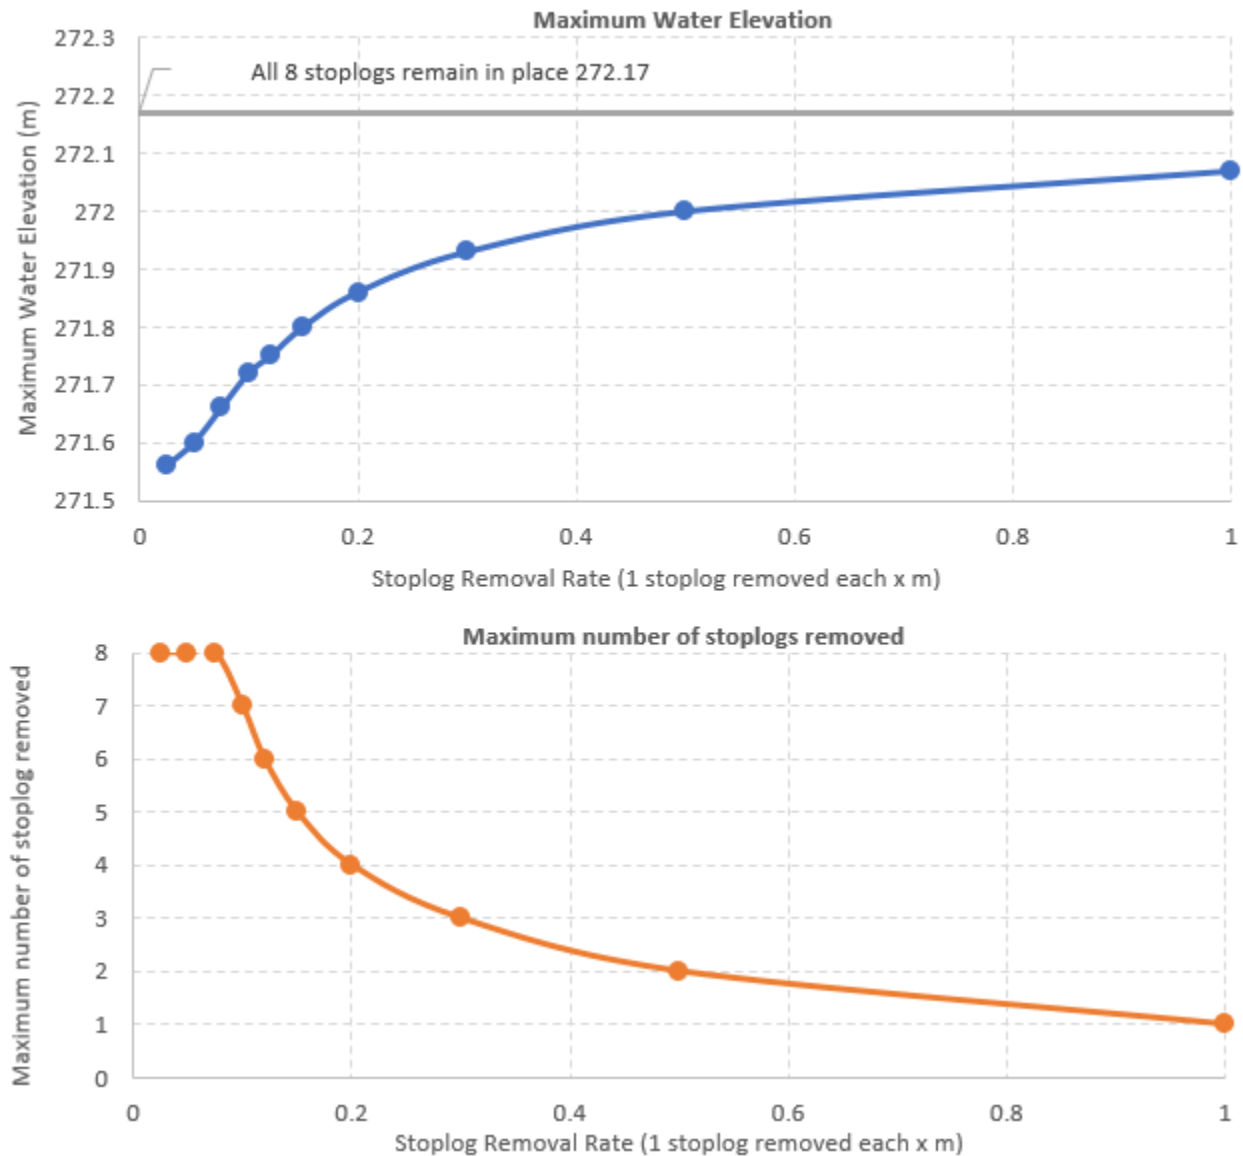
Third, intermediate scenarios were performed, using slower removal rates, and are presented in the upper part of **Figure 3-3**. The first stoplog is always removed at elevation 271.1 m (OMS requirement).

Note: With a rate of removing one stoplog when an increment of water is 10 cm, only seven stoplogs would be removed because the maximum water level in the reservoir (271.72 m) is lower than the last stoplog removal elevation (271.9 m). Therefore, for an increment higher than 10 cm, not all stoplogs are removed and this is shown on the lower part of **Figure 3-3**.

Figure 3-3: Stoplog Removal Rate Comparison

This sensitivity analysis shows that the water elevation with the best management scenario is 271.56 m, and the water elevation with worst management scenario is 272.17 m. Therefore, in case of IDF, the water elevation will vary between these limits depending on the real stoplog operating. The worst management scenario is not considered for the design of the dam, and elevation 271.56 m is considered for the summer IDF.

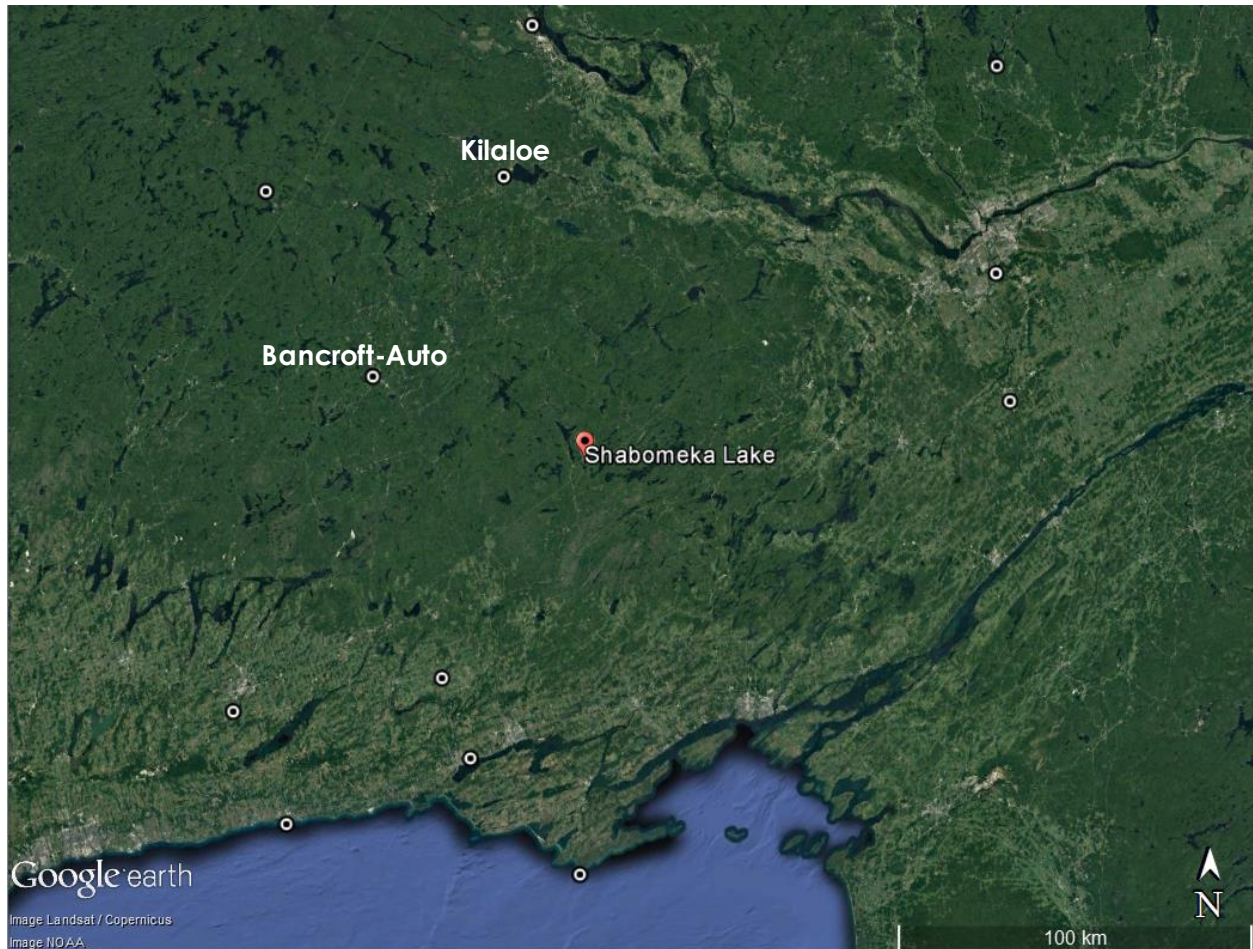
**Figure 4-1: Wind Recording Stations**

The Bancroft-Auto station recorded wind data from 1995 to 2015 (21 years), with 1 measure per hour (sustained wind on the hour of observation). A frequency analysis was performed on the maximum annual wind in each of the four cardinal directions. The analysis was also performed using the maximum summer wind (May 15<sup>th</sup> to October 15<sup>th</sup>). Four statistical distribution laws were compared (Gumbel, Normal, Log-Normal, Log-Pearson 3). It was chosen to use the same law for all directions, and the Log-Pearson 3 was chosen to be the best fit. The computed wind results are presented in **Table 4-1** and **Table 4-2**.

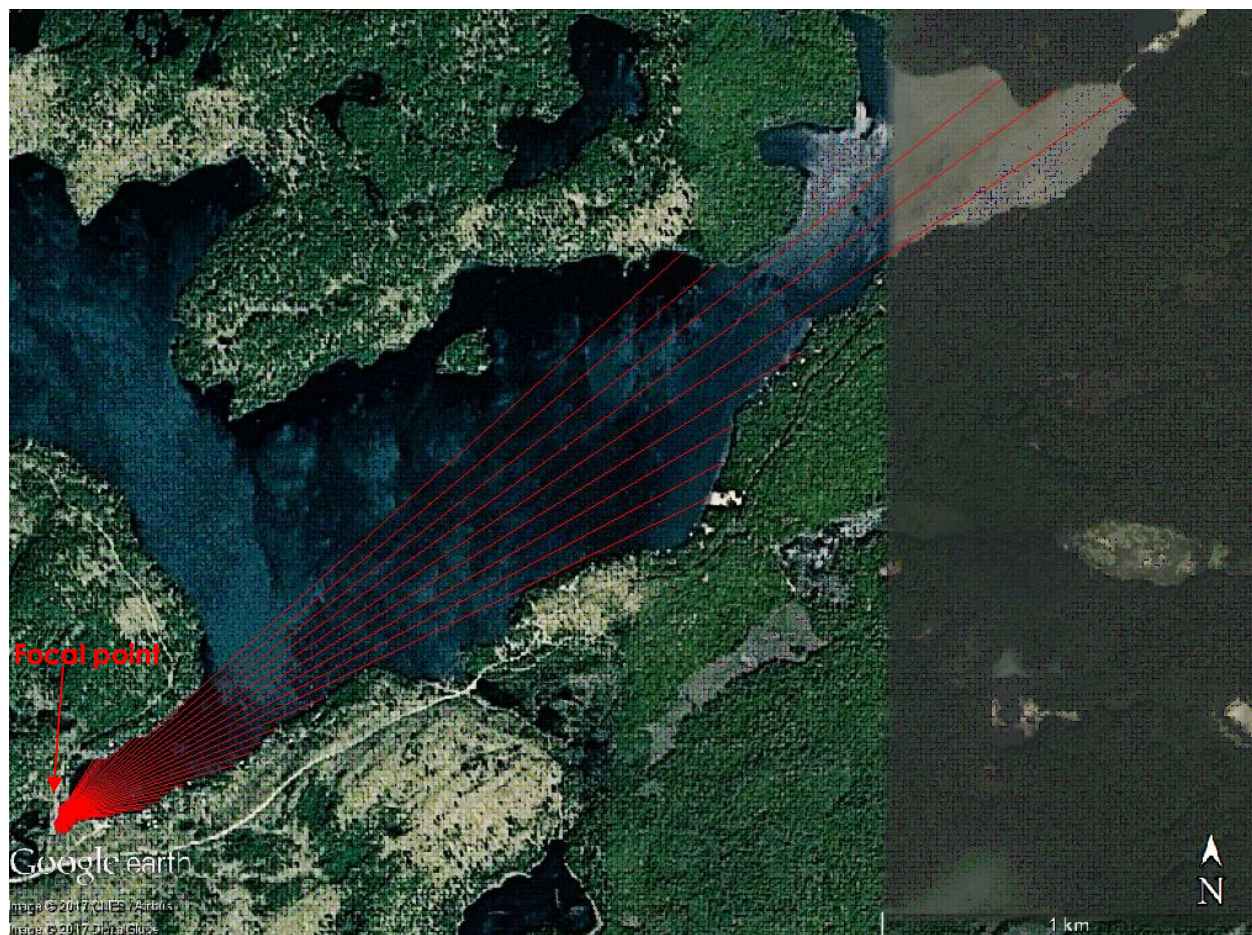
A focal point on the dam was chosen and the direct fetch was drawn on the uninterrupted water surface. The water surface was extracted from Google Earth imagery. The length and angle of each fetch were used for the wave height computation. The "*Guide Pratique de Dimensionnement du RipRap*" of SEBJ, 1997 is used. The following **Figure 4-2** shows the fetch of the focal point.

**Figure 4-2: Radials and Fetch Determination**

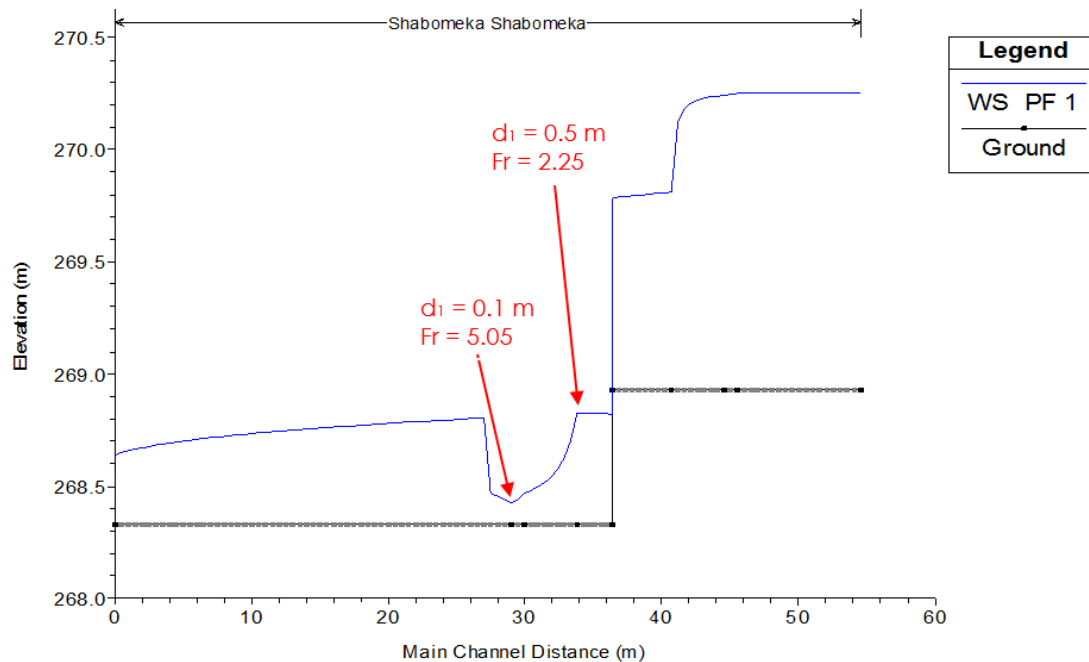
The energy dissipation will be done using a stilling basin with some baffles. The gate and the stilling basin have been included in HEC-RAS model to determine the required information for energy dissipator design, i.e. the water depth ( $d_1$ ) and Froude number ( $Fr$ ) of the proposed spillway. By imposing the downstream water level of the backwater curve, the analysis revealed the hydraulic jump is relatively small, and the Froude number is too low for design of a stilling basin. A more stringent scenario was chosen comprising of a lower downstream water level imposed by a normal depth. The normal depth varies between 0.01 and 0.0001, and there were no changes before the hydraulic jump where the values are taken for design. The following **Figure 4-3** shows the result of the HEC RAS model.

**Figure 4-3: Profile View of HEC-RAS 1D**

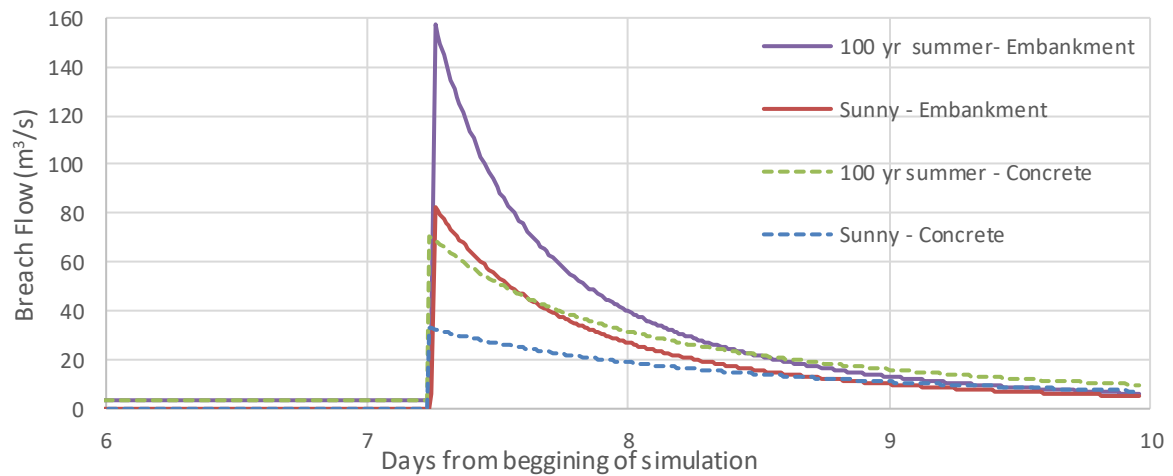
**Figure 5-1: Summer Dam Breach Hydrographs**

The dam breach was modeled in HEC-HMS (version 4.2), developed and distributed by the US Army Corps of Engineers. The dam breach parameters have been included in the model. The outflow curves from the dam breach are presented on **Figure 5-1** and **Figure 5-2**; and in **Table 5-2**. It shows that the embankment breach leads to higher flow than concrete structure and only the embankment breach scenarios will be modeled in this analysis.

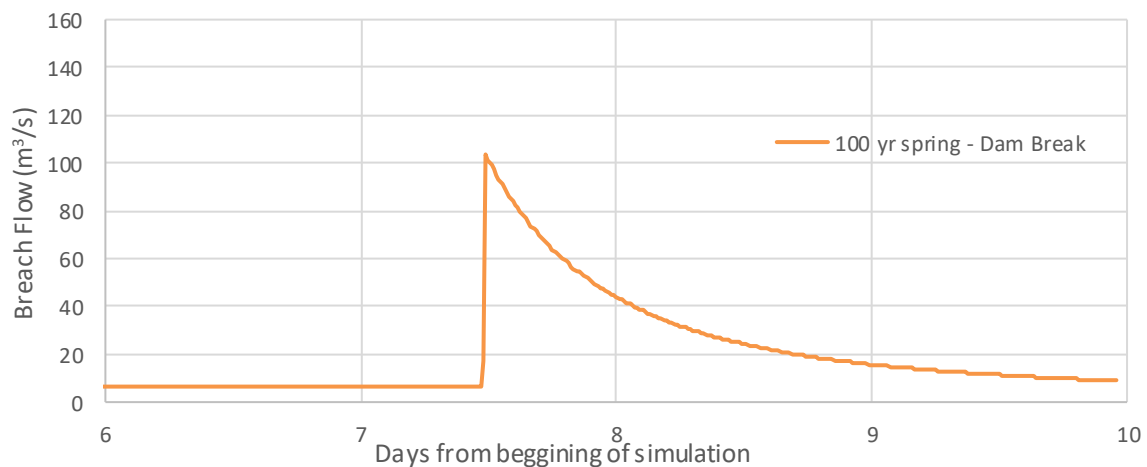
**Figure 5-2: Winter Dam Breach Hydrograph**

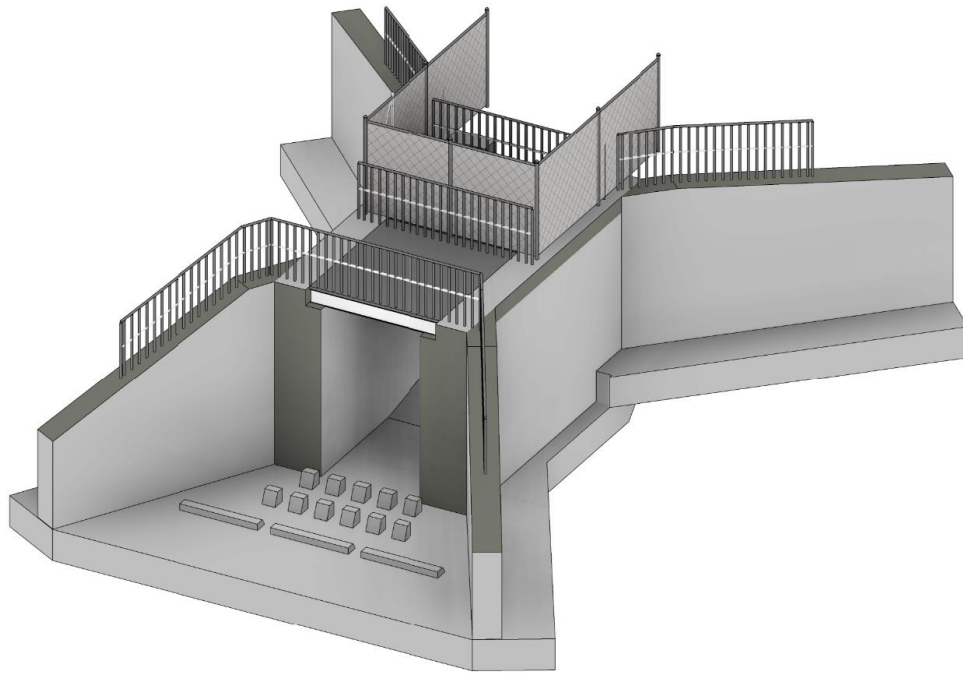
The assessment of the global stability of the structure will be conducted in accordance with the Canadian Dam Safety (CDA) Guidelines 2007-R13. The following includes the loads and values used to assess the stability.

**Figure 6-1: 3D View of the New Structure**

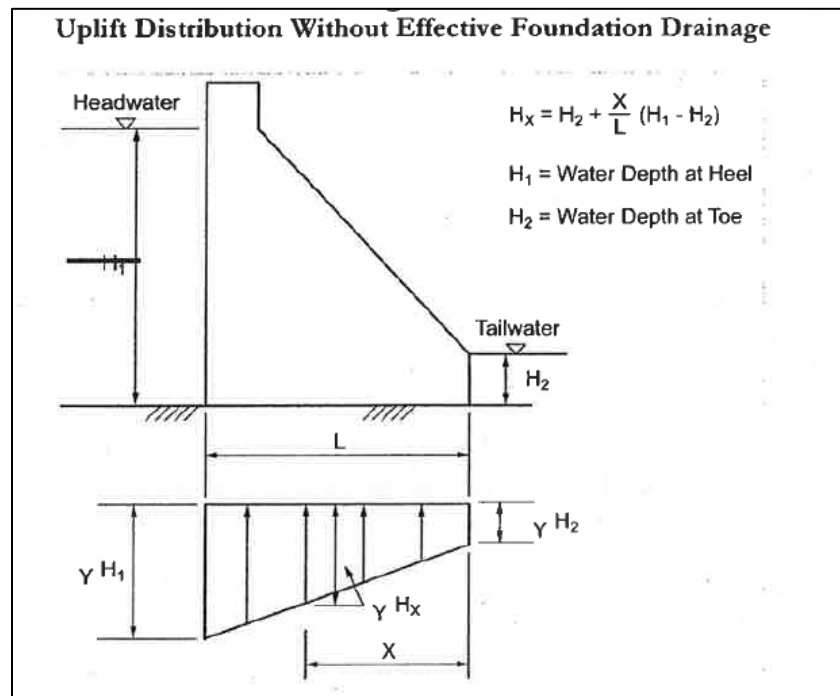
**Figure 6-2: Uplift Distribution**

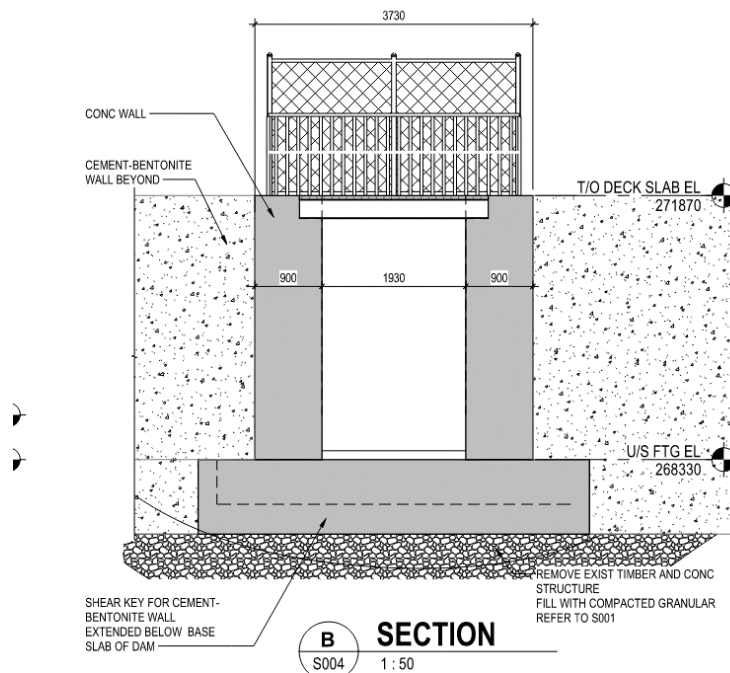
Figure 6-4: Section Through the Structure Showing Piers and Deck

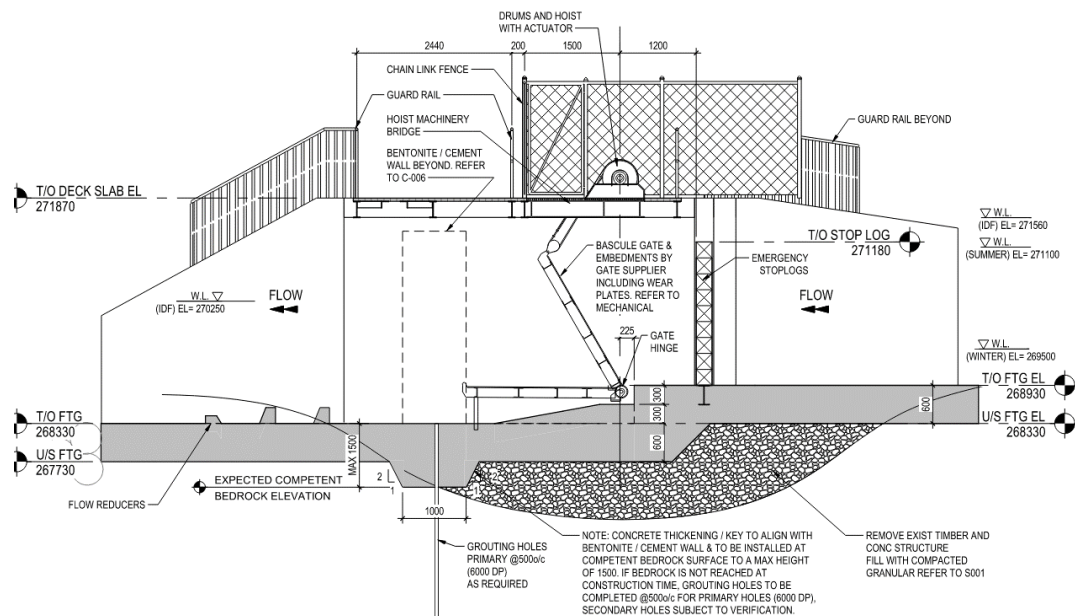
Figure 6-5: Section Through the Structure Showing Stoplogs

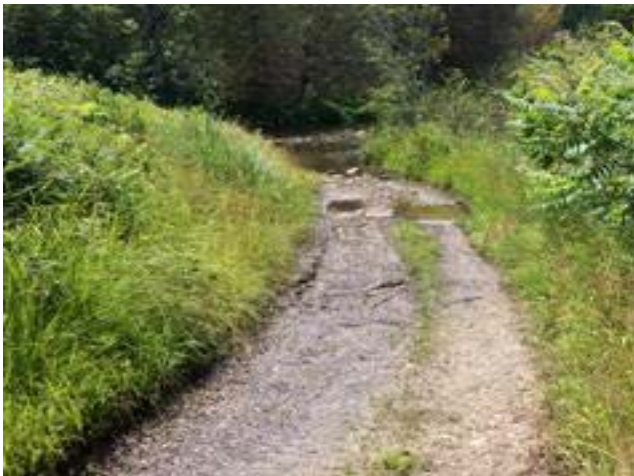
ATV trail to stream crossing south of dam. Note seepage along edge of berm.

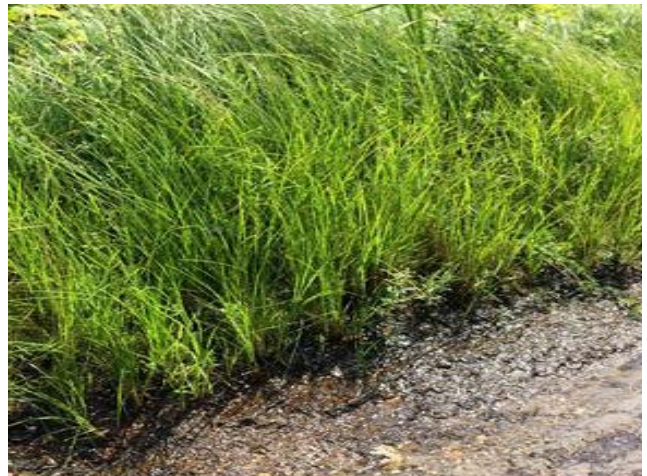
Seepage along front edge of north berm. Note wetland vegetation (sedges).

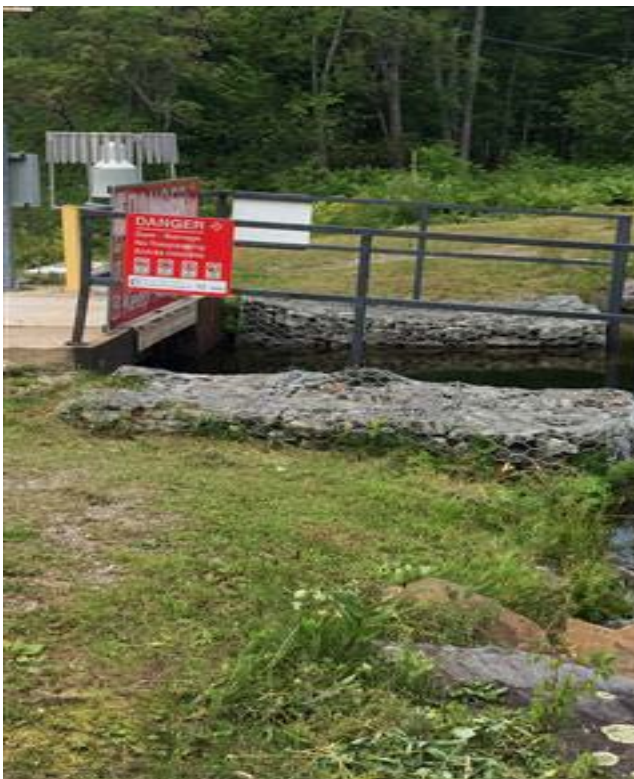
Berms flanking sluice structure, taken from south berm looking north.

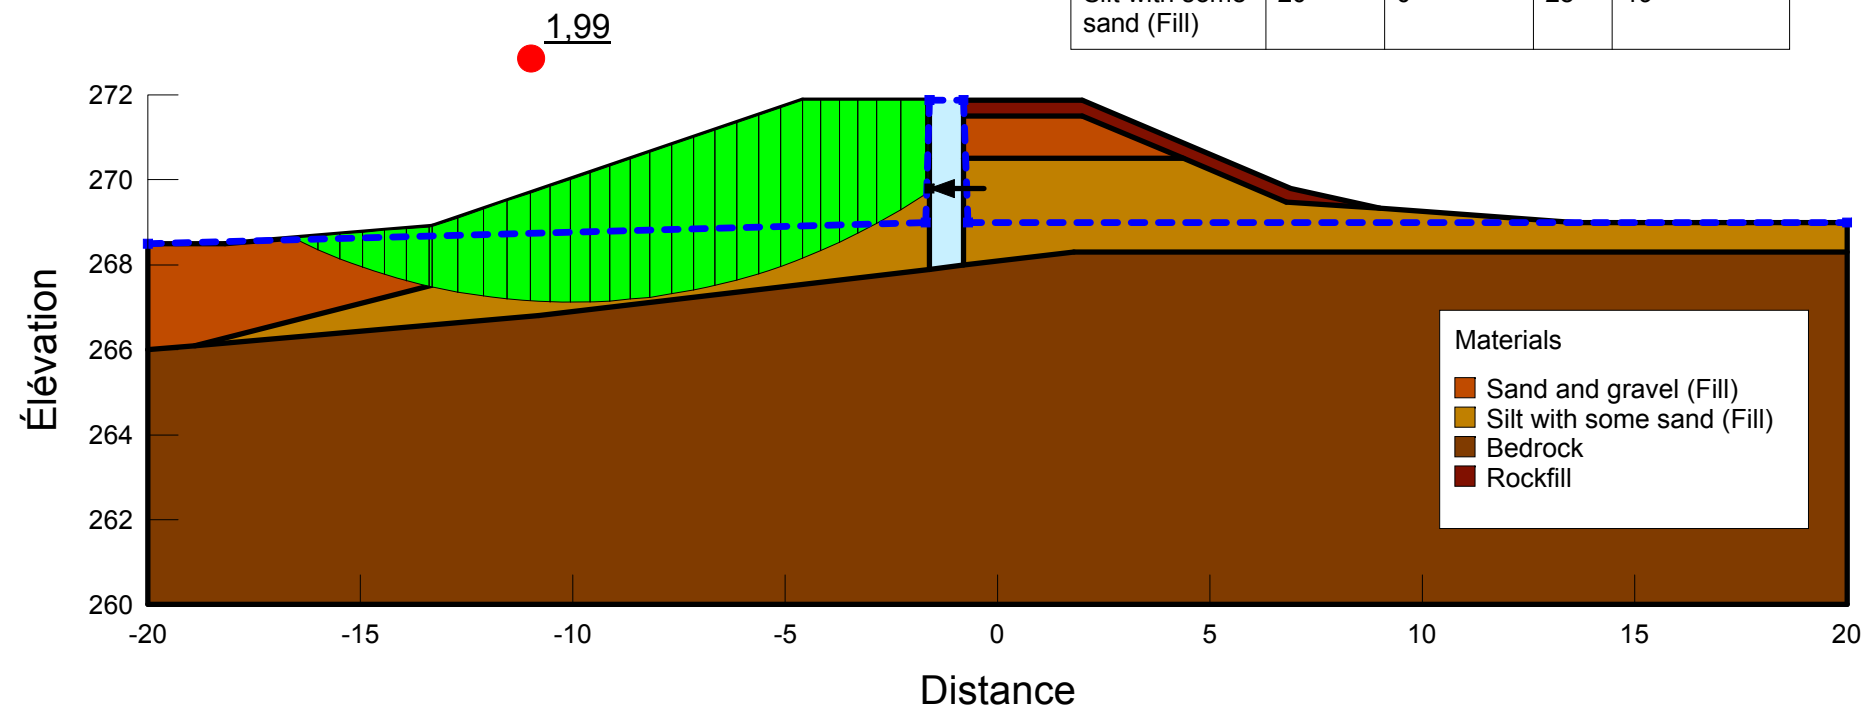
Name	Unit Weight (kN/m³)	Cohesion' (kPa)	Phi' (°)	Constant Unit Wt. Above Water Table (kN/m³)
Bedrock				
Rockfill	22	0	38	20,5
Sand and gravel (Fill)	21,5	0	30	20
Silt with some sand (Fill)	20	0	28	19

SLOPE/W Analysis

Shabomeka Dam - Downstream - During Construction.gsz

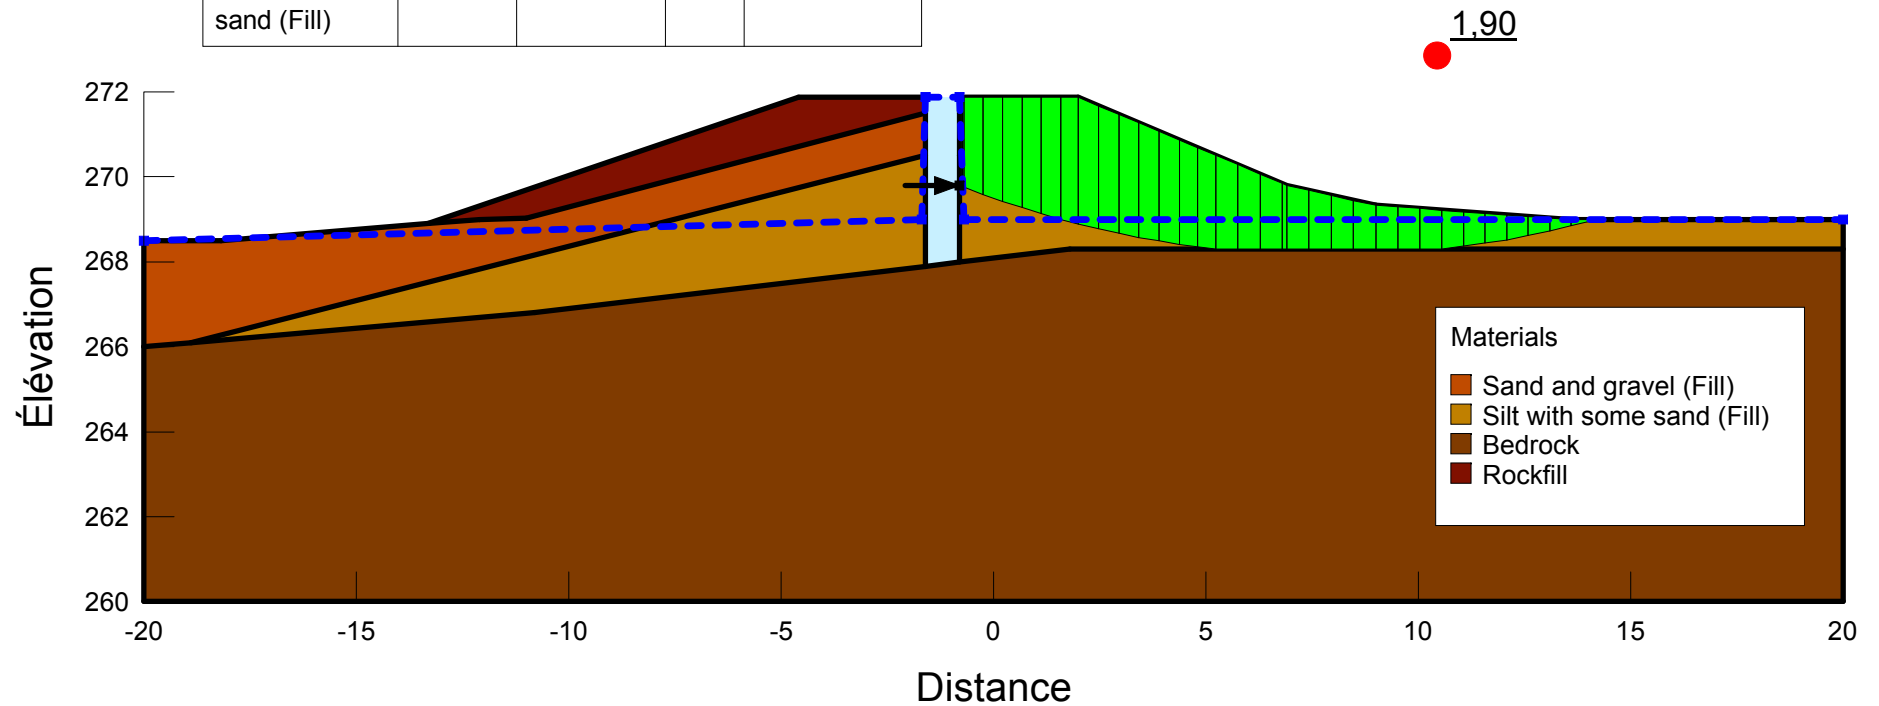
Name	Unit Weight (kN/m³)	Cohesion' (kPa)	Phi' (°)	Constant Unit Wt. Above Water Table (kN/m³)
Bedrock				
Rockfill	22	0	38	20,5
Sand and gravel (Fill)	21,5	0	30	20
Silt with some sand (Fill)	20	0	28	19

SLOPE/W Analysis

Shabomeka Dam - Upstream - During Construction.gsz

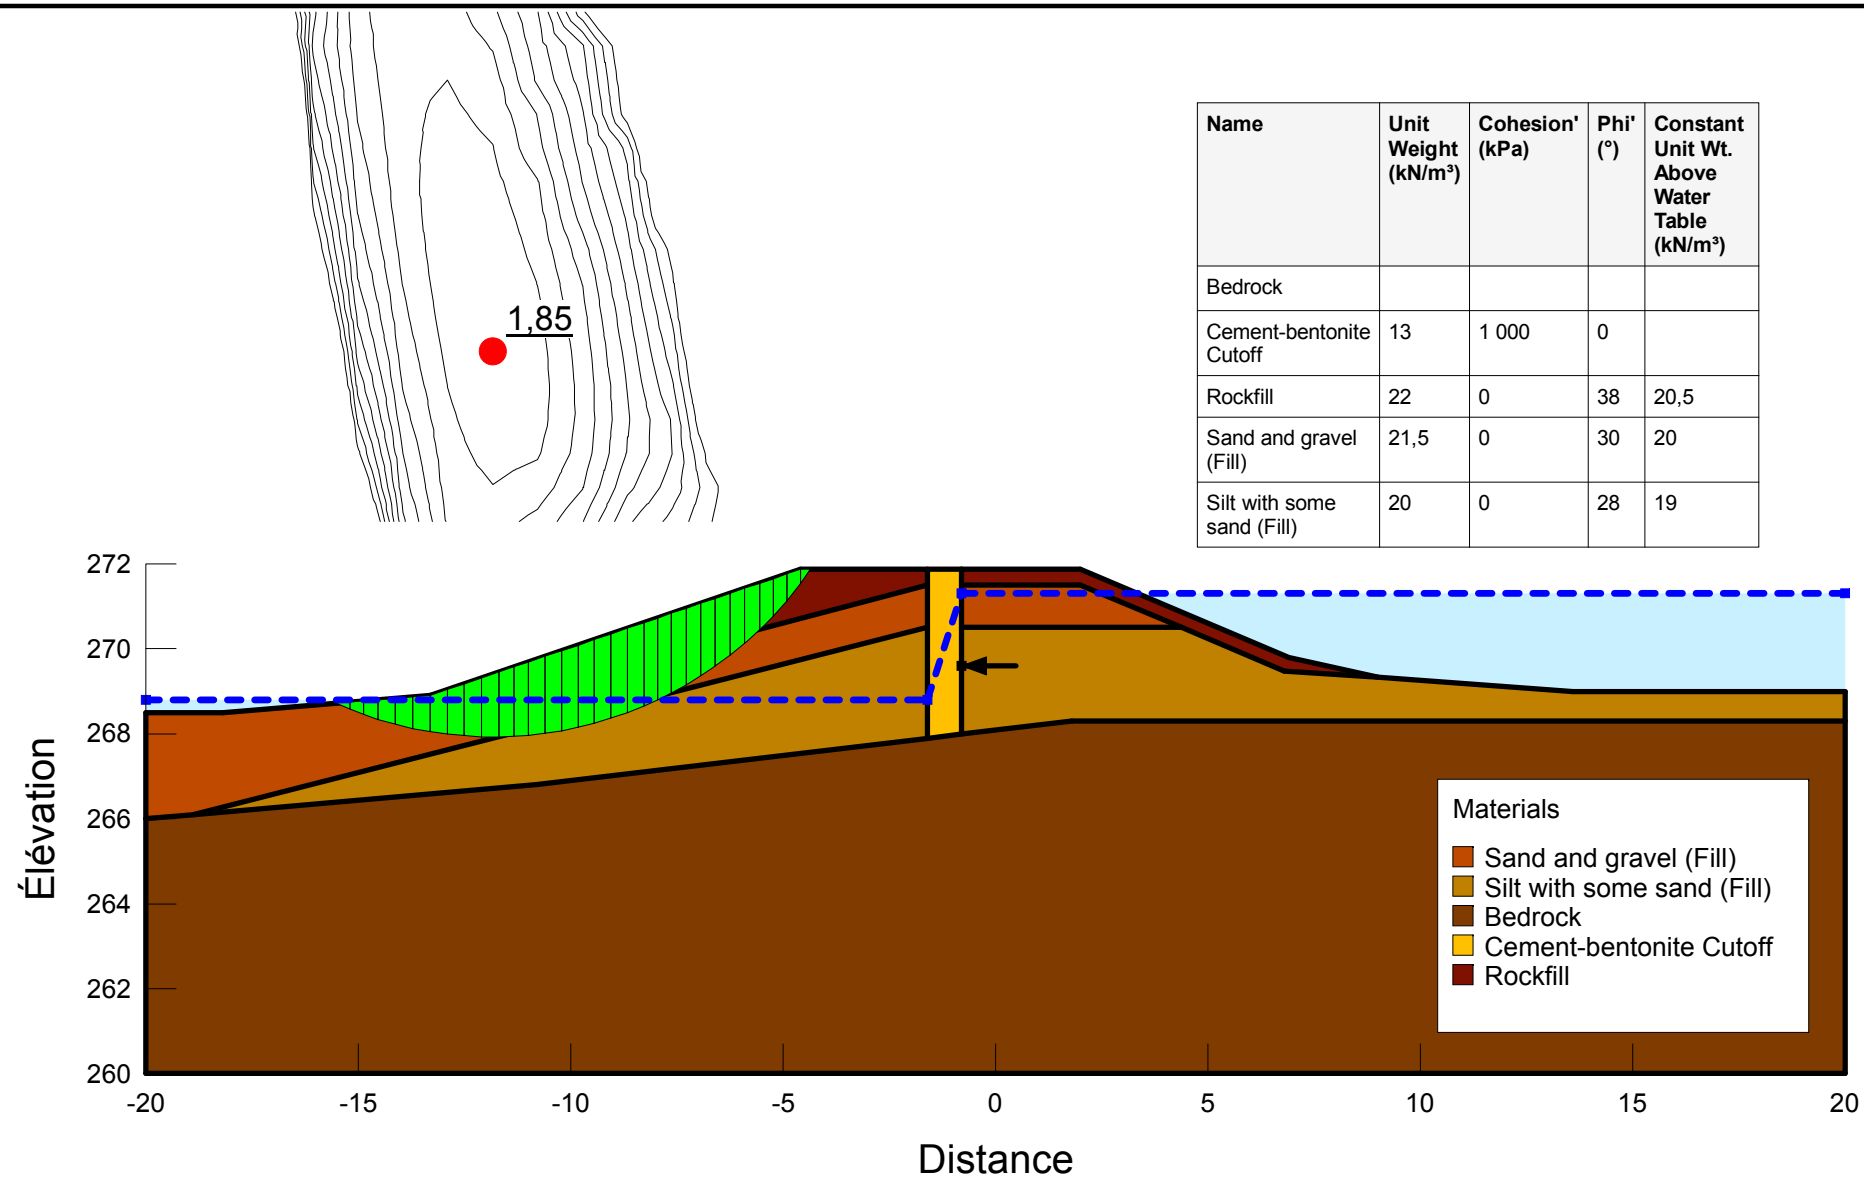
SLOPE/W Analysis

Shabomeka Dam - Downstream Static - After Construction.gsz

Name	Unit Weight (kN/m³)	Cohesion' (kPa)	Phi' (°)	Constant Unit Wt. Above Water Table (kN/m³)
Bedrock				
Cement-bentonite Cutoff	13	1 000	0	
Rockfill	22	0	38	20,5
Sand and gravel (Fill)	21,5	0	30	20
Silt with some sand (Fill)	20	0	28	19

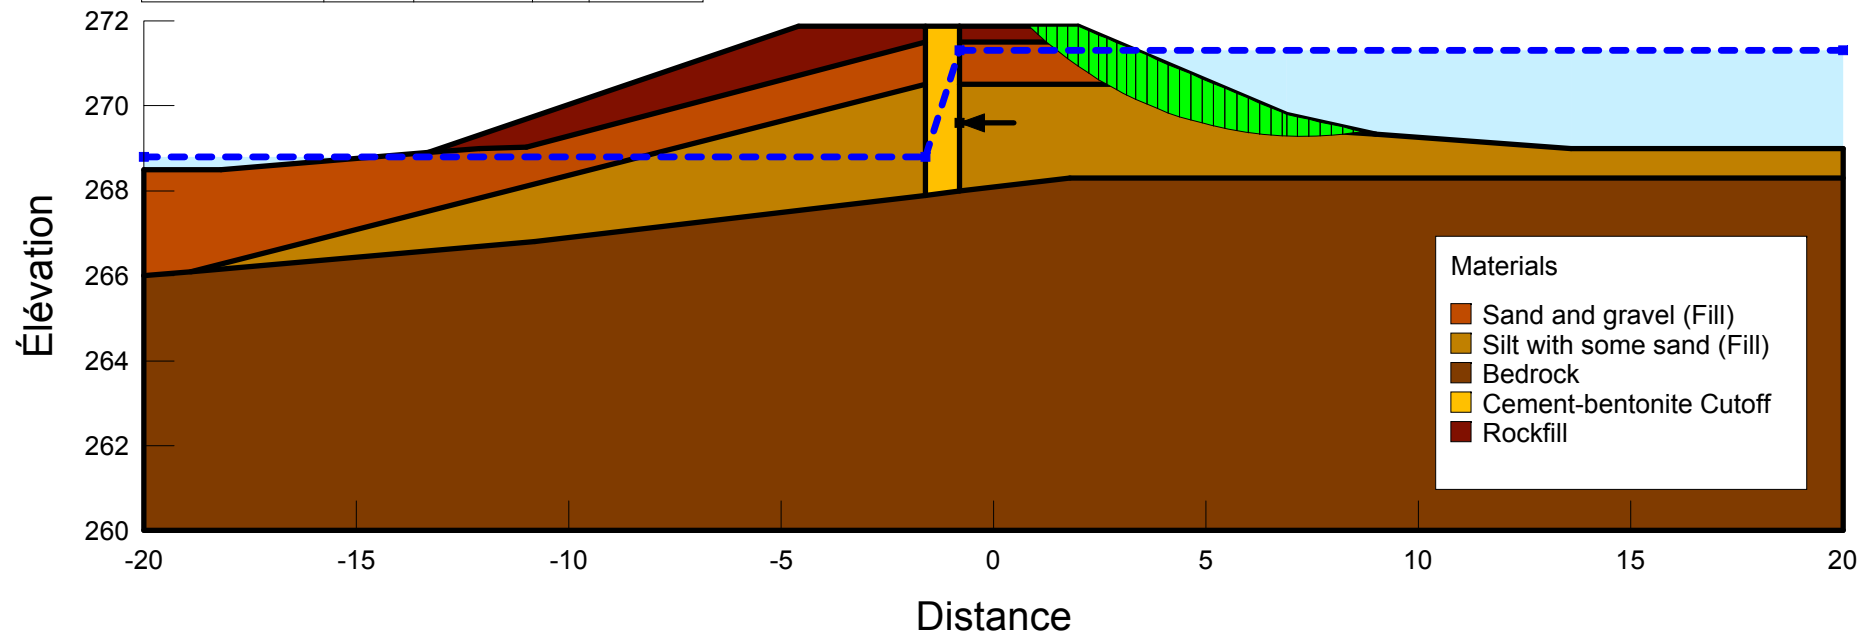
SLOPE/W Analysis

Shabomeka Dam - Upstream Static - After Construction.gsz

Name	Unit Weight (kN/m³)	Cohesion' (kPa)	Phi' (°)	Constant Unit Wt. Above Water Table (kN/m³)
Bedrock				
Cement-bentonite Cutoff	13	1 000	0	
Rockfill	22	0	38	20,5
Sand and gravel (Fill)	21,5	0	30	20
Silt with some sand (Fill)	20	0	28	19

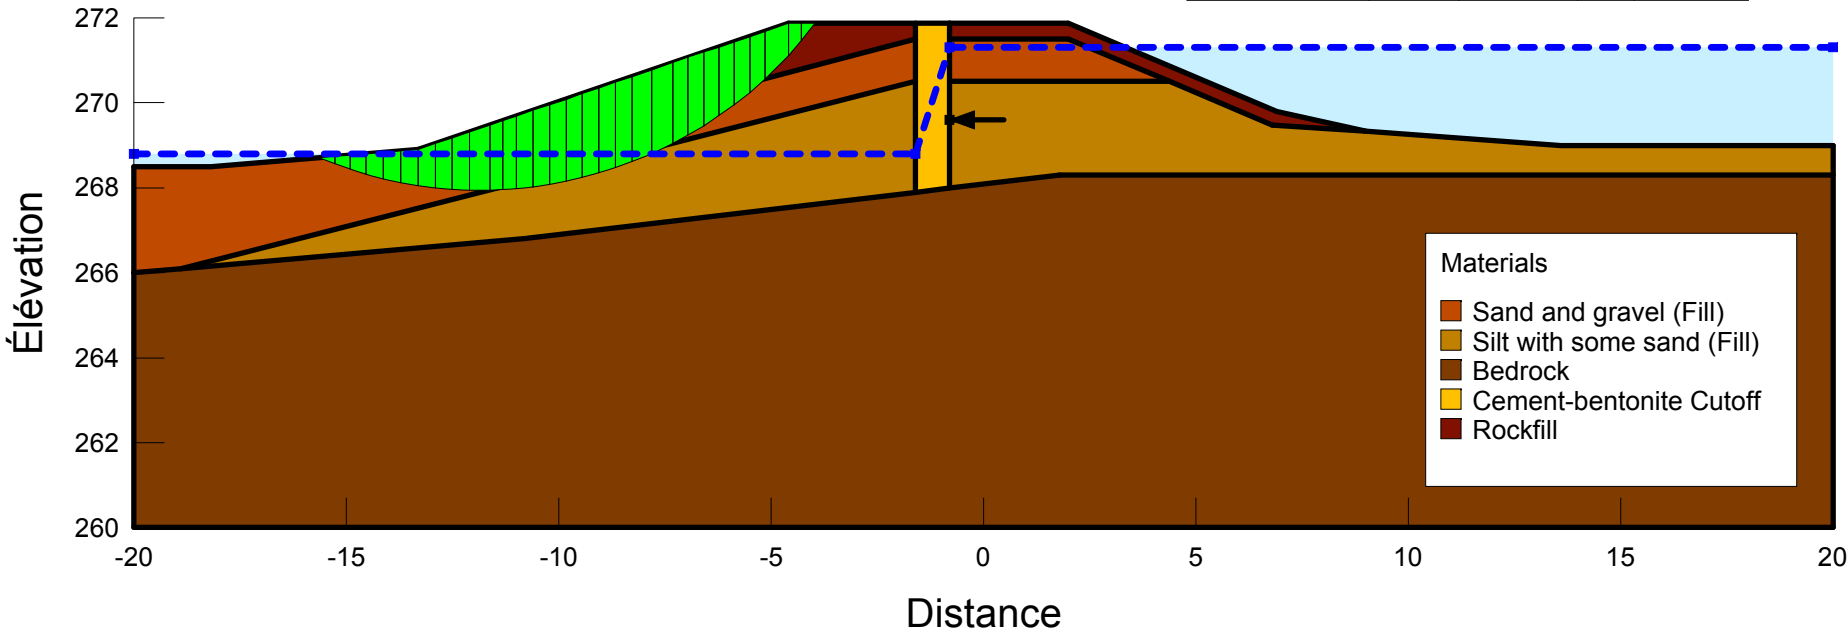
SLOPE/W Analysis
Shabomeka Dam - Downstream Seismic - After Construction.gsz
2018-02-06 1:178

Name	Unit Weight (kN/m³)	Cohesion' (kPa)	Phi' (°)	Constant Unit Wt. Above Water Table (kN/m³)
Bedrock				
Cement-bentonite Cutoff	13	1 000	0	
Rockfill	22	0	38	20,5
Sand and gravel (Fill)	21,5	0	30	20
Silt with some sand (Fill)	20	0	28	19
