# Shabomeka Lake Dam Rehabilitation Design Report

Mississippi Valley Conservation Authority (MVCA)  
June 2021  
Project: 159100826

Prepared by:  
Stantec Consulting Ltd.

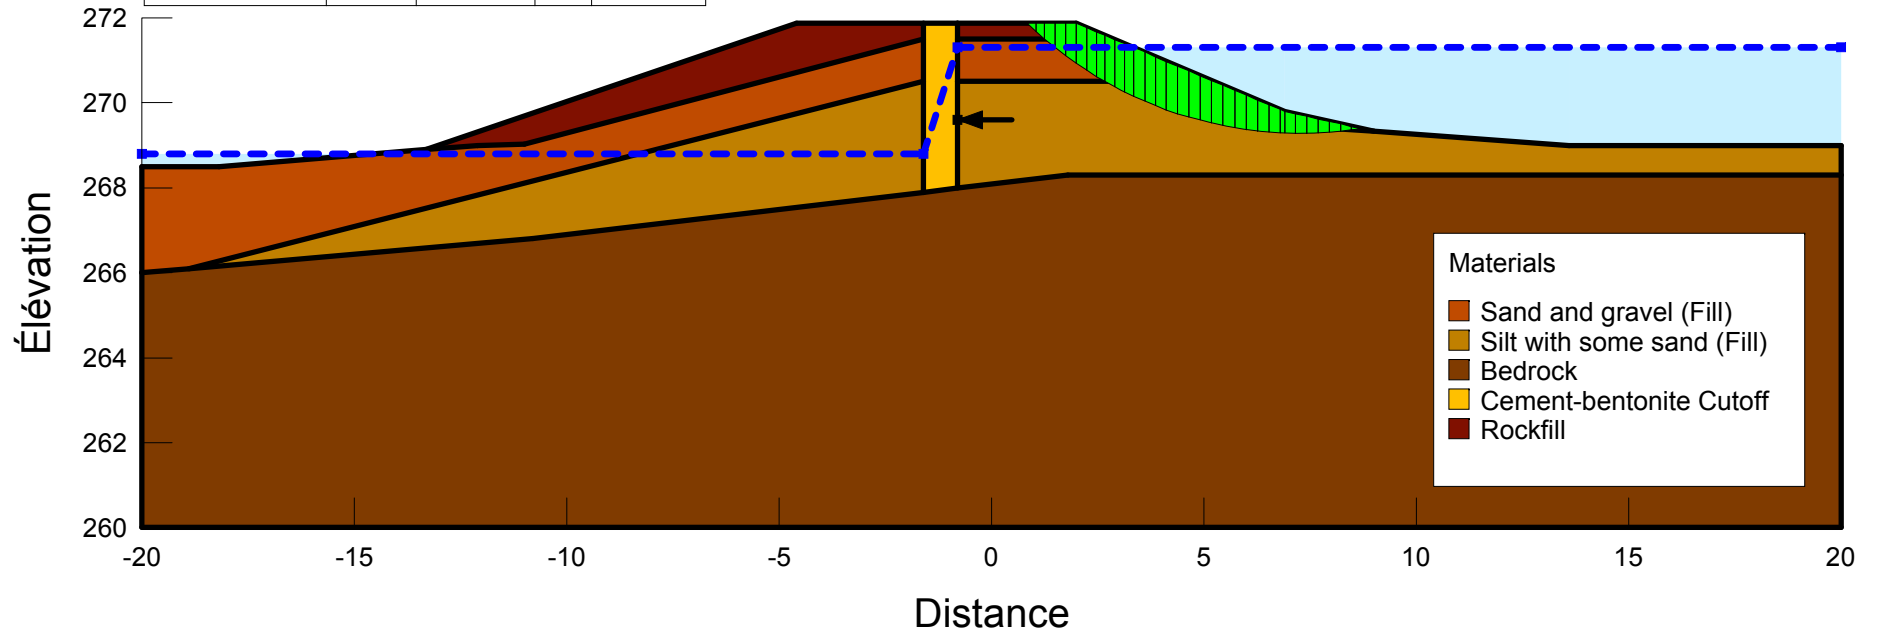
SLOPE/W Analysis

Shabomeka Dam - Upstream Seismic - After Construction.gsz

Name	Unit Weight (kN/m³)	Cohesion' (kPa)	Phi' (°)	Constant Unit Wt. Above Water Table (kN/m³)
Bedrock				
Cement-bentonite Cutoff	13	1 000	0	
Rockfill	22	0	38	20,5
Sand and gravel (Fill)	21,5	0	30	20
Silt with some sand (Fill)	20	0	28	19

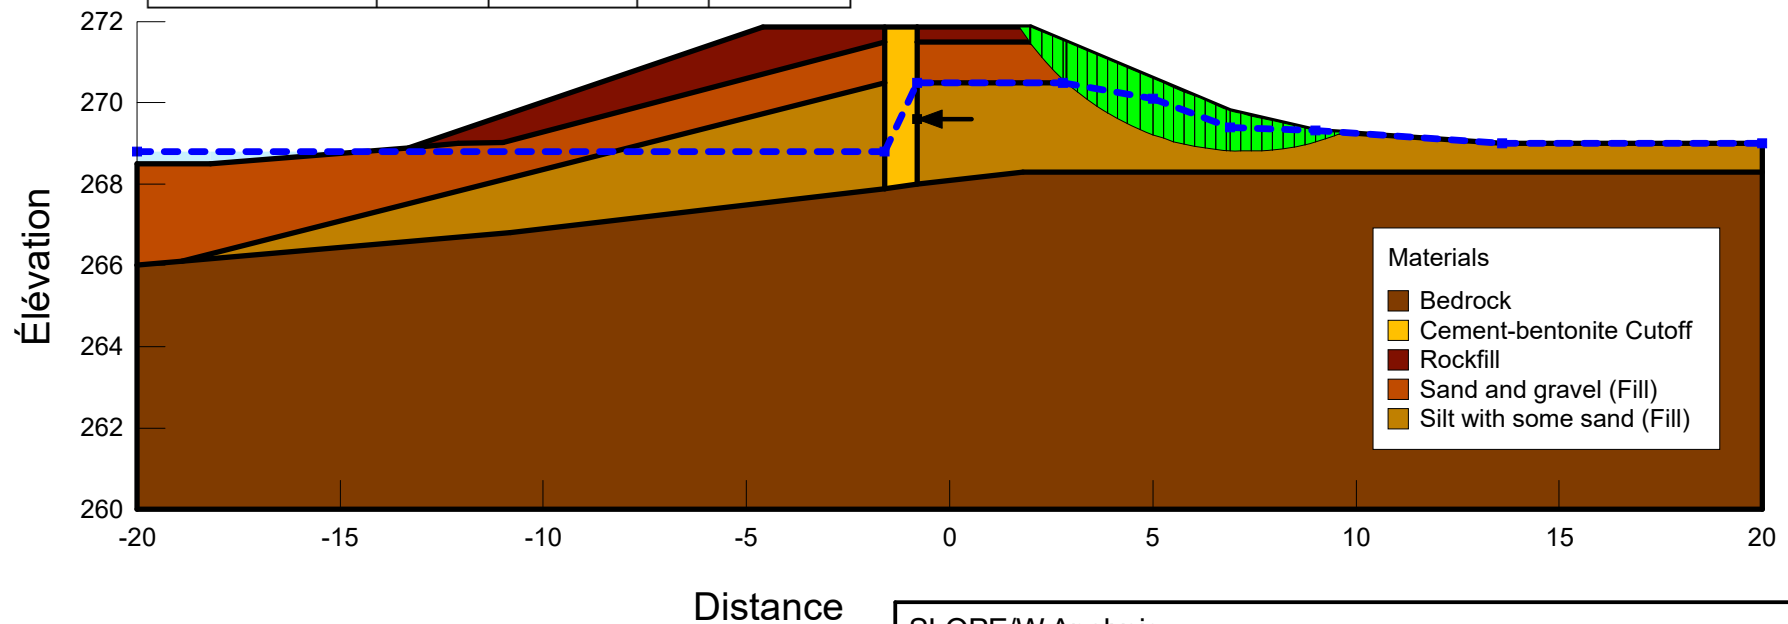
SLOPE/W Analysis

Shabomeka Dam - Rapid Drawdown-2021.gsz

Name	Unit Weight (kN/m³)	Cohesion' (kPa)	Phi' (°)	Constant Unit Wt. Above Water Table (kN/m³)
Bedrock				
Cement-bentonite Cutoff	13	1 000	0	
Rockfill	22	0	38	20,5
Sand and gravel (Fill)	21,5	0	30	20
Silt with some sand (Fill)	20	0	28	19

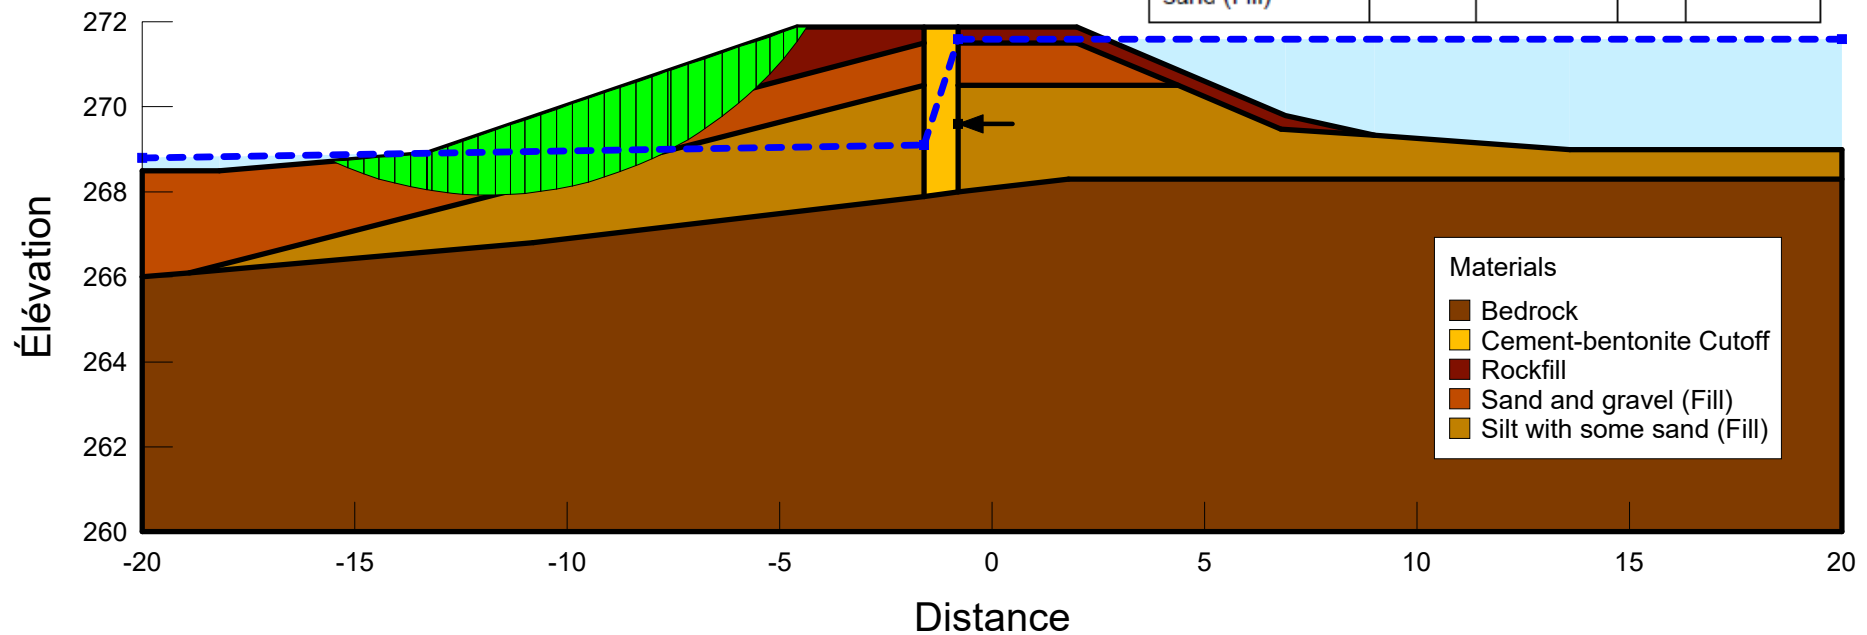
SLOPE/W Analysis
Shabomeka Dam - Downstream Static - IDF.gsz
03/22/2021 1:178

Name	Unit Weight (kN/m³)	Cohesion' (kPa)	Phi' (°)	Constant Unit Wt. Above Water Table (kN/m³)
Bedrock				
Cement-bentonite Cutoff	13	1 000	0	
Rockfill	22	0	38	20,5
Sand and gravel (Fill)	21,5	0	30	20
Silt with some sand (Fill)	20	0	28	19

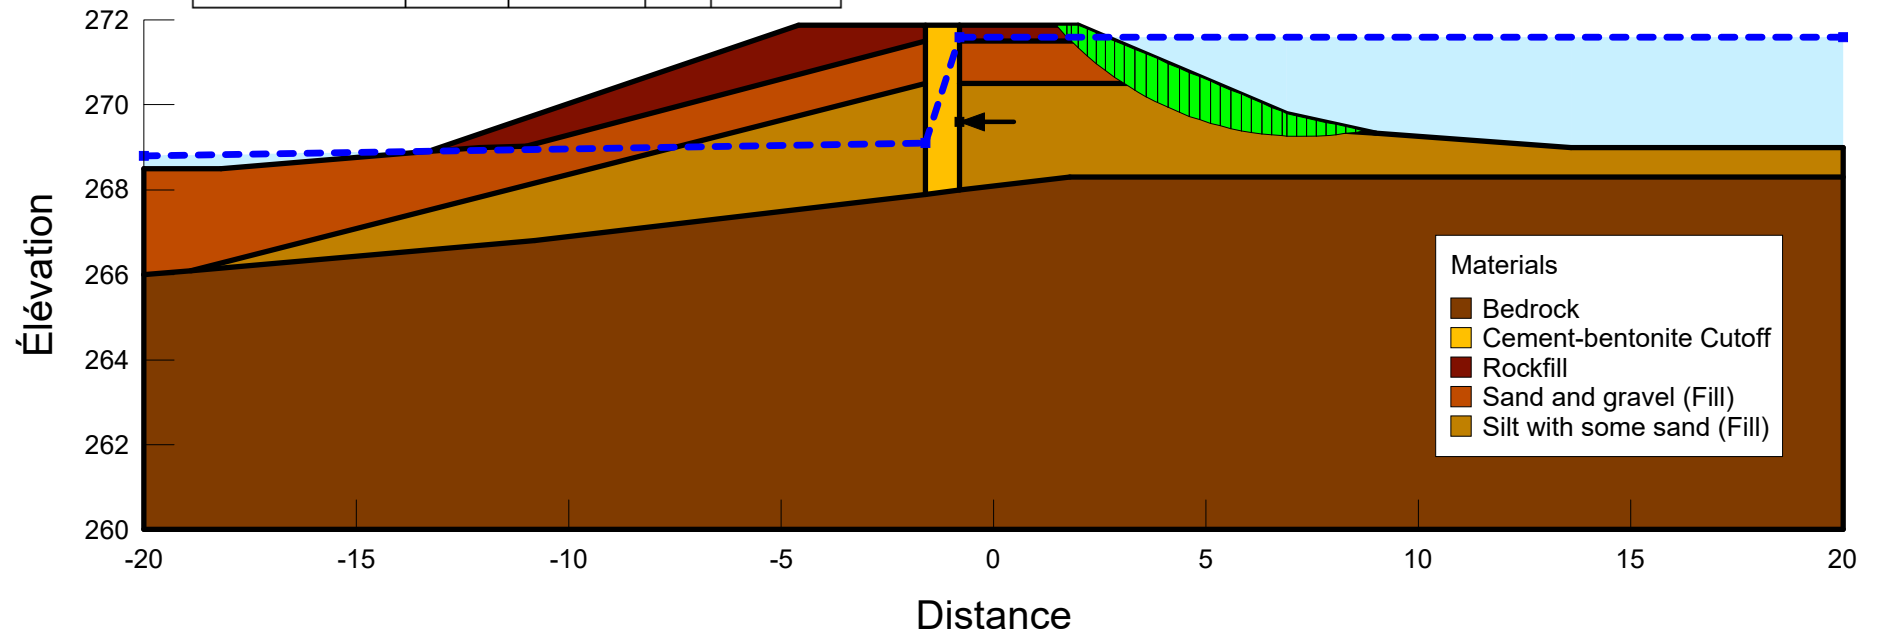
SLOPE/W Analysis

Shabomeka Dam - Upstream Static IDF.gsz

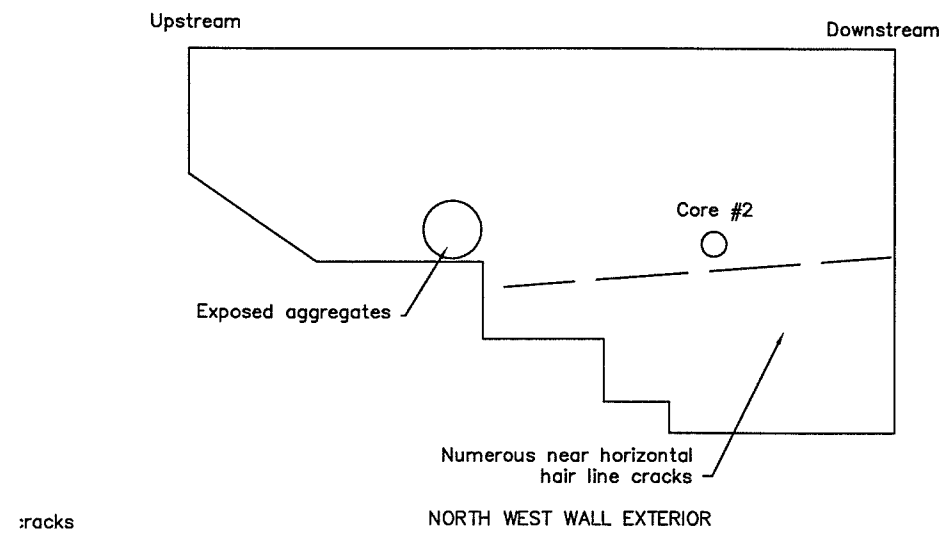
NORTH WEST WALL EXTERIOR

# CONTROL STRUCTURE DEFECTS AND CORE LOCATIONS
