Asset Management Plan

October 2024

1 Mississippi Valley Conservation Authority (MVCA)

2 Asset Management Planning (AMP)

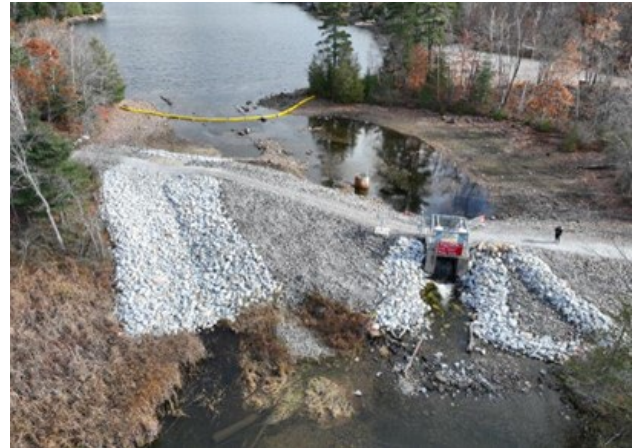
Figure 5. Shabomeka Lake Dam

Shabomeka Lake Dam is the first major water control structure in the headwaters of the Mississippi River watershed. MVCA assumed ownership and operation of the dam from MRIC in January 1991. The dam is a single bay concrete stop log structure with an earthen overflow embankment on either side of the control section. There is a total of 8 (eight) stop logs in the dam. The winch equipment consists of a 1-ton chain fall assembly on an overhead gantry system. The gantry system was engineered to also act as an overhead for fall arrest for the operators.

In 1998, extensive repairs were undertaken to the concrete surfaces of the dam, the piers were cleaned of deleterious concrete, and rebar was added, formed and re-poured. During 2021-22, MVCA carried out major reconstruction of the earthen abutments, replacement of metal works, and installation of various safety measures.

Seepage has been and continues to be observed at the downstream end of the new emergency spillway. A non-destructive geophysical survey program was developed to delineate potential pathways of water seepage within the earth dam.

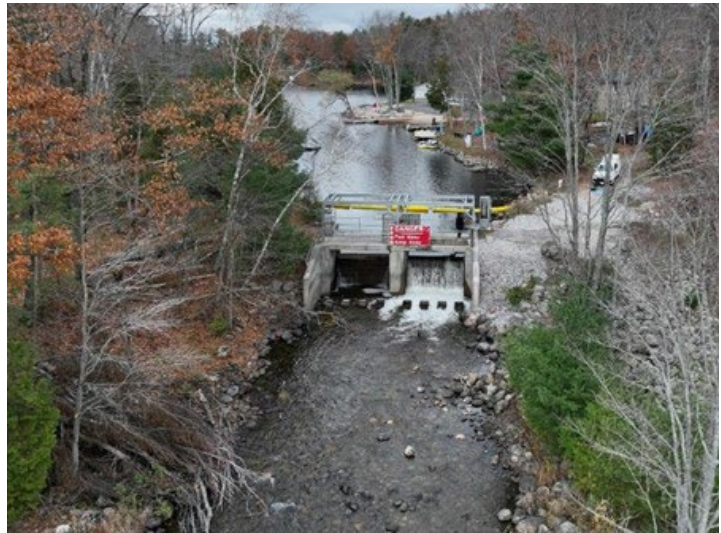
Figure 6. Mazinaw Lake Dam

MVCA took over ownership and operation of the dam from MRIC in 1991 and rebuilt it in 1992. Several improvements have been made to the structure including installation of several safety measures such as an overhead gantry, gates, fencing, and new booms.

The by-pass was washed out in the both the 2002 and 2019 floods; both times the fill was replaced later in the year. In general, the earth and concrete structures meet all stability criteria under normal and extreme conditions. Under the Inflow Design Flood (IDF), the earth spillway will be overtopped by about 0.2 m, but the dam structure is expected remain stable assuming all logs are pulled out of the two concrete spillways. Under this relatively minor overtopping of the earth spillway, scour of the sandy matrix between boulders could occur, which will necessitate repairs following the flood event to maintain the integrity of the structure. During overtopping, access to the dam control structure from the access road over the emergency spillway at the left abutment may not be possible. Access from the right abutment is feasible, but it is a walking-only access.

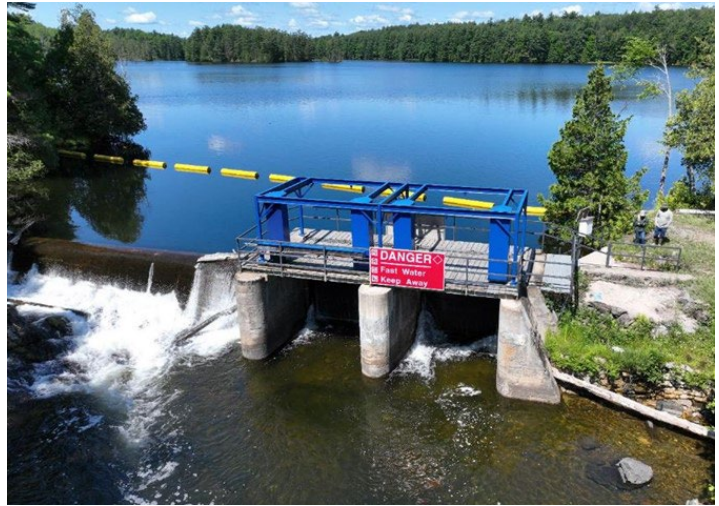
Figure 7. Kashwakamak Lake Dam

The Kashwakamak Lake Dam is in the Township of North Frontenac on the main channel of the Mississippi River and discharges to Farm Lake. The Kashwakamak Lake Dam was built in 1910 by the MRIC. In 1991, ownership and operation were transferred to the MVCA. The structure includes a small concrete saddle dam, an overflow weir spillway, and a sluiceway containing two stop log bays. The stop logs are placed and removed using manually operated chain falls as part of an overhead gantry system. There are steel handrails around the control structure and a floating safety boom upstream of the dam.

The dam had undergone relatively minor repairs to the concrete surfaces until 1988, when extensive work was completed to the concrete surfaces of the weir. In 1995, MVCA undertook a repair program to reduce or eliminate the seepage around the earth embankment at the entrance to the dam. In 2000, MVCA undertook a grouting program and repairs to cracked and spalled concrete on the weir and the abutments. In 2002, the deck of the dam was replaced. In 2020, a proposed repair option was prepared by Cleland Jardine Engineering Ltd, which was not implemented. A Class Environmental Assessment was initiated in 2023 in preparation for potential reconstruction of the dam.

The proposed reconstruction project is to replace the Kashwakamak Lake Dam to mitigate the risk of dam overtopping and failure, which has been exacerbated by more frequent and severe extreme weather events. A 2022 Dam Safety Review Report completed by Hatch Ltd. states that the dam concrete structures are deteriorating and require substantial rehabilitation or replacement within the next five years. Major concrete repairs are required at the overflow structure, which has extensive spalled concrete surfaces at the upstream face and a severely deteriorated horizontal joint at the toe.

The new dam will be designed for an updated IDF and HPC to effectively address the increasing risk of failure of the existing structure. The project will incorporate future climate change considerations into the new dam design to ensure the new structure provides much needed flood protection and mitigation to the local communities, residents, businesses, and environment over the course of its service life.

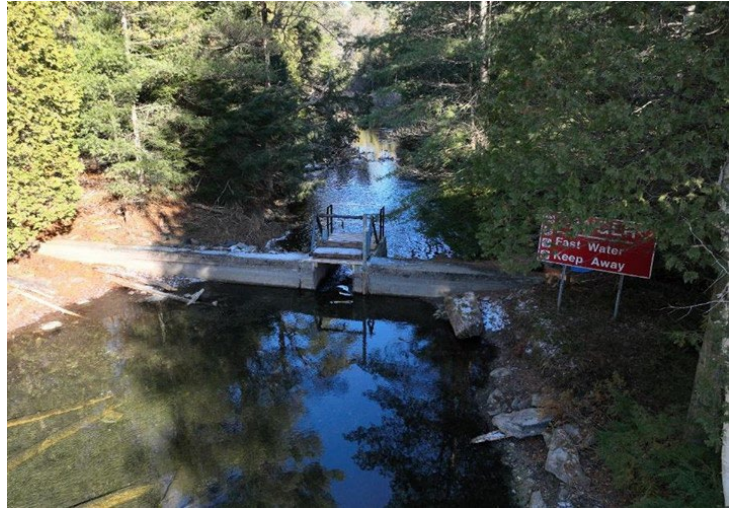
Figure 8. Mississagagon Lake Dam

Mississagagon Lake Dam is located at the east end of Mississagagon Lake on Swamp Creek. It is situated approximately 15 km east of Cloyne on Lot 2, Concession IX in the Township of North Frontenac. The dam was originally built to support lumber operations in the 1860s. In 1923, it was reconstructed by the MRIC as a rock filled timber crib dam with wood sheeting on the upstream face. The sluiceway was rebuilt in 1960, and a concrete membrane was installed on the upstream face in 1973. Ownership was transferred from MRIC to MVCA in January 1991. Until 1997, dam operations were carried out by locals on a contract basis. Access to the structure is via a 0.5 km (privately owned) dirt road.

Mississagagon Lake Dam is one of six key flood control structures in the Mississippi River watershed that act as storage reservoirs in the spring to alleviate flooding.

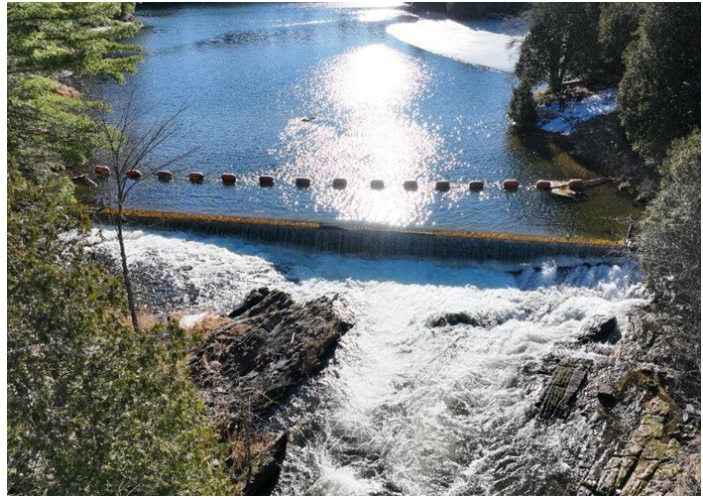
Figure 9. Farm Lake Dam

The existing structure is a rock filled timber crib. The upstream face of the dam is sheathed in plywood at a 2:1 slope and has a level top 0.60 m wide. A 0.20 m flashboard was installed across the top of the crib in 1984 by MVCA. The dam varies in height and is 30.08 m long. The weir elevation is estimated to be around 248.01 m.

The wooden flashboards and plywood are repaired and replaced annually on an as needed basis. Leakage issues throughout the summer months have become a common occurrence due to the age and type of weir. Tarps are placed on the upstream plywood to better seal the structure and slow down the seepage. Continuous monitoring and repair of the leakage is needed until the structure can be replaced.

The Farm Lake Dam is located in the Township of North Frontenac. The dam was originally built in 1926 by one of the lumbering companies of that time and was rebuilt by the MVCA in 1976. The access road is privately owned and MVCA has an easement across the road. The dam is an overflow weir and therefore has no operating plan. The dam is used to sustain recreational water levels on the upstream Farm Lake. It has a drainage area of 427.9 sq km and a lake surface area of 120 ha.

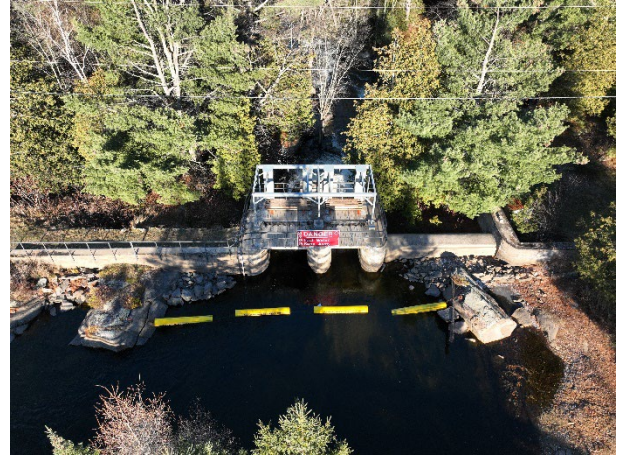
Figure 10. Big Gull Lake Dam

In January 1991, ownership was transferred from MRIC to MVCA. MVCA has an easement on the municipal right-of-way to access the dam per an agreement between the Townships of Clarendon and Miller, OPG and MRIC that transferred with the dam. The dam is a concrete structure consisting of two bulkhead walls, two sluiceways and a weir. The north bulkhead wall extends from the road embankment to the north pier of the control section, a length of 26.98 m. The wall is divided into two sections. Three concrete piers form the two sluices. The piers support a wooden deck, a steel pipe railing around the deck, and the stop log gantry assembly.

MVCA undertook extensive repairs to the structure in 1995, and a dam safety review was completed in 2006. A visual condition assessment of the dam was carried out in 2016 that concluded the dam was safe to operate for at least another 5 years.

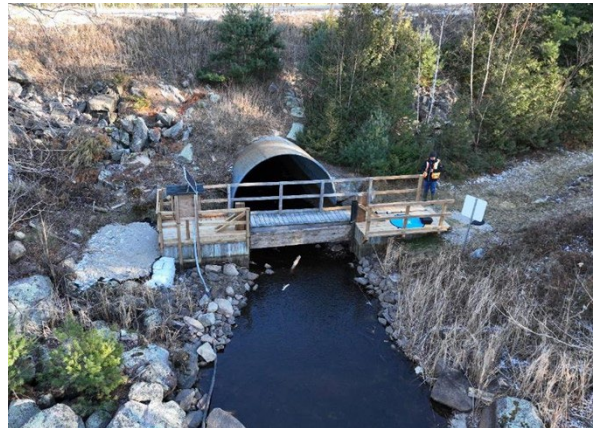
Figure 11. Pine Lake Dam

In the late 1980's the residents again requested that MVCA build a more permanent structure. At that time a survey was undertaken to ensure that the majority of the residents around the lake were in favour of this proposal. The majority were in favour and in 1990 MVCA designed and built the present structure. The original operating guidelines called for the stop logs to be removed from the dam in mid-August to ensure the lake dropped enough to allow adequate cleansing of the walleye spawning beds. This was met with opposition and in 1993, following another survey of the residents, the operating guideline was changed to the present one.

When logs are out of the structure they are kept suspended in the gain by chains and locks. It should be noted that under high flows, the dam should be checked often, as levels in the channel could get high enough to be blocked by the suspended logs in the gain and cause interference with the structure's effectiveness. If this happens logs should be lifted or removed from the gains.

Over the years, seepage has continued to be an issue at this structure especially around the north embankment. There have been multiple attempts to repair the seepage around the upstream north embankment (with rock and or sandbags) and a few of these attempts have been vandalized. This seepage impacts the effectiveness of this structure to maintain stable water levels for the lake above.

The Pine Lake Dam is located at the outlet of Pine Lake, just south of the hamlet of Ardoch on Lot 16, Concession 4, Clarendon Ward in the Township of North Frontenac. Around 1970 the Townships of Clarendon and Miller rebuilt the Ardoch Highway and enlarged the culvert at the outlet of Pine Lake. According to residents on the lake, this had an adverse effect on the water levels on the lake. At that time, the cottagers requested that MVCA build a dam at the outlet of the lake. MVCA built a sand bag structure, which deteriorated over time and was not replaced.

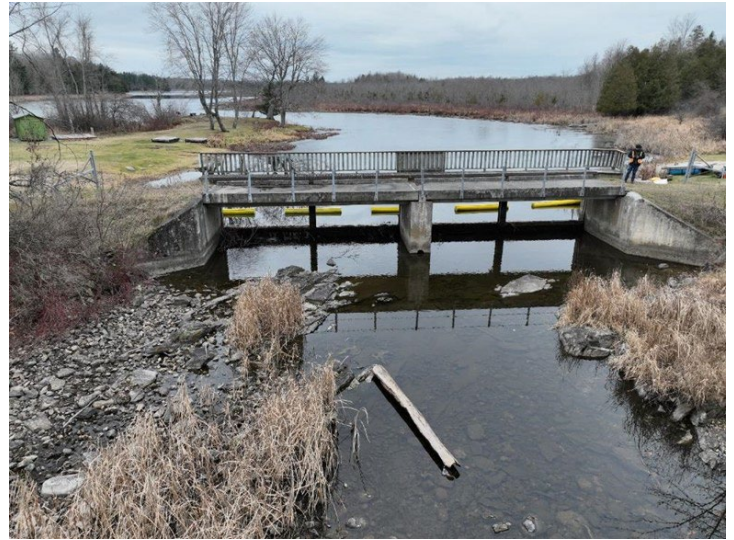
Figure 12. Bennett Lake Dam

The dam was built at the request of cottage associations members from Bennett Lake and Fagan Lake in 1964 and again in 1970. In 1970, MVCA received Queens Council approval to undertake a Preliminary Engineering study to access the feasibility of constructing a dam at the outlet of the Bennett Lake. A Water Survey of Canada (WSC) gauge was installed downstream of the dam in 1970 to support analysis.

Following the study and consultation with the cottagers, approval was given to construct the dam. MNR staff constructed the dam with MVCA staff on hand to supervise between November 1974 and April 1975 at a cost of ~\$70,000.

The Bennett Lake Dam is located at the outlet of Bennett Lake on the Fall River, on Lot 18, Concession X, in the Township of Bathurst, Lanark County. It is accessed via a 100 m private access road.

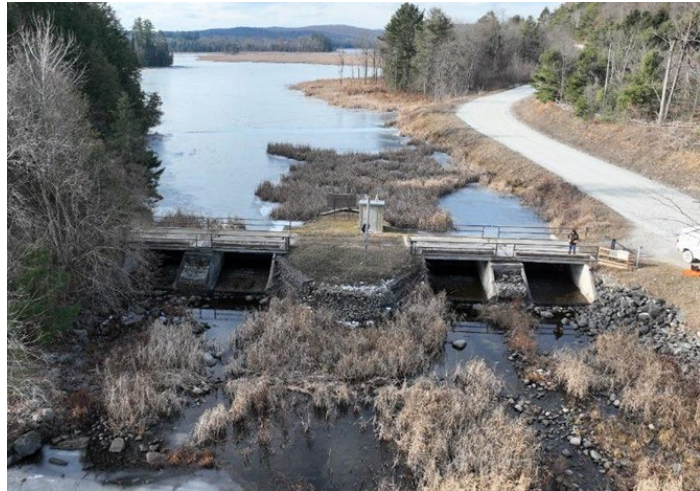
Figure 13. Widow Lake Dam

The dam was originally built in the 1800s to support the timber trade. MVCA purchased the land from John and Grace Grew in 1974 and reconstructed the timber cribbing dam.

Engineered drawings and specifications were

commissioned for replacement of the concrete decking in 2019 but upgrades were not carried out due to expiration of the funding. Work was subsequently deferred due to COVID-19 and other capital priorities.

The Widow Lake Dam is located on the Clyde River at the outlet of Widow Lake, adjacent to the French Line and east of the hamlet of Clyde Forks on Lot 16, Con 4, Lavant Ward in the Township of Lanark Highlands. Widow Lake is the last major storage basin on the Clyde River to alleviate spring flooding at Cedardale and Lanark Village.

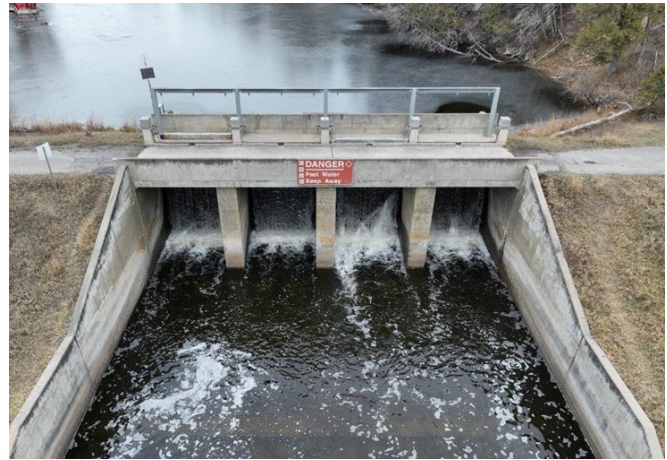
Figure 14. Lanark Dam

The dam has a drainage area of approximately 650 km². MVCA operates the dam to mitigate flooding upstream of the George Street bridge in the village of Lanark. The dam is also used to maintain stable water levels for recreation on the river and Kerr Lake and for fire suppression.

In 1998, the Clyde River experienced a severe flood. Flows exceeded the 100-year return period and peaked on April 5, 1998 at 158 m³/s.

The Lanark Dam is located in the lower Clyde River watershed in the Village of Lanark. The dam was originally built as a grist/saw mill in the 1800's. It was rebuilt by the MVCA in 1977.

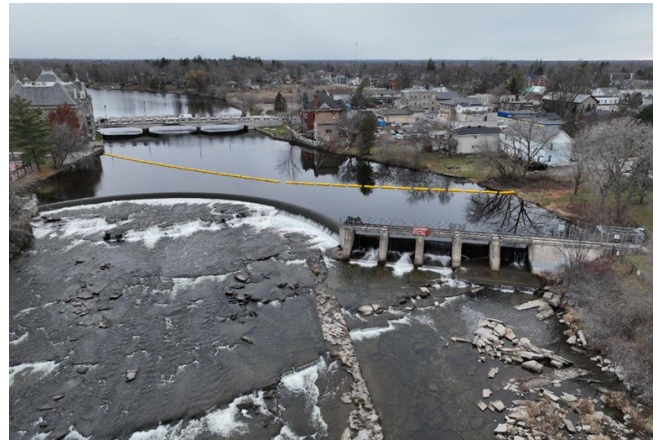
Figure 15. Carleton Place Dam

The Carleton Place Dam maintains water levels for the Mississippi River in the town and has some impact on water levels on Mississippi Lake located approximately 2 km upstream of the dam. Mississippi Lake is the last major storage basin on the Mississippi River to alleviate spring flooding. There are approximately 1700 residential structures along the shores of the lake, and there is a water intake pipe located between the lake and the dam.

The dam is a concrete structure consisting of two major sections: a control section and an ogee shaped (round crested) weir. The control section consists of five sluiceways which contain a total of 48 stop logs. There are 10 stop logs in each of the first three bays and 9 in the last two bays. The stop logs are removed and replaced by a gantry system with 2-ton chain hoists that is used under normal conditions as well as a two-rail mounted crab winch system for operating under high flows. The ogee crested concrete weir spans the rest of the river for a distance of 75.15 m. A safety boom extends across the river upstream of the dam to warn boaters and swimmers of the danger.

The Carleton Place Dam is located in the lower Mississippi River watershed in the Town of Carleton Place. The dam was originally built in the 1820's. It was rebuilt in 1973 by the MRIC and MVCA took ownership of the dam in 1975.

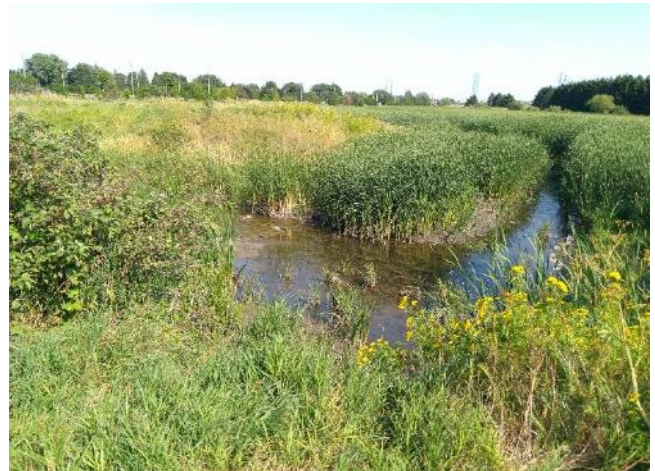
Figure 16. Glen Cairn Flood Control Facility

The Glen Cairn Flood Control Facility is located within the Carp River watershed and owned by MVCA. It was constructed in 1979 at the request of the province and the former City of Kanata to address flooding of Glen Cairn subdivision. This detention basin is not actively operated by MVCA. There is a maintenance agreement in place with the City of Ottawa and MVCA to distinguish responsibility of cost and maintenance of this structure.

The detention pond area has a concrete inlet along Castlefrank Road and extends to a small concrete weir at the outlet. The pond is surrounded by a well grassed sloped embankment covered with small non-symmetrically placed rip rap along the edge of the pond.

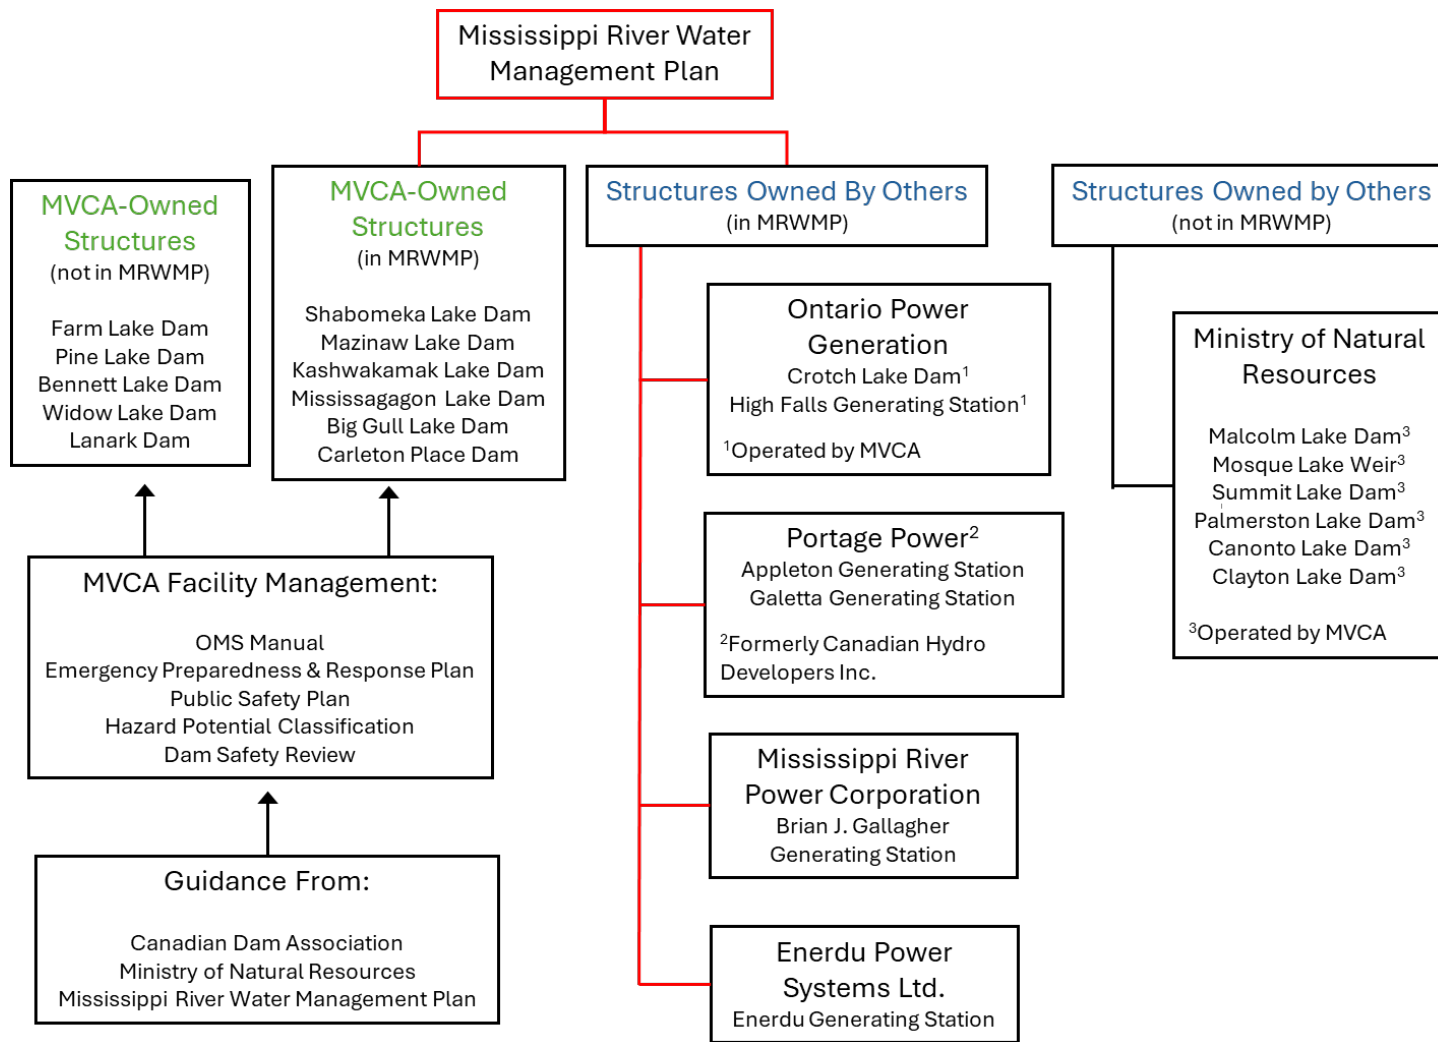
MVCA operates water control infrastructure according to the management plan shown in Figure 17. Only about half of MVCA's structures are guided by procedures set out in the MRWMP. MVCA uses the MRWMP as well as other federal and provincial guidelines to ensure all applicable standards are met and that MVCA's management practices are updated accordingly. The federal and provincial guidelines are described in Section 3.3.1, followed by a brief description of the various documents MVCA references in operating water control structures.

Figure 17. Guidance Documents for MVCA's Water Control Infrastructure

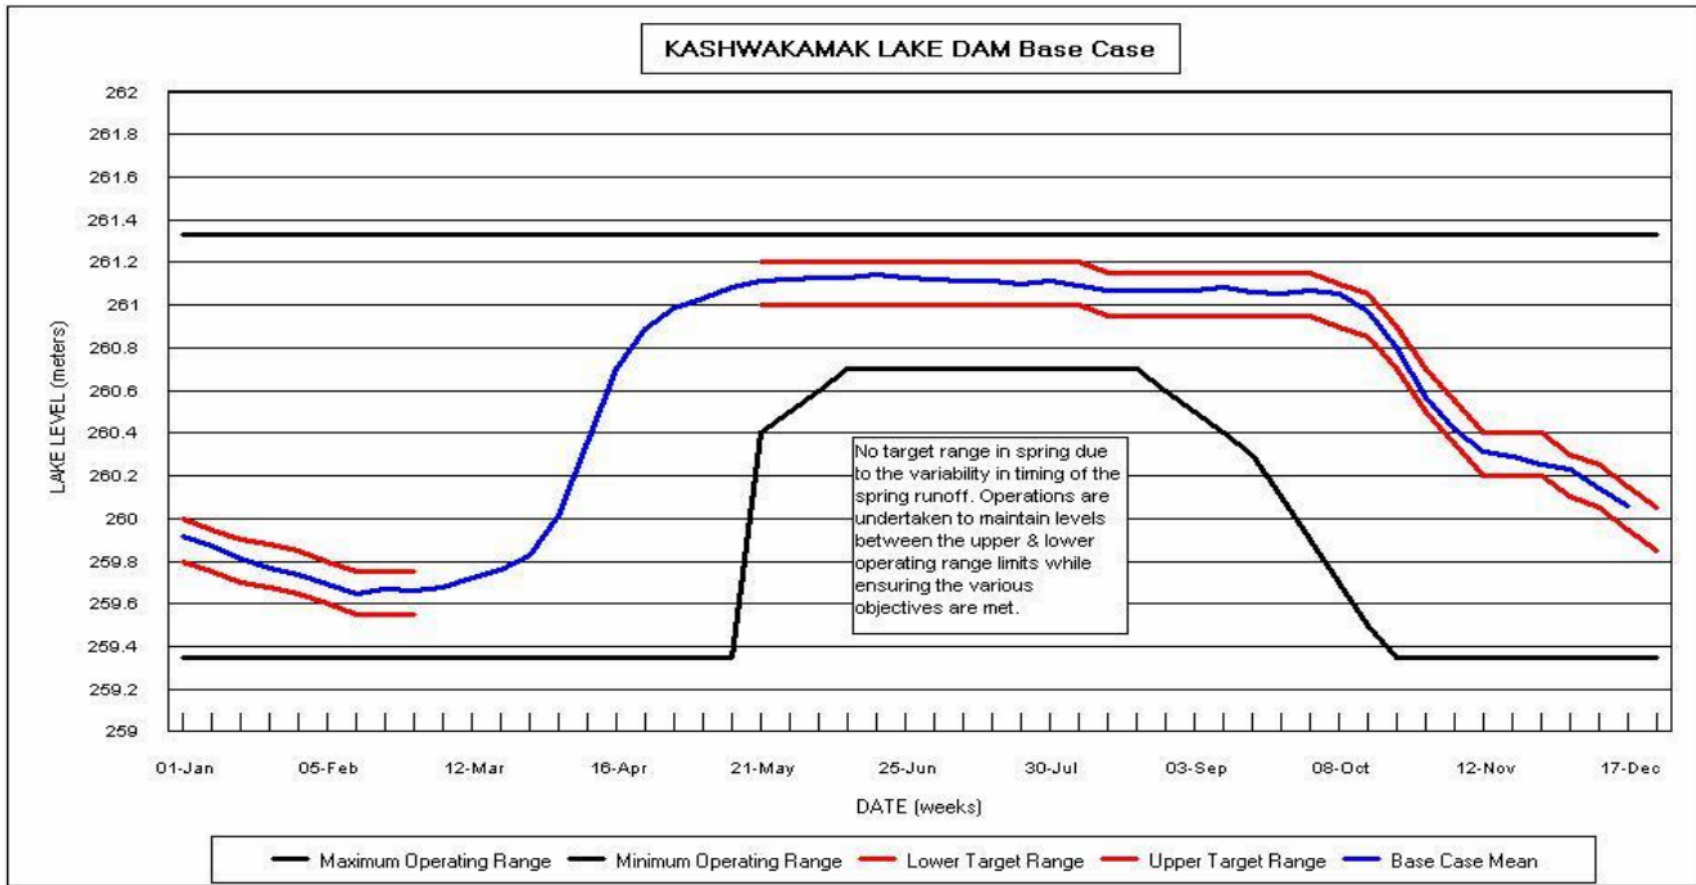
Figure 18. Kashwakamak Lake Dam Operating Guidelines

This section contains excerpts from the Mississippi River Water Management Plan (MRWMP), produced by MVCA, OPG, Portage Power⁸, Enerdu Power Systems Ltd., Mississippi River Power Corporation, and the Ontario MNR, as amended October 2020. The MRWMP includes MNR-approved operating parameters, as demonstrated in Figure 18 below. The black lines represent the maximum and minimum water levels, red lines are the target levels, and the blue line is the actual historic mean water level. No targets are specified during the springtime due to high variability of flows/levels and the different timing of freshet each year.
