MORRIS ISLAND CONSERVATION AREA MASTER PLAN

Dec 1987

CAUSEWAY RECONSTRUCTION STUDY

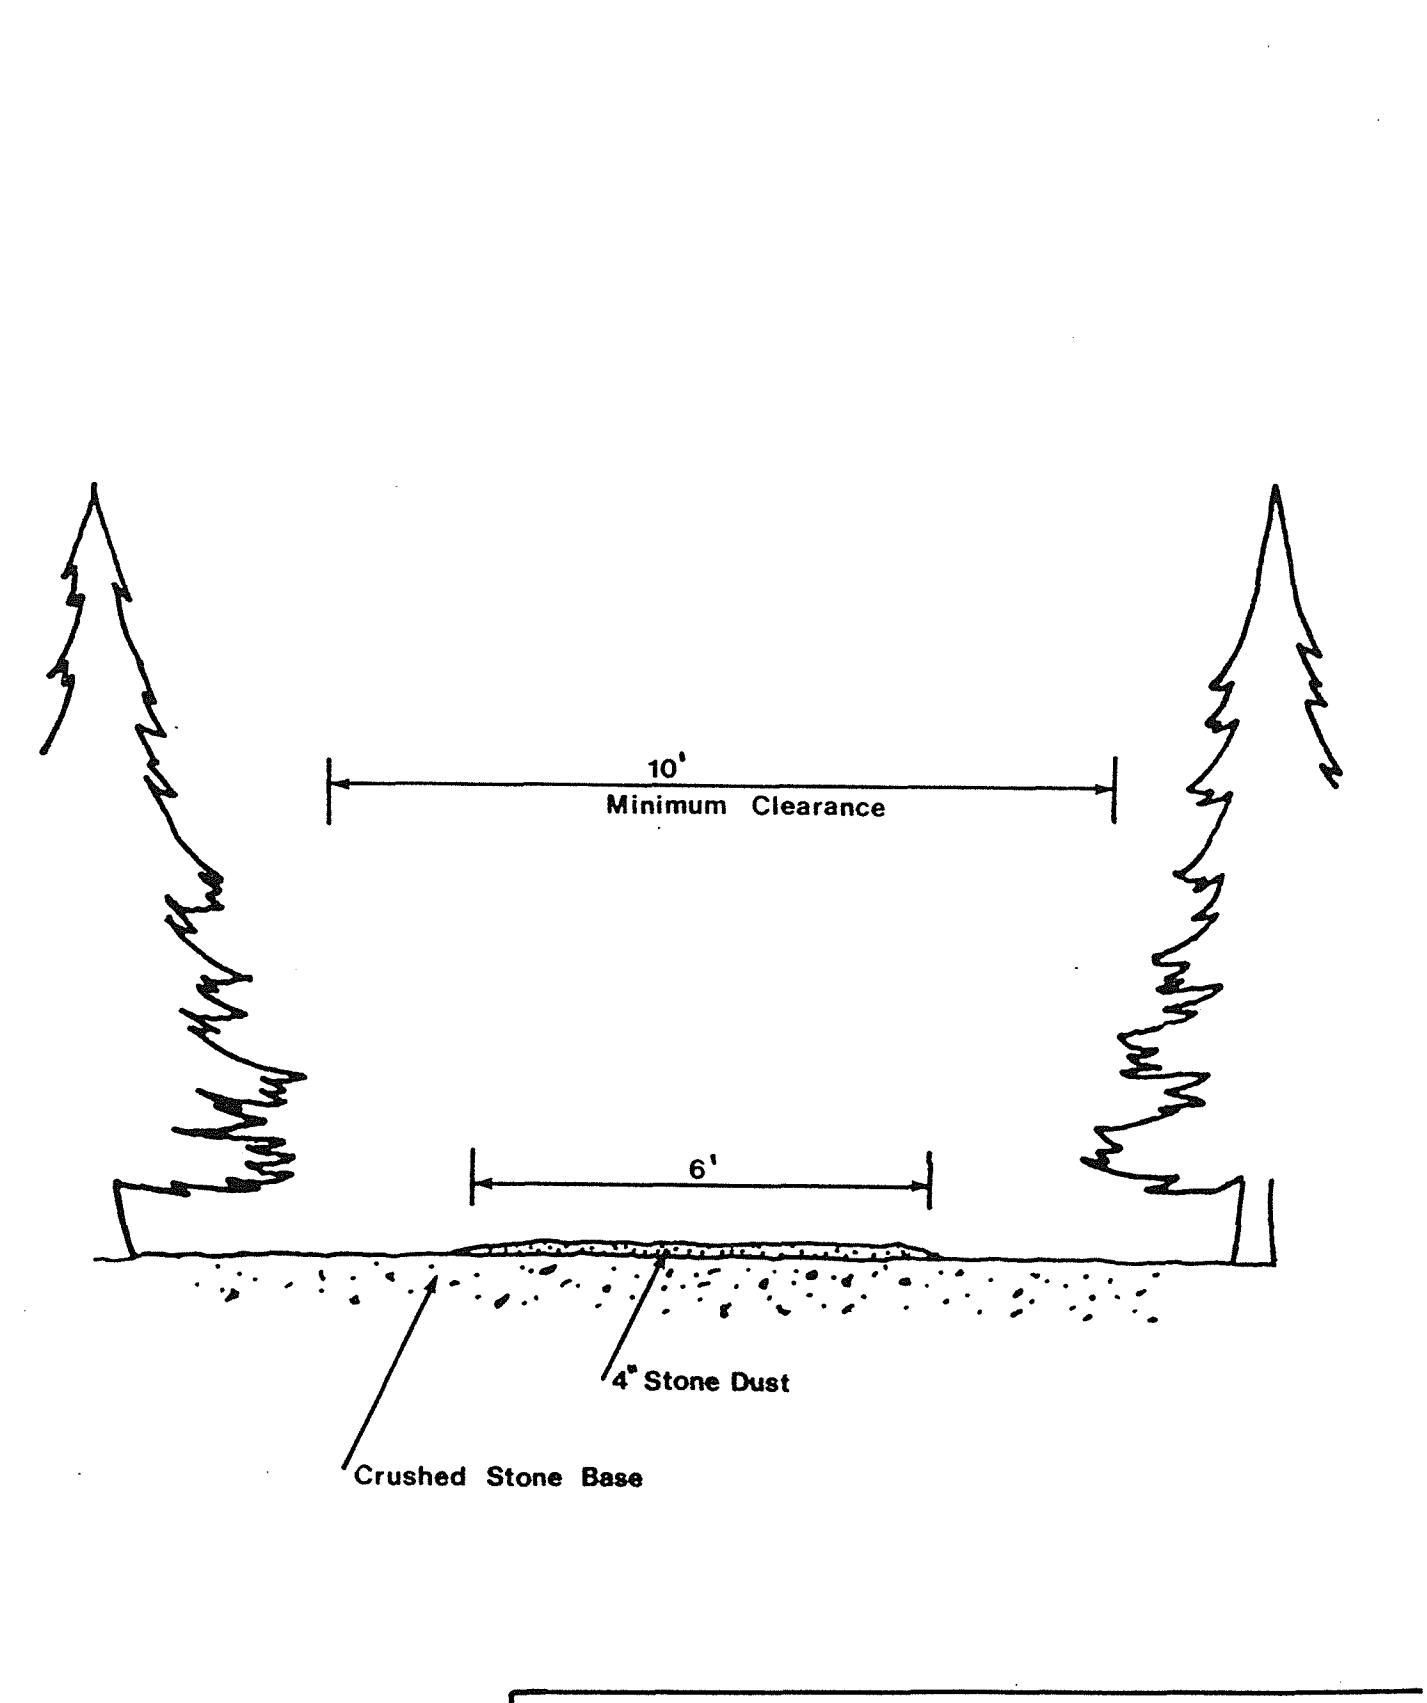
MISSISSIPPI VALLEY CONSERVATION AUTHORITY			
FEBRUARY 1987	Appendix 12:. Accessible	Trail	
MORRIS ISLAND CO	ONSERVATION AREA	M.D.

The relatively flat and straight nature of the old rail bed indicates that it will be suitable for a wheelchair trail. It is therefore intended that development and repair of the causeway and the trail, from the parking lot to the eastern end of the conservation area, be designed for handicap use. This trail will be approximately 1800 meters (6000 ft) long. The surface of the trail will be improved and the causeway rebuilt to provide a smooth even surface for wheelchair A thick layer of stone dust will form the surface traffic. and proper erosion control will be established to keep this surface in good repair. The causeway will be rebuilt with a minimum tread width of 2.5 meters (8 ft). The bridge over the culverts will be designed with low level rails and a surface suitable to allow easy passage of 2 wheelchairs. In addition, space will be given to allow a wheelchair or individual to stand and fish in the shallow water under the bridge. Two additional viewing platforms will be built into the wheelchair trail on the causeway. A third platform will be built at the east end of the trail to provide a destination point for the trail and a place to turn wheelchairs around, since they must return on the same trail.

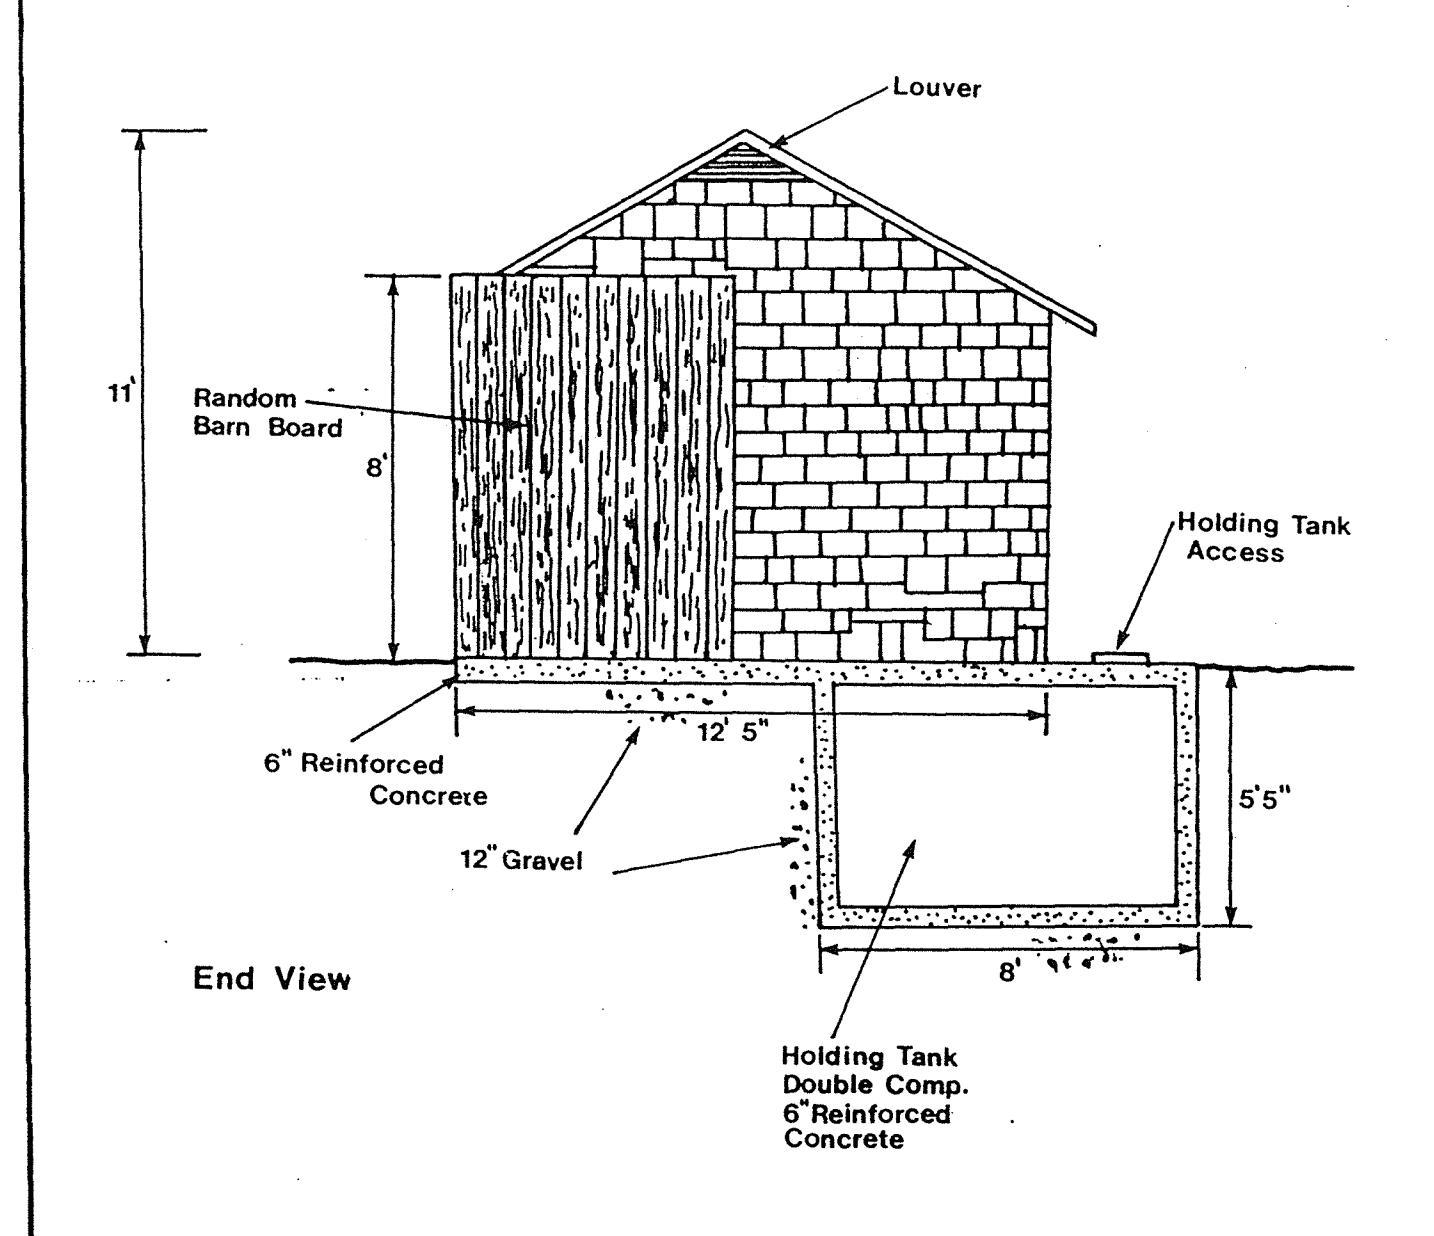
MISSISSIPPI VALLEY CONSERVATION AUTHORITY			
FEBRUARY 1987	Appendix 15. Accessible Washroom		
MORRIS ISLAND CO	ONSERVATION AREA	M.D.

The washroom in the main picnic area will have separate male and female sections. The two main rooms will have one handicap stall each, with flush toilets, and one sink. This development will require a drilled well, holding tank, and electrical service. A service connection and approximately six hydro poles would be needed to bring electricity into the site.

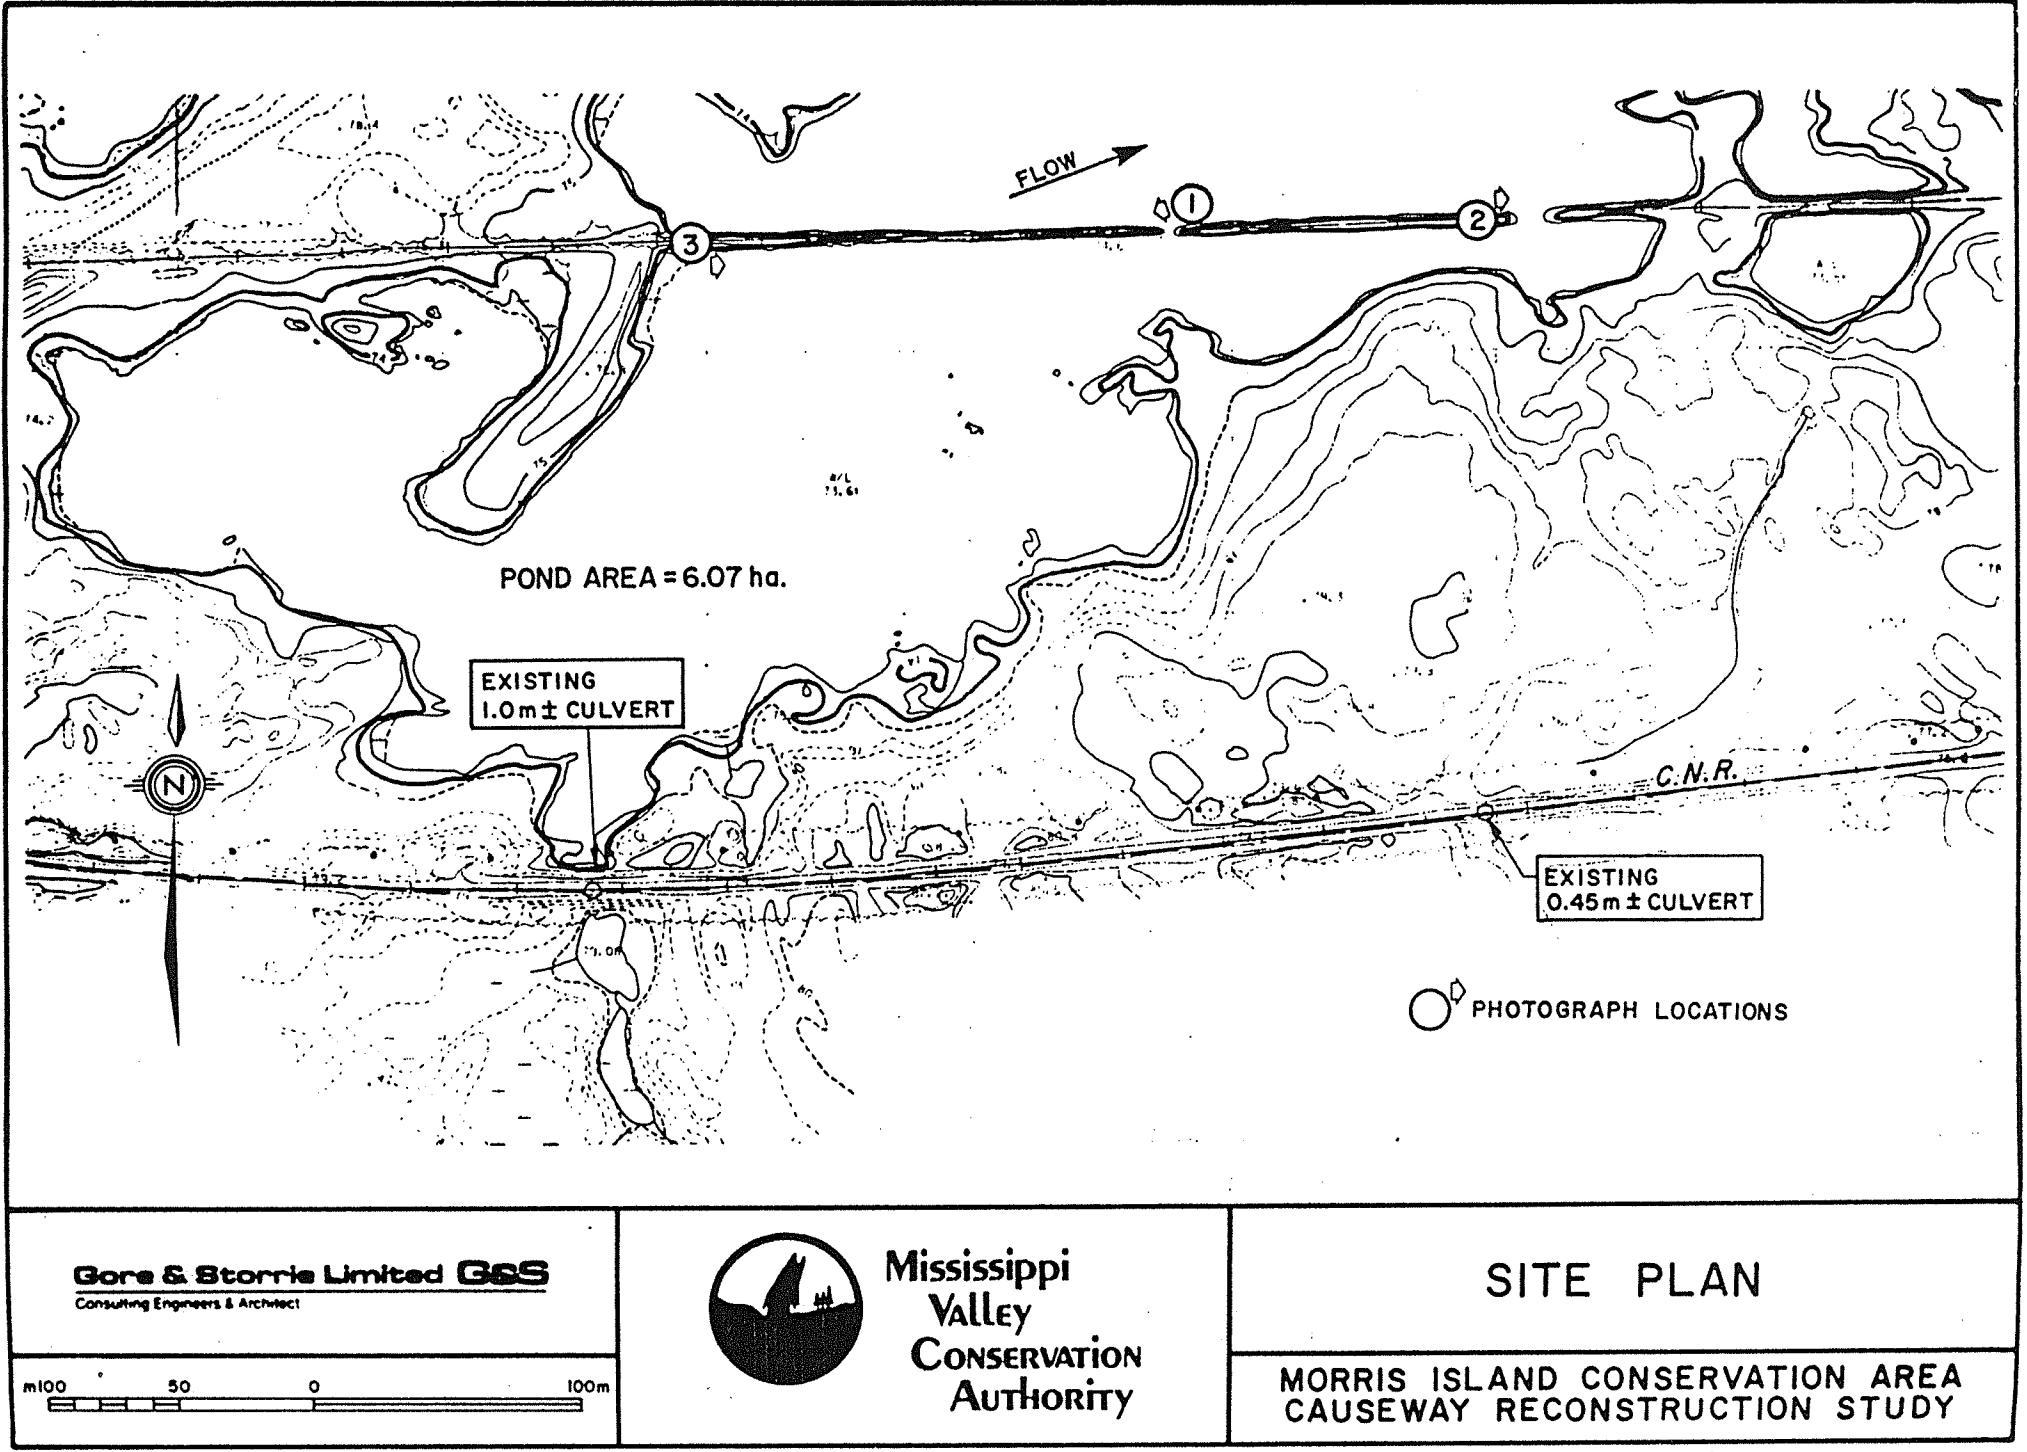
The operation of the Chats Falls Dam located approximately 3km east (downstream) of the site causes a daily fluctuation in the bay level. This in turn, causes flows to reverse through the embankment during periods of reservoir filling and vice versa during drawdown. Ontario Hydro has advised that the maximum fluctuation between operating levels is 74.02m and 74.30m (GSC). This translates to a fluctuation at the site of approximately 0.3m.

Ontario Hydro also advises that the maximum rate of drawdown is in the order of 0.01m/hr. MVCA staff observed level changes which appeared higher than this during field activities on March 3, 1987. Consequently, the embankment and crossing must be designed to accommodate normal drainage from Morris Island, and the effect of operating levels at the dam. In the matter of natural drainage, it is recommended that the crossing be equivalent in area to that currently under the new CNR alignment. A maximum rate of drawdown of 0.1m/hr was 0.3m/h assumed to be an appropriate design condition. To accommodate reverse flow through the embankment, we have estimated the flow rate to equalize the levels as follows:

-	Pond area upstream of the embankment	6.07ha	
-	Maximum fluctuation in the level	0.50m	2000 - 2000
	Total volume to equalize $(60,700m^2)(0.50m) =$	30 350m ³	
-	Time to equalize (0.5m @ 0.10m/hr)	5 hr	
-	Maximum equalizing flowrate	1.69m ³ /sec	5.1 ~ 1/500

It is recommended that the Authority confirm the actual rate of water level fluctuation at the site prior to proceeding to final design. We are recommending that 3-1 000mmØ CSP culverts be placed at the breach located in the central part of the embankment, as shown on Drawing No. 1, which is appended. It is also recommended that the Authority consider inlet improvements and seepage control on both ends in view of the reverse flow. Year round flows may necessitate gratings as well.

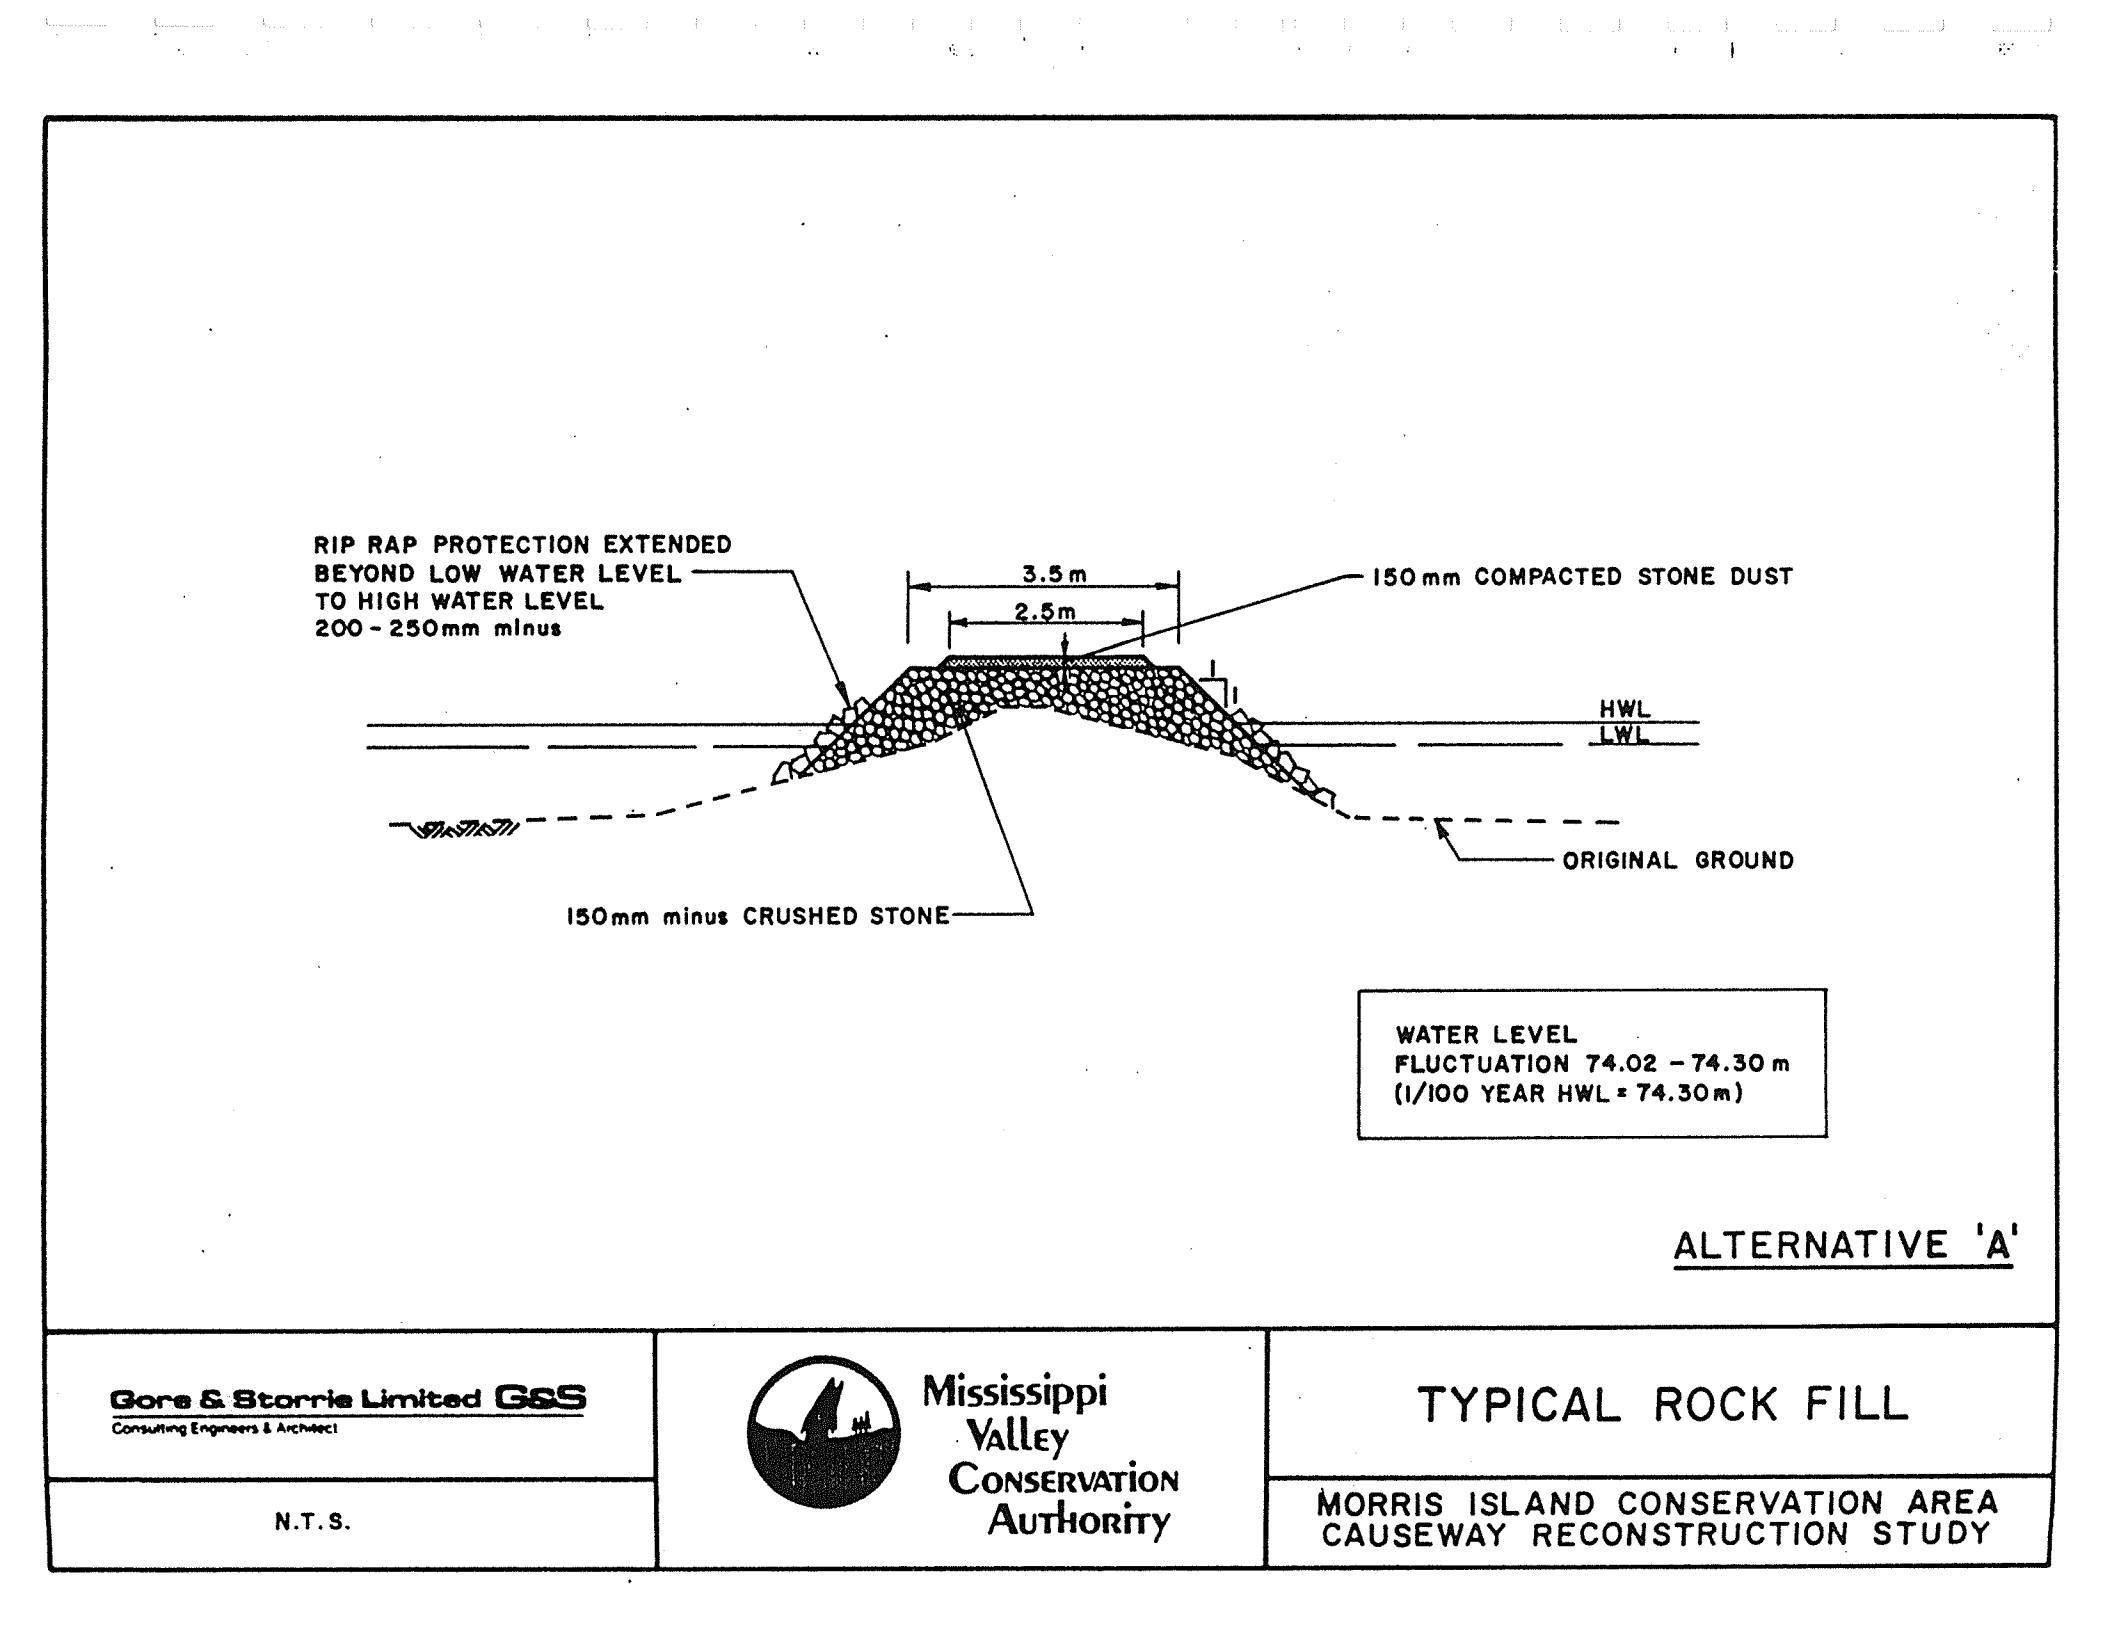
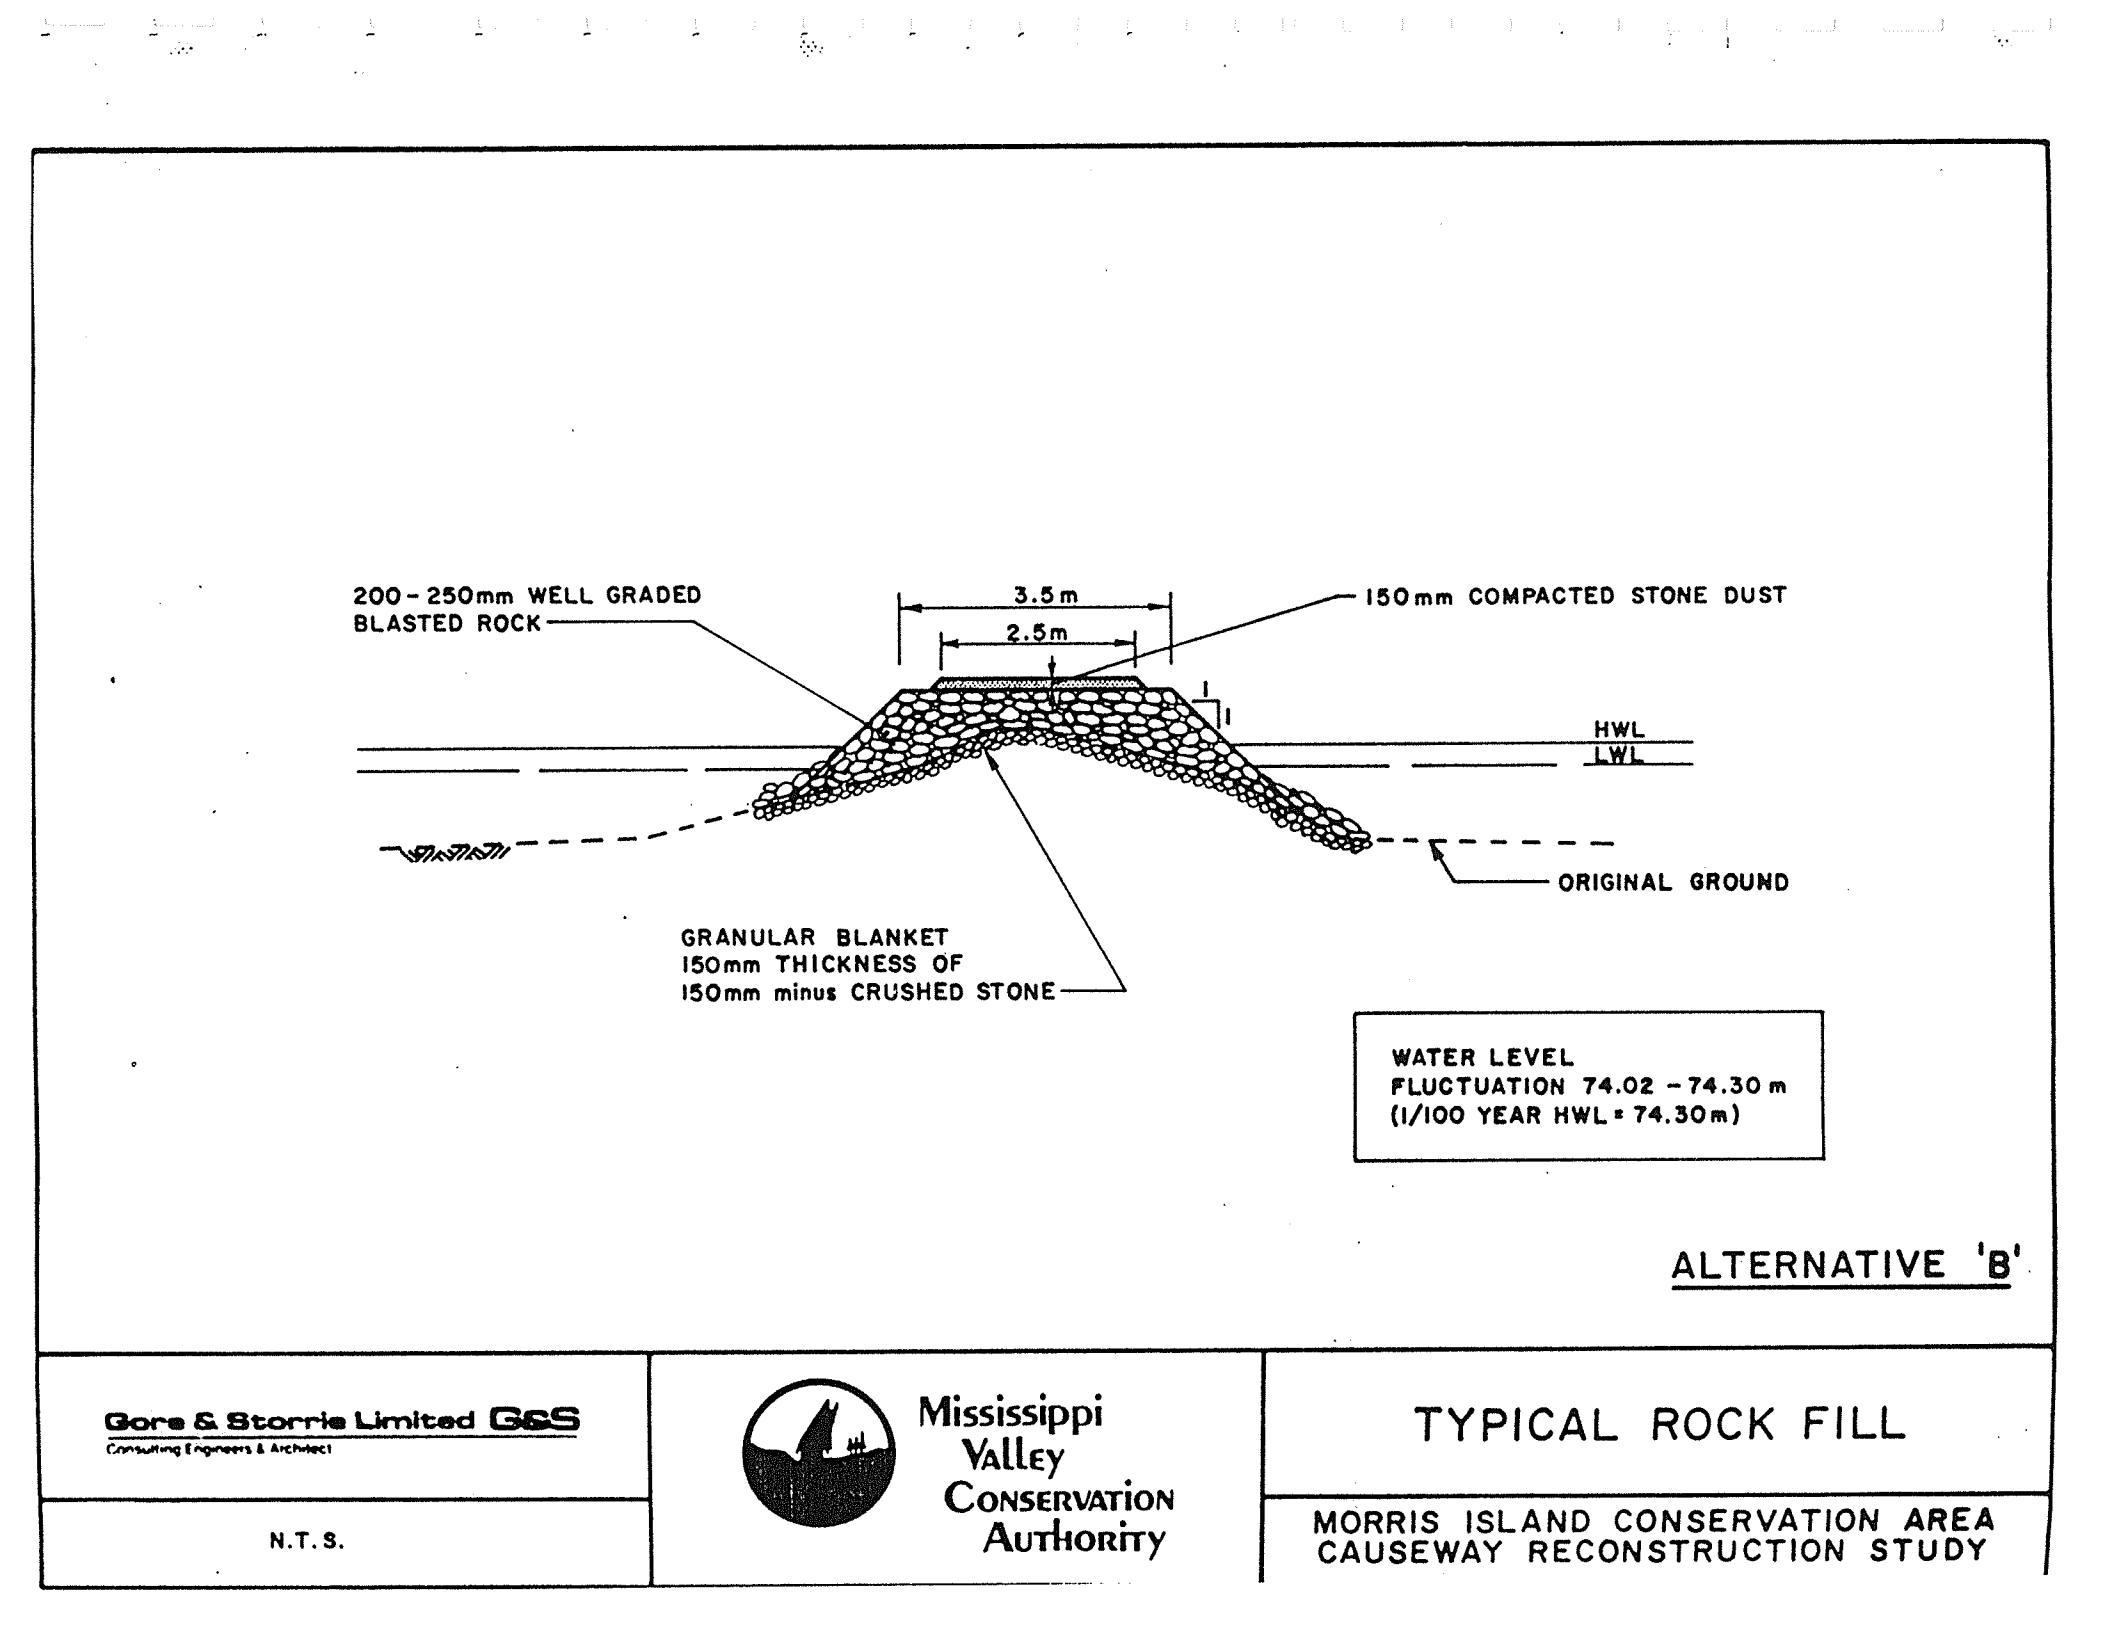
The layout of the proposed culvert replacement is shown on Drawing No. 1, which is appended. Installation should be as per OPSD 801.02, 802.01 and 803.03.

- . The new embankment should be centered on the old embankment to minimize settlement.
- . Two alternatives are proposed to reinstate the embankment. The first consists of using a core material of well graded 150mm minus and bringing the embankment to the proposed subgrade. To guard against wave action, a 450mm thickness of 200mm or 250mm minus well graded blasted rock would be placed along the exposed sideslopes up to high water level. Alternatively, the core could be made up entirely of 200mm or 250mm minus well graded blasted rock. No erosion protection would be necessary to guard against wave action, however, a granular blanket consisting of a 150mm thickness of 150mm minus would be necessary to prevent loss of the finer native material. Both options are presented as Figure 3A and 3B respectively. We have costed the first option (core made up of 150mm minus).

- . Where the existing embankment will not be regraded, but rather stabilized or reshaped, the existing sideslopes should be protected by placing a 450mm thickness of well graded 200mm-250mm minus to the maximum expected high water level.

- . The culvert should be placed within the limits of the former embankment. Both ends of the culvert should be protected against scouring velocities by placing a 600mm thickness of riprap.
- . The culvert outlet protection should be placed within the limits of the old embankment to minimize loss of material into the soft organics.
- Augerholes indicate little or no highly compressible material for 8.5m north of the centreline of the embankment and 3.0m south of the embankment.
- . Substantial settlement can be expected in the area of the former bridge (near the east end of the site) where no previous embankment existed.
