Upper Poole Creek Restoration Plan

DRAFT-December 2019

Based on Objectives of the Upper Poole Creek Subwatershed Study

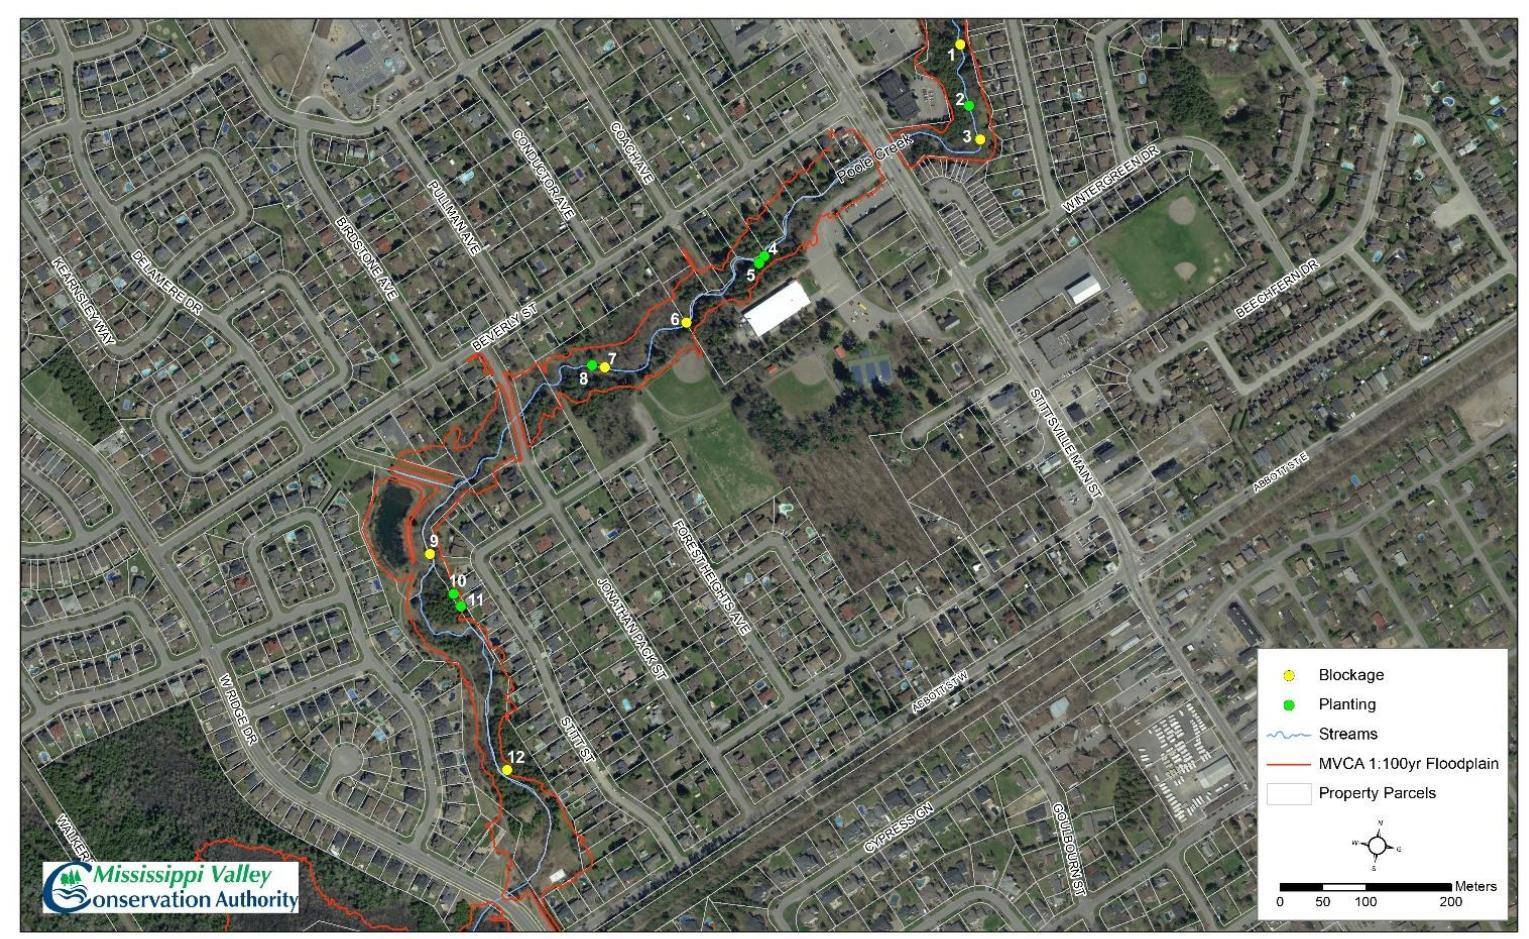
Figure 1: Map of sites recommended for restoration as described in Table 2.

Along UPC, there is a section upstream of the pedestrian bridge at Stitt Street Park that has been diverted from the existing channel into a manmade channel. It was observed that water was pooling over the banks. Sites 10 and 11 are along this section of the creek and have been identified for potential rehabilitation due to erosion. The Restoration Plan from 2013 recommended channel realignment to bring the creek back to its original state; however, this would be an expensive process. Instead, the current recommendation is to stabilize the shorelines along the manmade channel to minimize erosion, specifically at Sites 10 and 11. Initial contact was made with landowners at Sites 10 and 11, planting enhancements were completed at Site 11. Encroachment was discussed further and remains an issue. At Site 10, benefits of shoreline planting and stabilization were discussed with landowner but no further interest from landowner to date. Due to current use of the backyards adjacent to the creek, it may be difficult to address these sites.

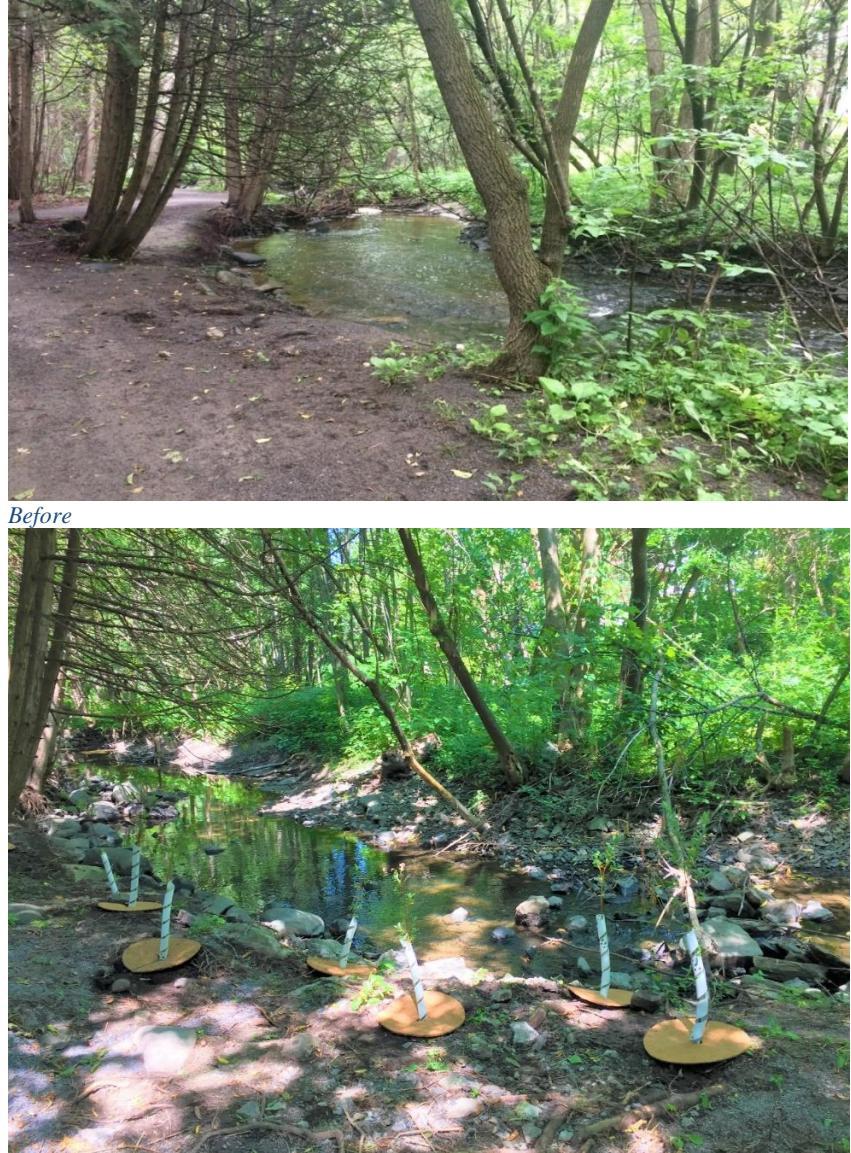
After

This site is City of Ottawa owned. It requires maintenance to stabilize the shorelines and minimize the erosion. Pedestrian trail along the south bank is too close to the water and is eroding the stream banks.

In 2019, 35 trees and shrubs were planted along the shoreline of the pedestrian trail between Main Street and Hesse Crescent. The shoreline planting will help to stabilize the shoreline and provide a buffer along the trail. Species planted include; bebb's willow, nannyberry and red osier dogwood.

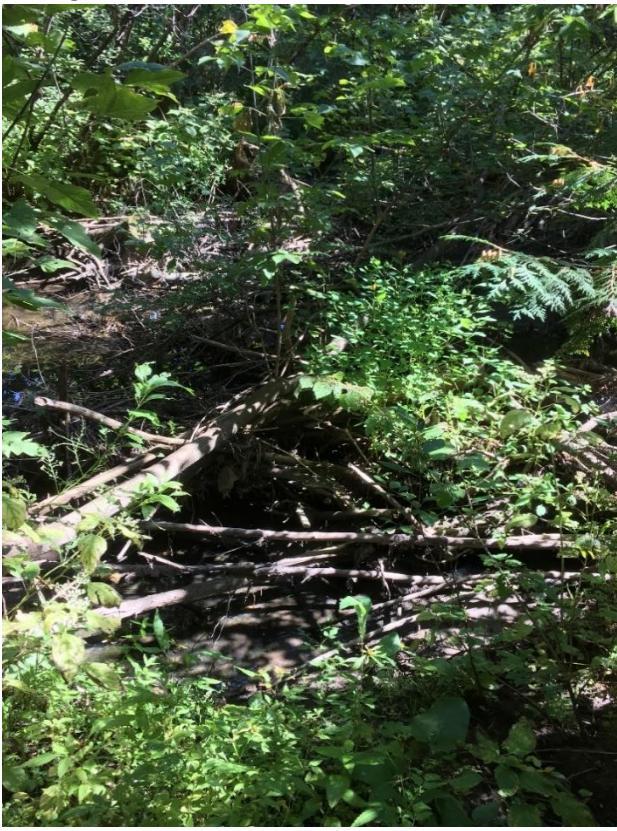
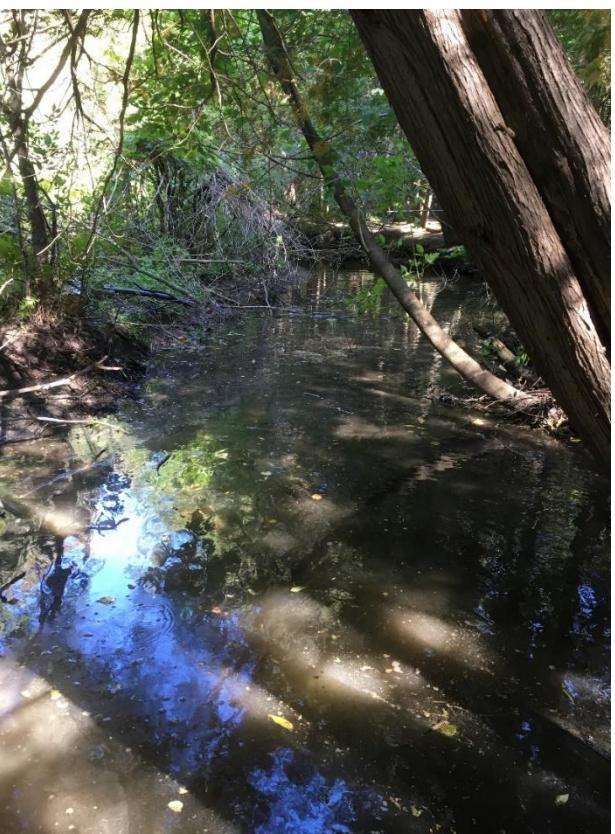
This site is City of Ottawa owned. Maintenance was required to improve flow and reduce blockages along trail between Main Street and Hesse Crescent. Blockages were removed in September 2019; woody debris placed along the shoreline (to contribute to habitat).

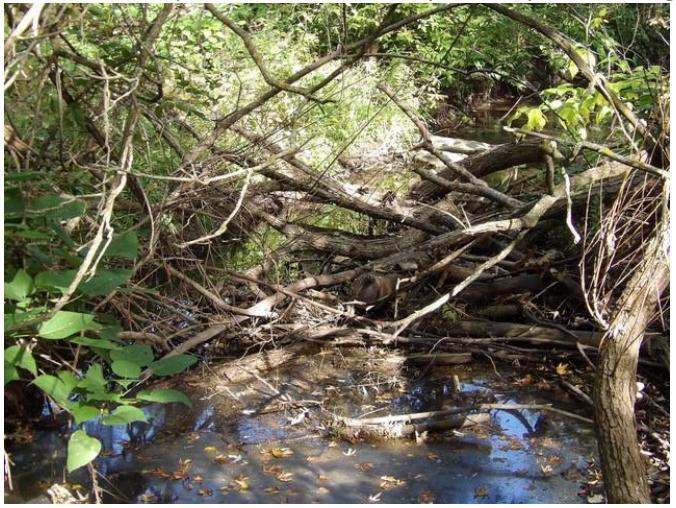
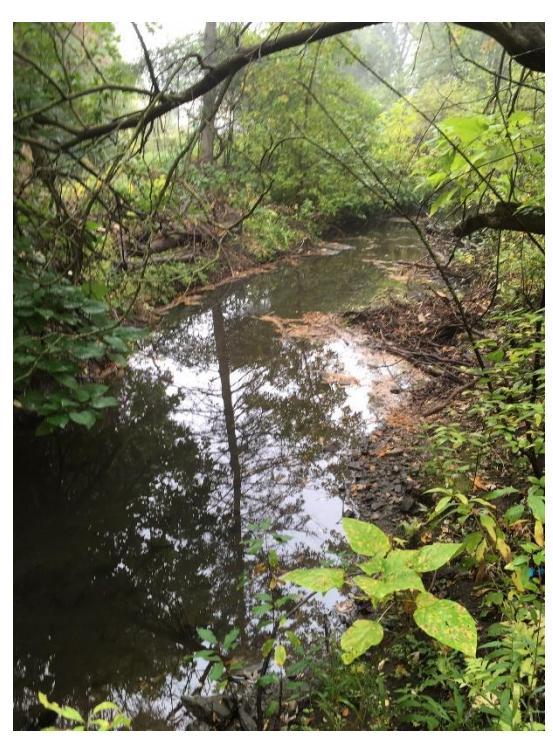
Site 3a

This site is City of Ottawa owned, not identified in the list of sites assessed previously. Maintenance was required to improve flow and reduce blockages along trail between Main Street and Johnny Leroux arena. Blockages were removed in September 2019; woody debris placed along the shoreline (to contribute to habitat).

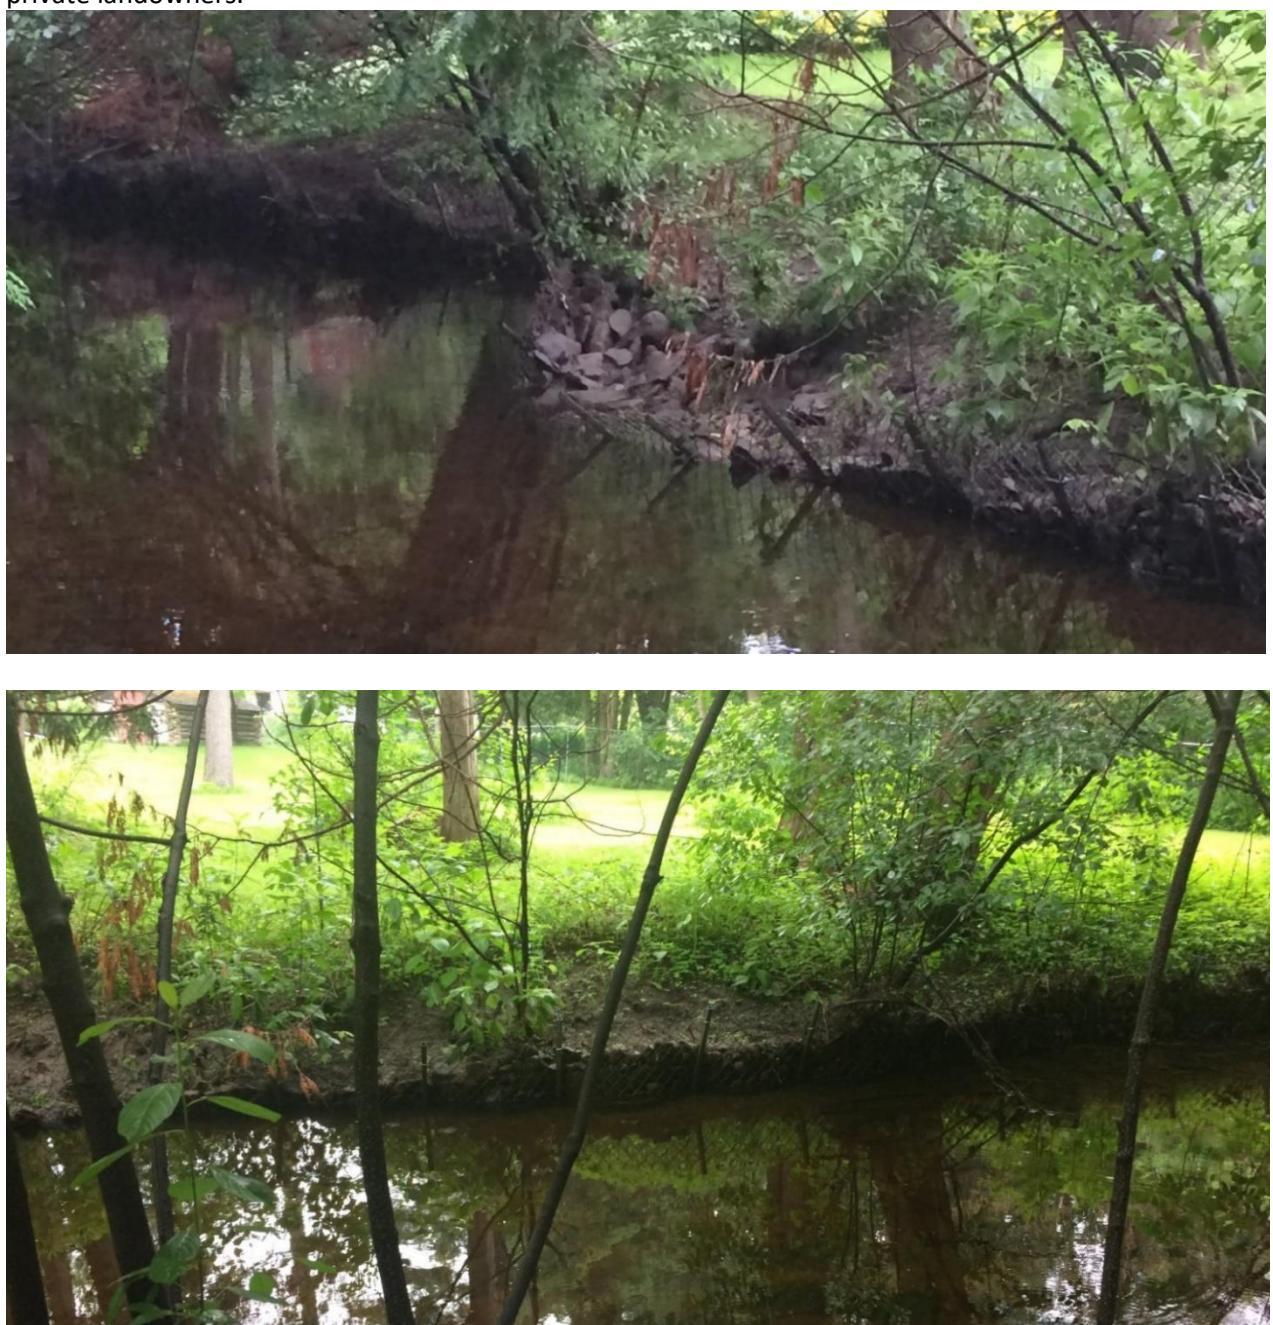
This site is a City of Ottawa owned (former Township of Goulbourn) property that is maintained by adjacent private landowners.

Issues: Fence retaining rubble is falling into the creek and there is a lack of shoreline vegetation. **Access:** 14 Beverly Street (or neighbouring house)

Plan: Contact landowner and discuss potential work that could enhance their shoreline. Landowner was contacted in 2019 in regards potential shoreline work. There was a positive response to complete work, although the property was up for sale at that time. It is recommended to return to the property in 2020 to contact new landowners if funding is available for removal of the fence and stabilization of the shoreline. **Action:** There is the opportunity for potential work to be completed for this property's shoreline. The type of work will be dependent upon the response of the landowner and funding. The work may be costly to remove the fence and stabilize shoreline.

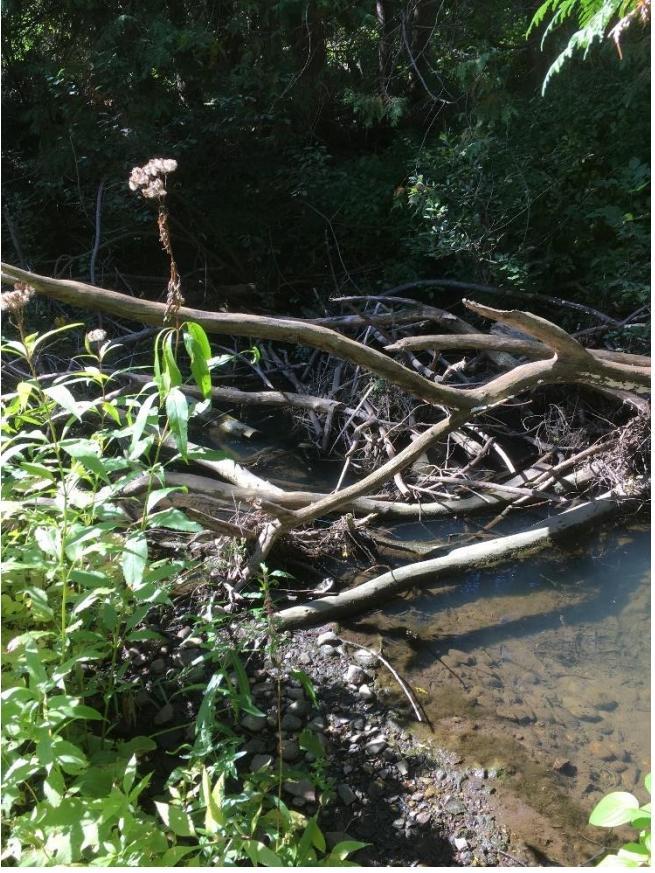
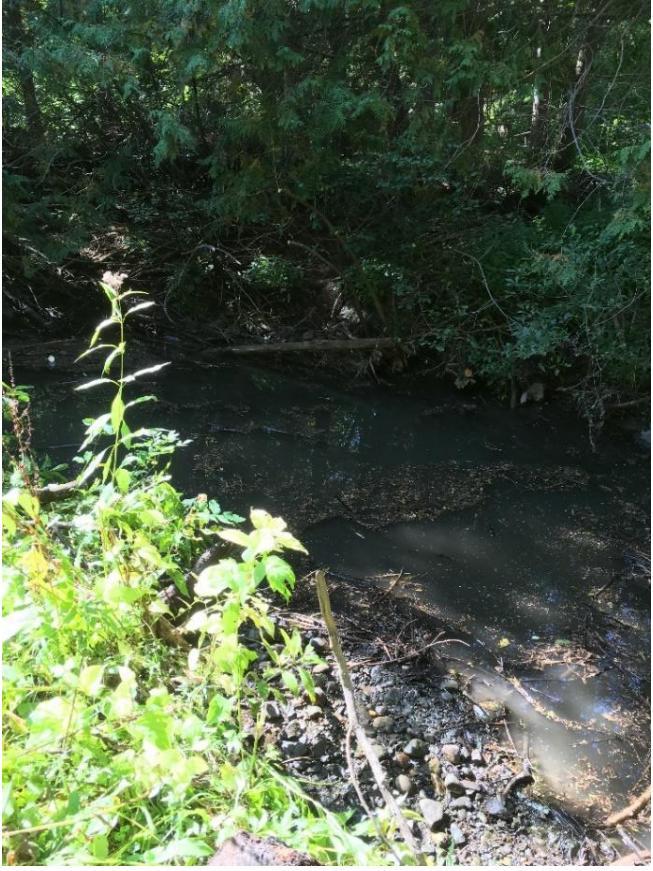
Site 5a

This site is City of Ottawa owned. Maintenance was required to improve flow and reduce blockages along trail between Main Street and Johnathan Pack. Blockages were removed in September 2019; woody debris was placed along the shoreline (to contribute to habitat).

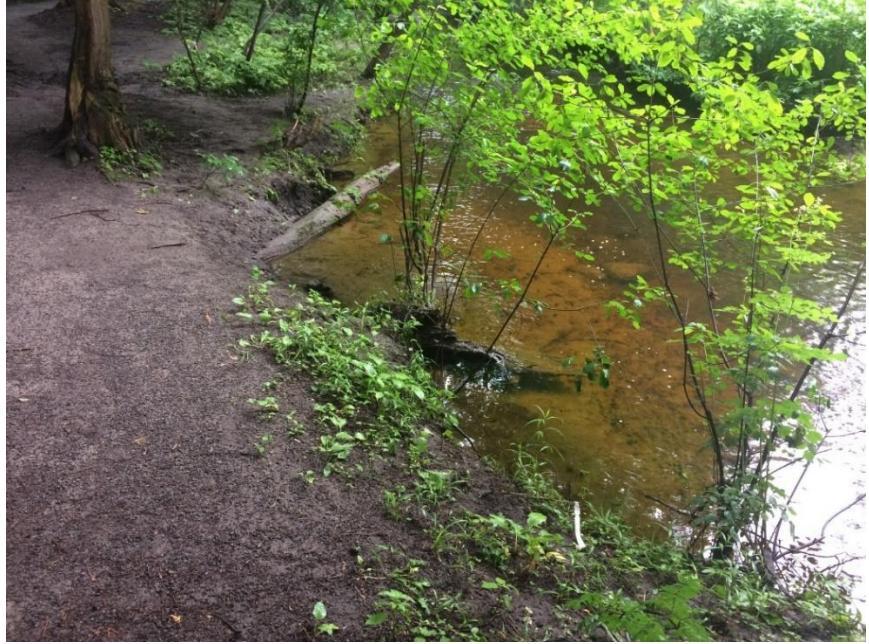
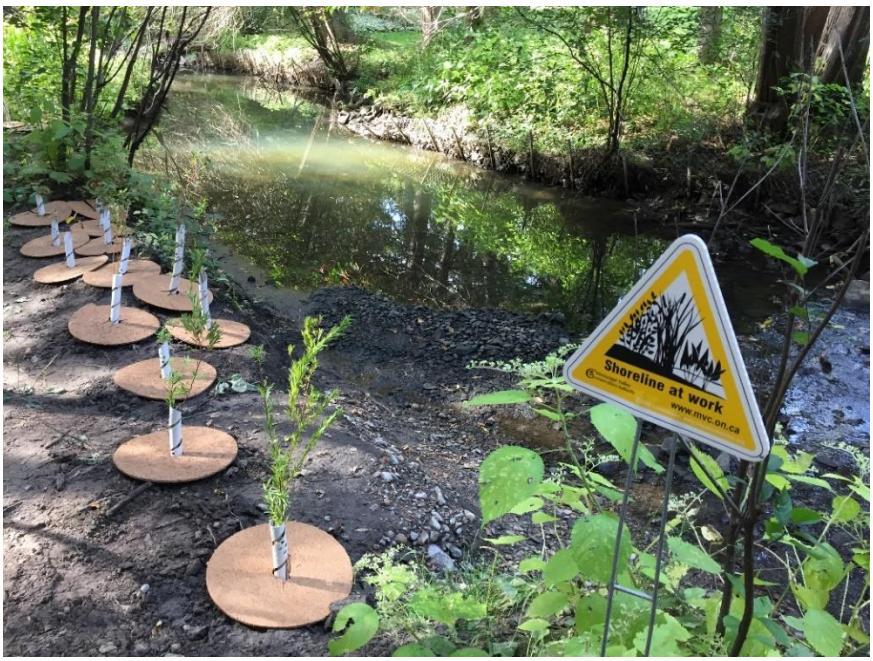
This site is City of Ottawa owned. It requires maintenance to stabilize the shorelines and minimize the erosion.

Issues: Pedestrian Trail is too close to the water, causing erosion.

Plan: Stabilize the banks with riprap or a bioengineering solution.

Action: There is approximately 10 m of eroding shoreline upstream of Main Street that needs to be stabilized with riprap by an external company. Part of site along this stretch of trail was planted with 31 trees and shrubs in 2019. Rip rap proposed in specific areas along pathway.

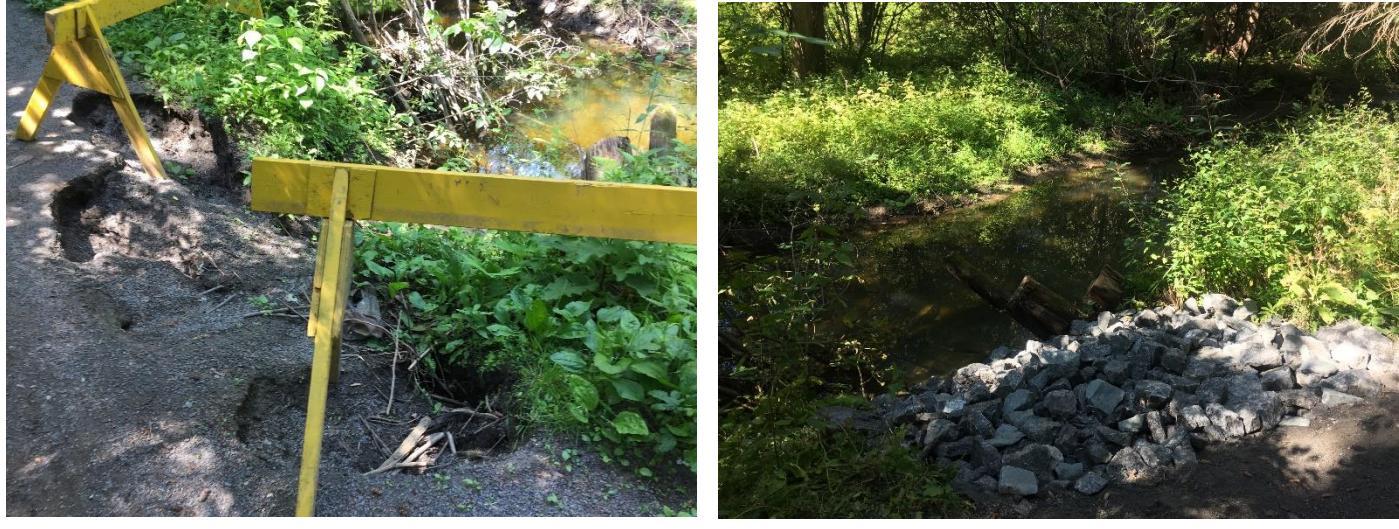
Site 5b

This site is City of Ottawa owned. It required maintenance to stabilize the shorelines caused by erosion in the spring of 2019. Received an emergency repair with rip rap erosion protection.

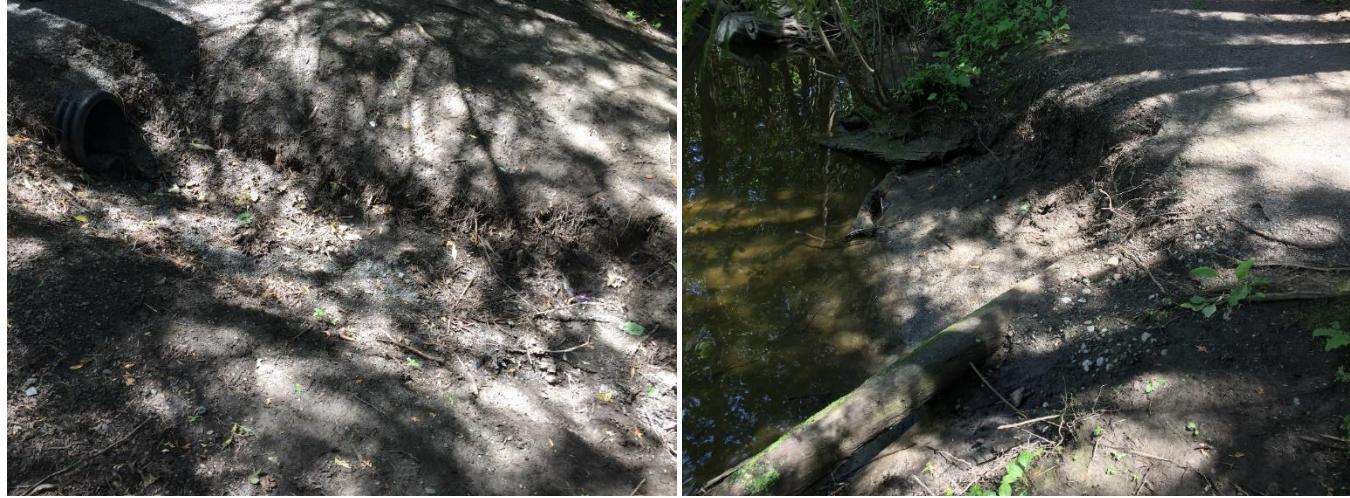
Site 5c

These sites are City of Ottawa owned. Rip rap erosion protection may be an option to stabilize these areas.

Culvert outlet by the ball diamond.

Eroded area, path is close to the creek.

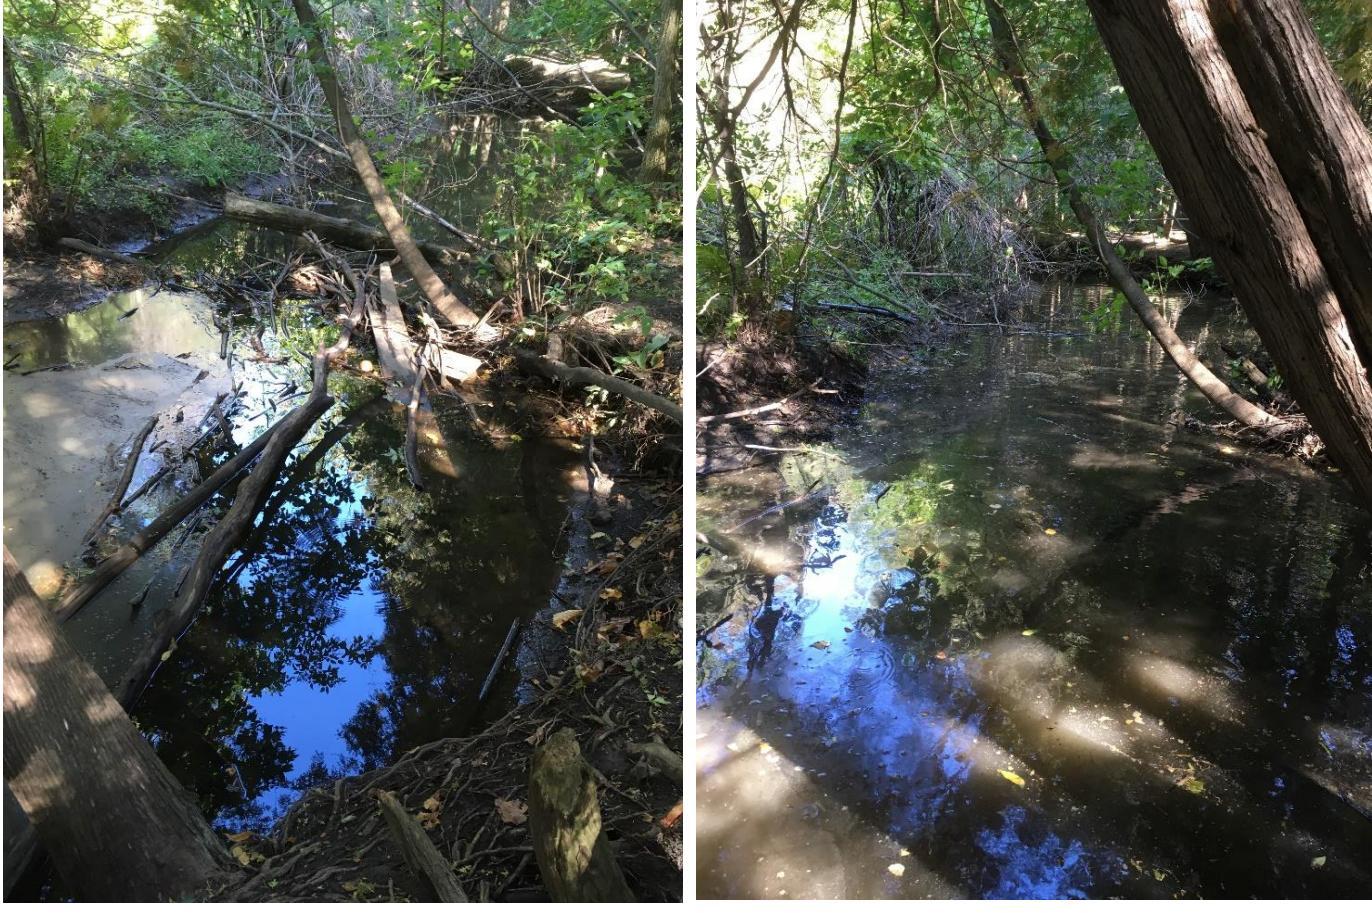
This site is City of Ottawa owned. Maintenance was required to improve flow and reduce blockages along the trail between Main Street and Johnathan Pack. Blockages were removed in September 2019; woody debris was placed along the shoreline (to contribute to habitat).

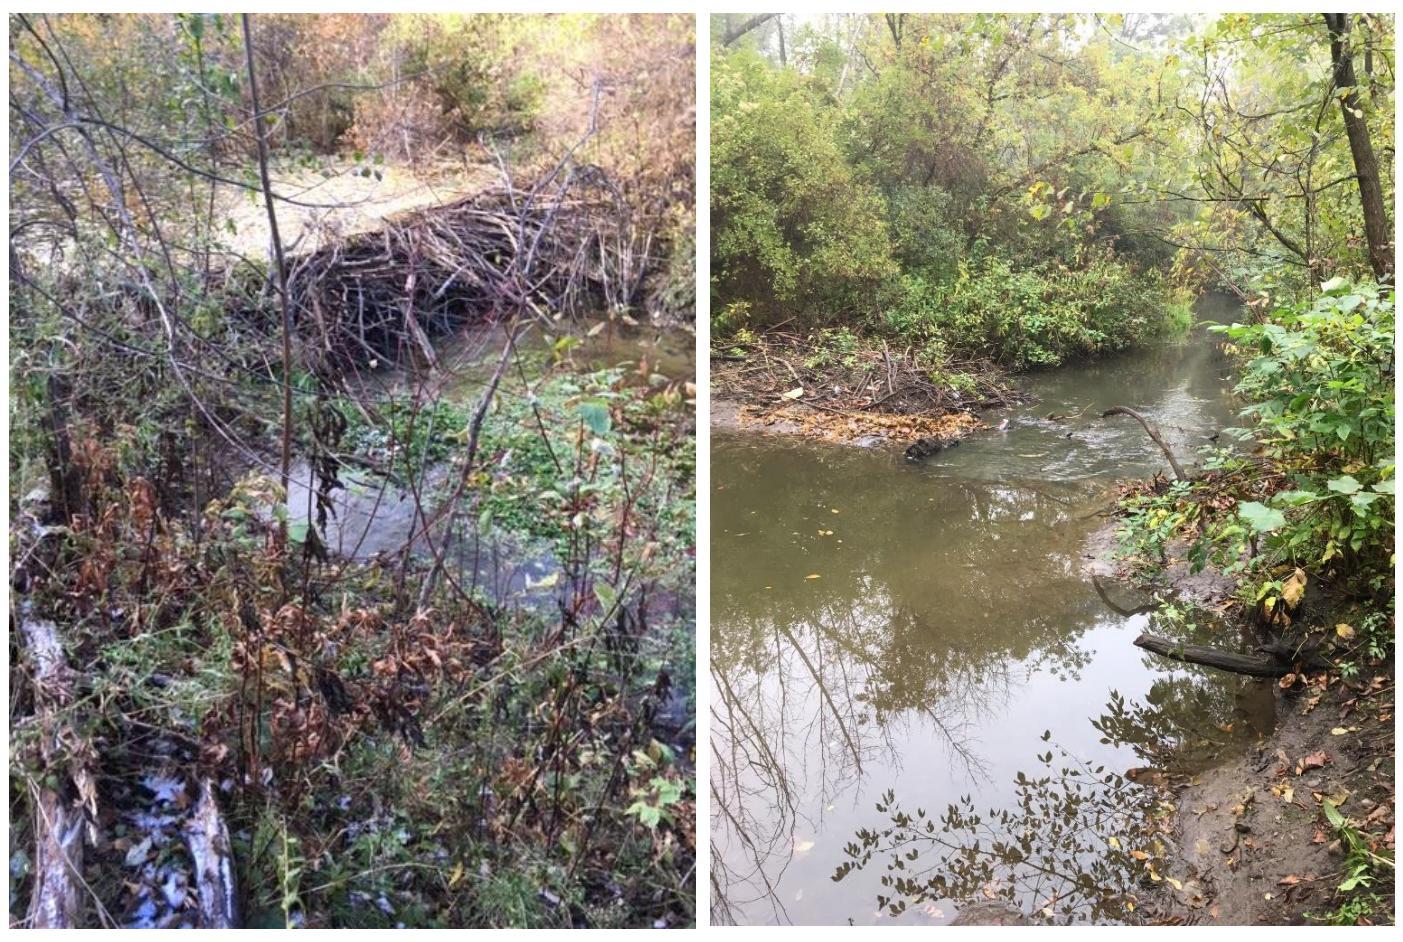
This site is City of Ottawa owned. Maintenance was required to improve flow and remove beaver dam blockage between Main Street and Johnathan Pack. Blockages were removed in September 2019; woody debris was placed along the shoreline (to contribute to habitat).

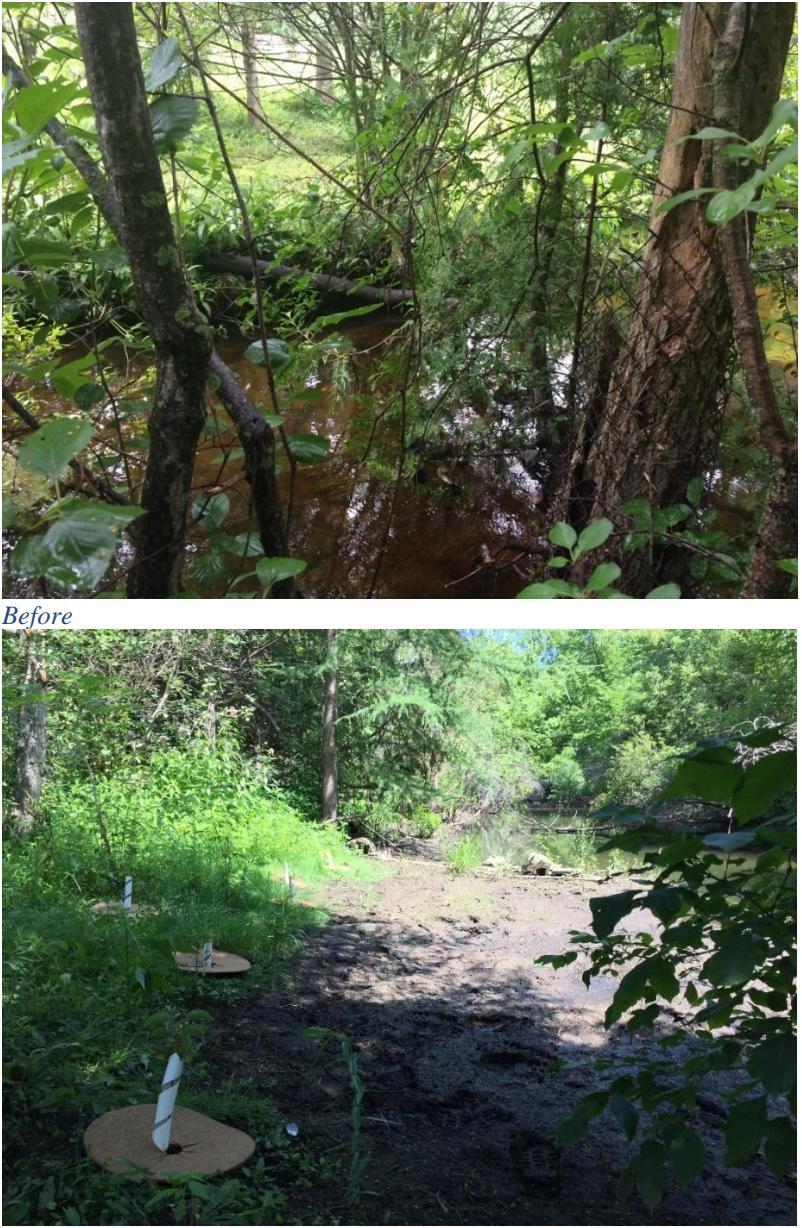
This site was specifically outlined in the UPCSWS. This site is a City of Ottawa owned property that is maintained by adjacent private landowners.

MVCA staff discussed shoreline planting with the landowner in 2019 and 13 trees and shrubs were planted at the site. At this time, the property was also impacted by the beaver dam in close proximity downstream. Species planted include nannyberry, ninebark and red maple. There were existing plants on the property providing a minimal buffer, including established trees providing overhead cover. The new plants should help to fill in the gaps of the buffer area and mowing activities to stop further away from the shoreline.

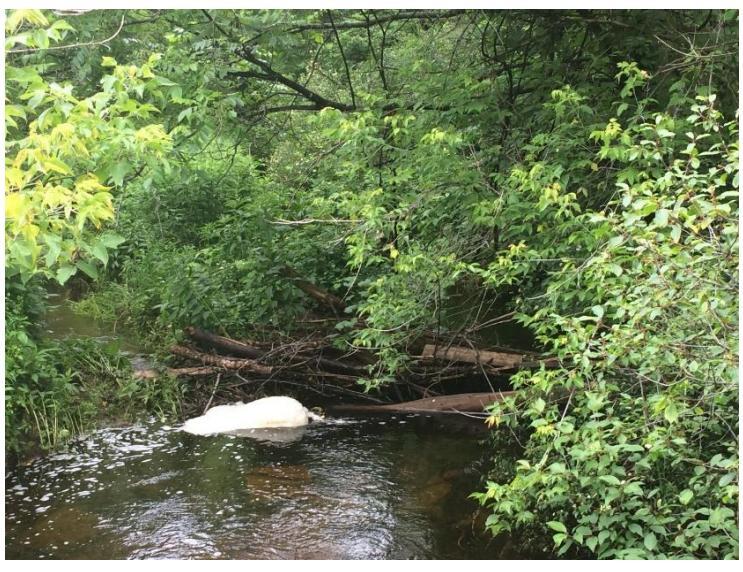
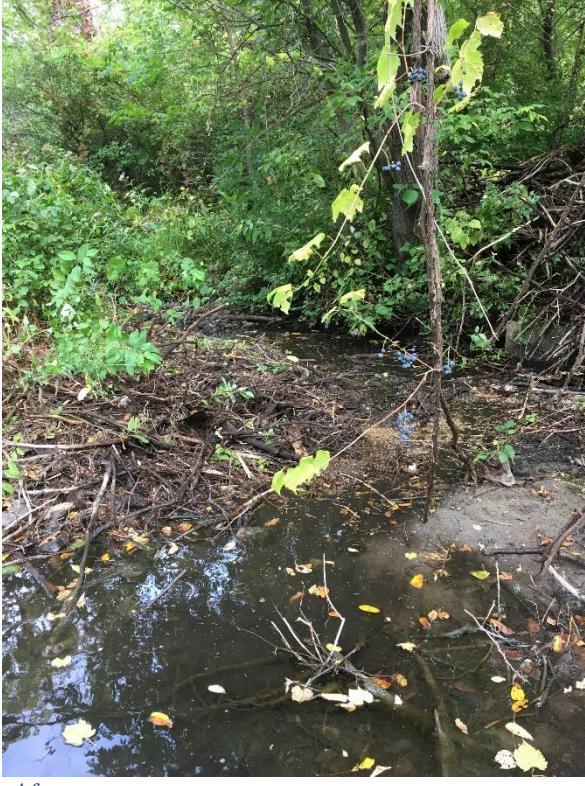
This site is City of Ottawa owned. Maintenance was required to improve flow and remove blockages by the pedestrian bridge a Stitt Street Park. Blockages were removed in September 2019; woody debris was placed along the shoreline (to contribute to habitat).

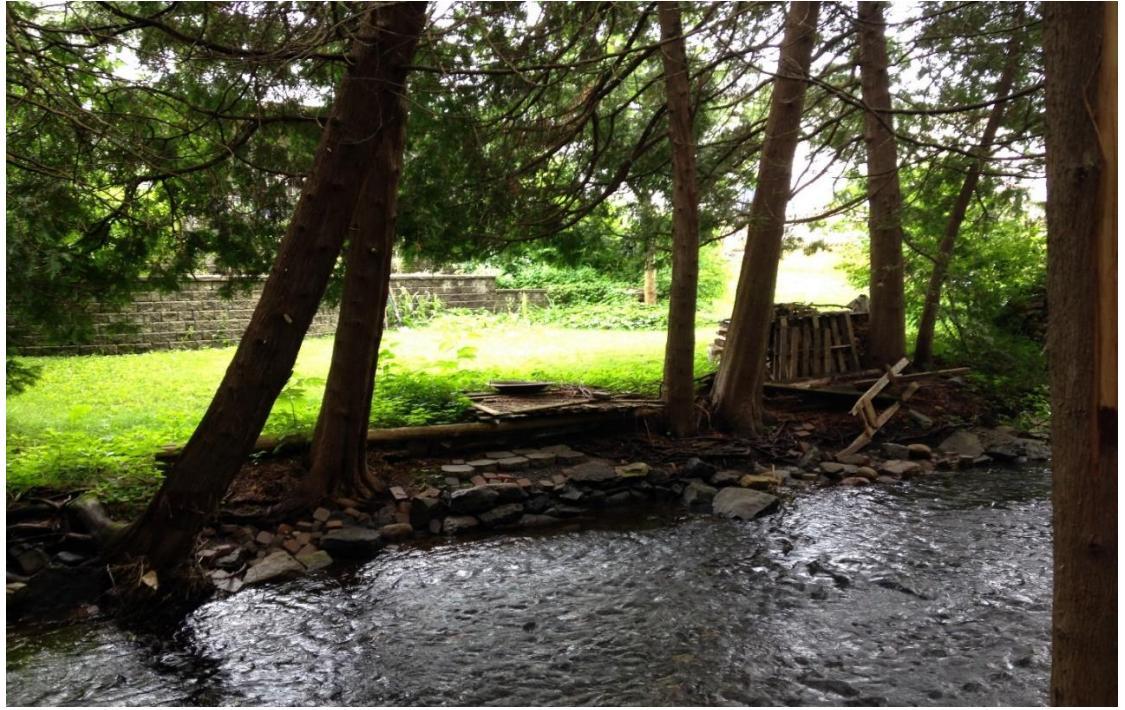
This site is City of Ottawa owned. This is where the creek has been diverted to create a man-made channel.

Issues: Lawn is mowed to the edge and the shoreline is eroding.

Plan: Contact landowner and discuss potential work that could enhance their shoreline.

Action: There is the opportunity for potential work to be done for this property's shoreline. The type of work will be dependent upon the response of the landowner.

The landowner was contacted in 2019 through a letter delivered with information about Upper Poole Creek and shoreline planting opportunities. Further, during a volunteer event near Stitt Street, this landowner communicated with MVCA staff regarding shoreline planting and erosion control including the permit process. However, the landowner did not follow up further with MVCA in 2019. Initial communication with the landowner was positive, and there may be opportunity to return to the site.

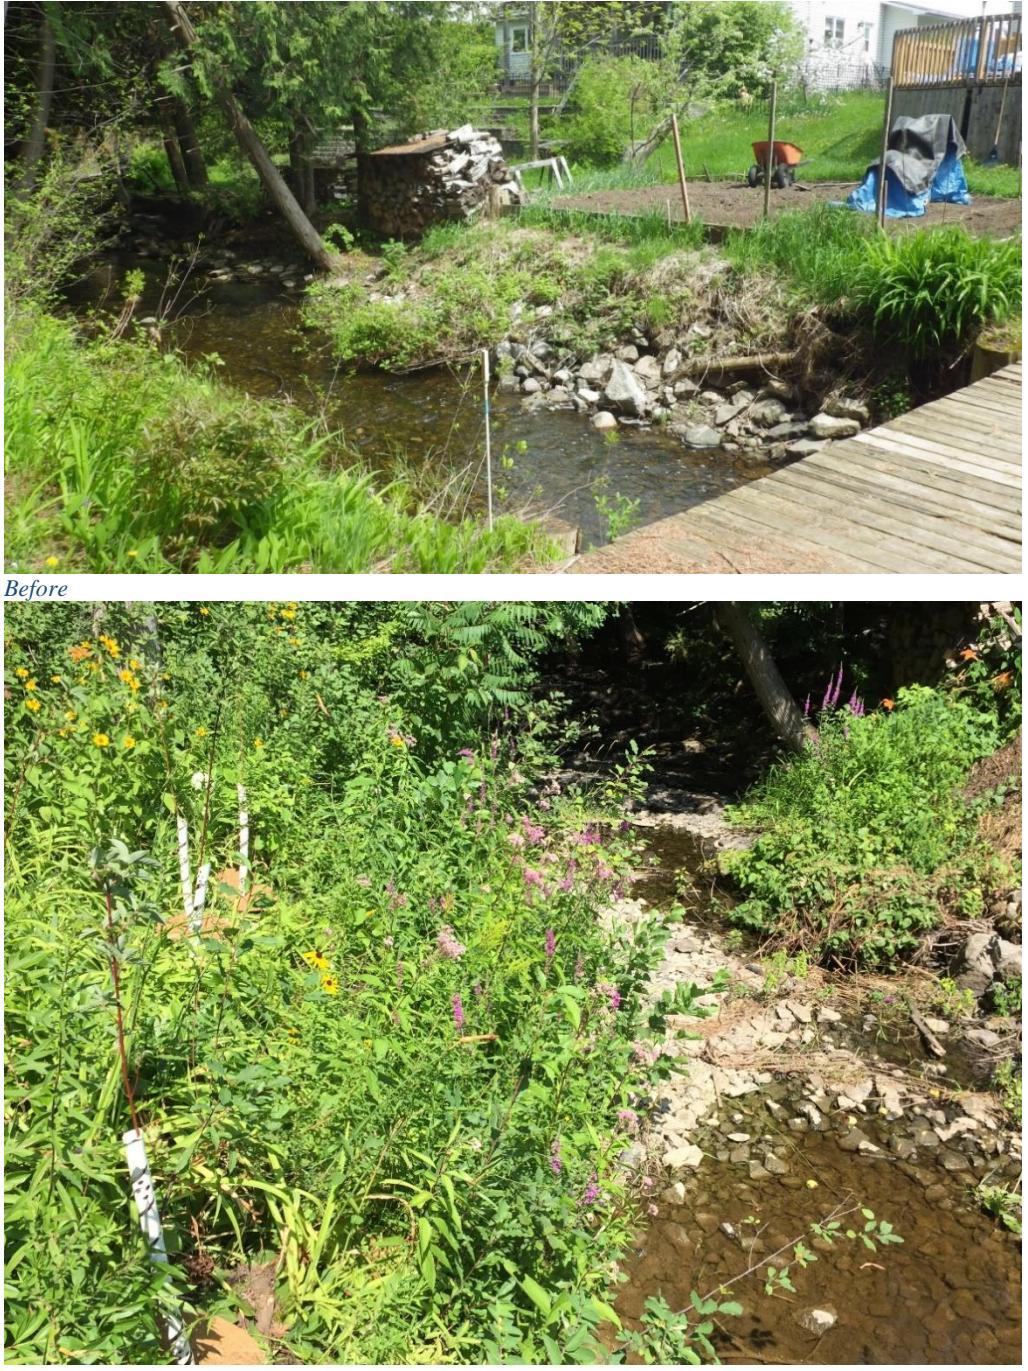
This site is a City of Ottawa owned property that is maintained by private landowners.

MVCA staff discussed shoreline planting and erosion due to encroaching on the shoreline with the landowner in 2019. There was a positive response from the landowner, with an understanding of stabilizing the bank. Due to the proximity of the landowner's garden to the creek, there is limited area to make improvements along the bank. On the opposite shore 10 trees and shrubs were planted. Species planted include red osier dogwood, ninebark and red maple. There may be potential for further work on the residential side of the creek with a change in landowner or change in use of the property.

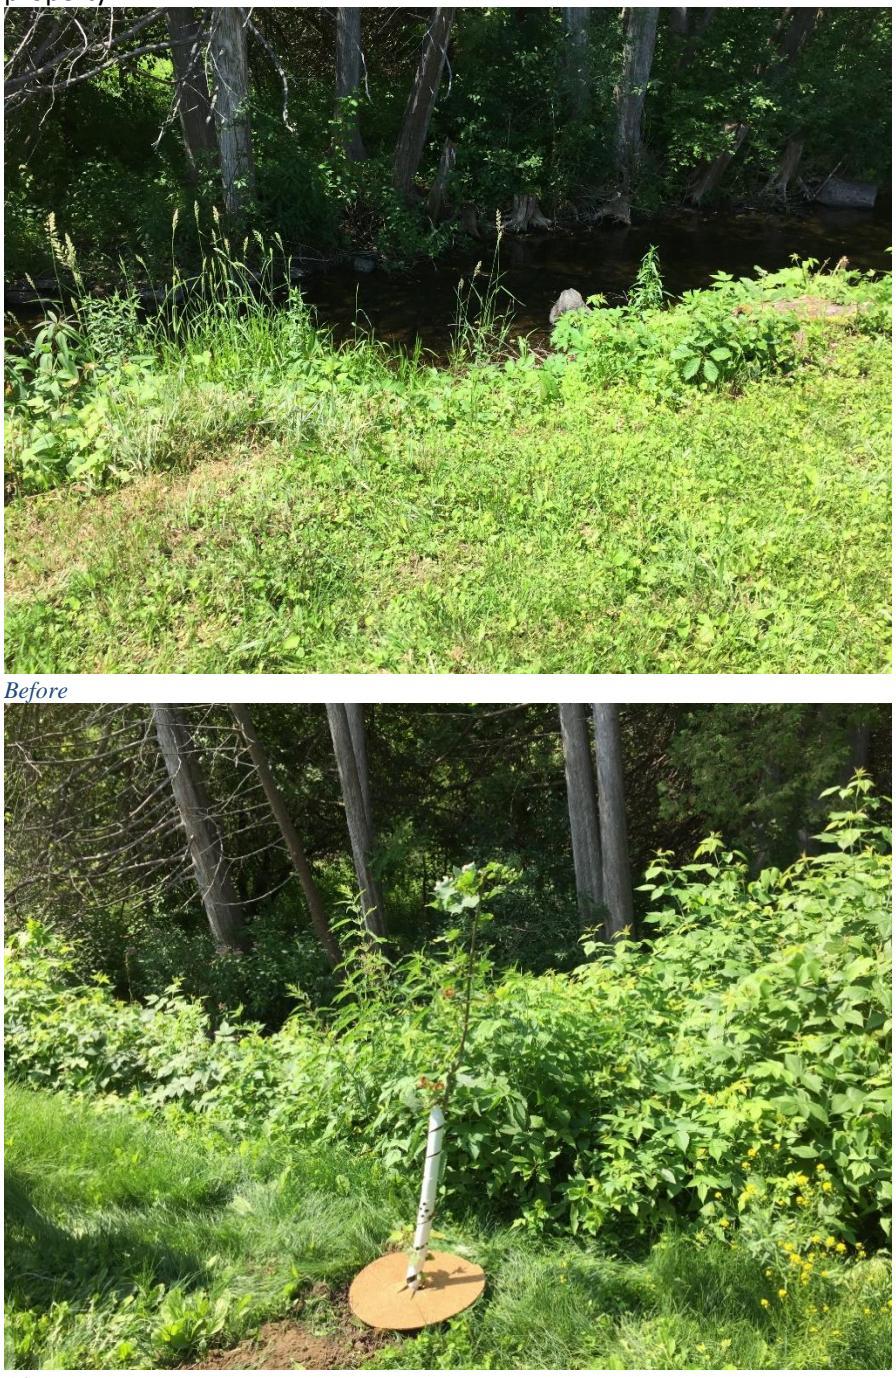
Site 11a

This site is a City of Ottawa owned property that is maintained by private landowners. It was not specifically identified in the UPC Restoration Plan, but outreach to landowner was established during visit to neighbouring property.

MVCA staff discussed shoreline planting and erosion due to encroaching on the shoreline with the landowner in 2019. The landowner was open to planting since trees that previously existing were damaged and had to come down. It was agreed to plant two red maples. There may be opportunity for further planting if there is interest from the landowner, they have MVCA's contact information and native shoreline species information.

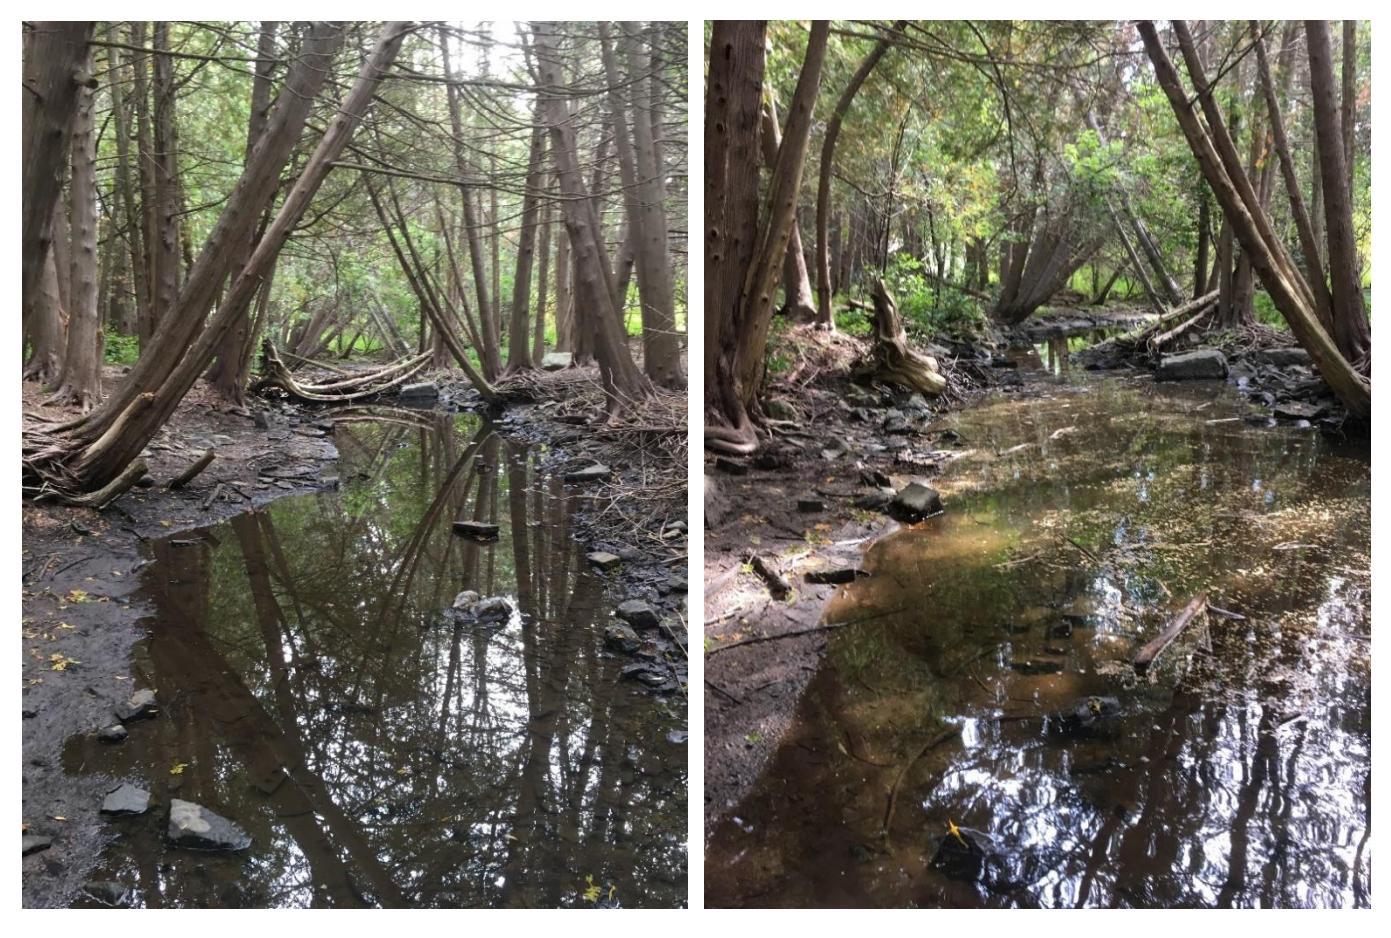
This site is City of Ottawa owned. Maintenance was required to improve flow and remove blockages along the stretch between Stitt Street and West Ridge Drive. Blockages were removed in September 2019; woody debris was placed along the shoreline (to contribute to habitat).

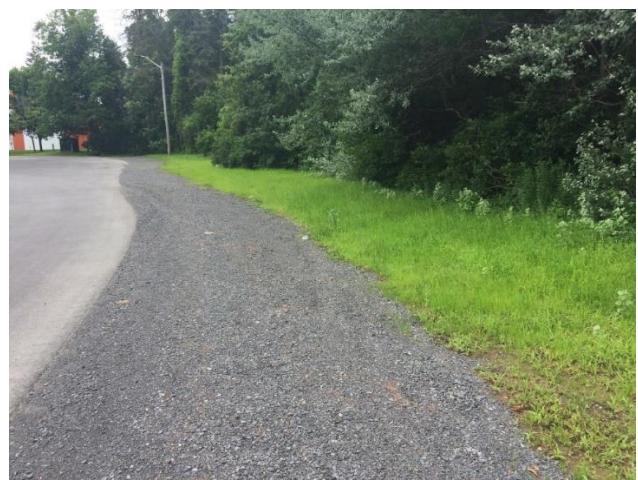
View along north of roadway looking west.

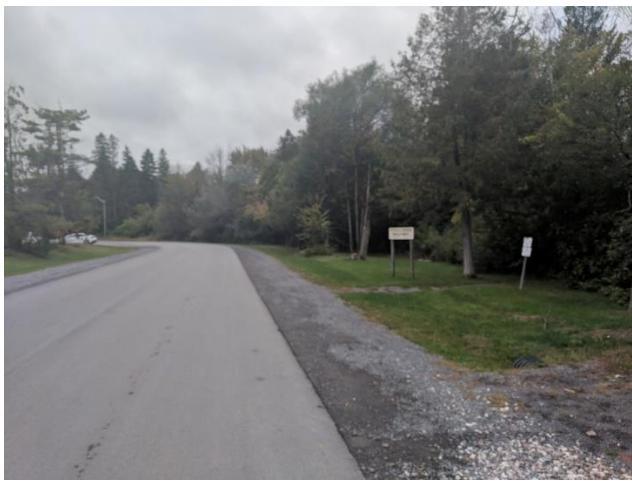
View along north of roadway looking west (with the possible location of the SWM facility near the pathway)

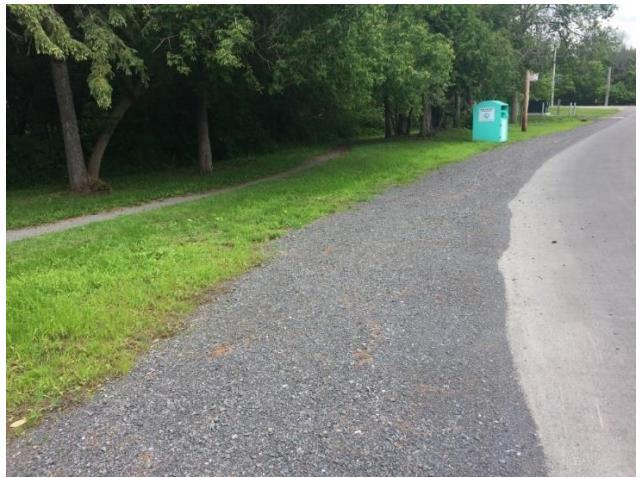
View along north of roadway looking east.
