# STATE OF THE LAKE Environment Report 2014

# FAWN LAKE

A lake monitoring program of the Mississippi Valley Conservation Authority

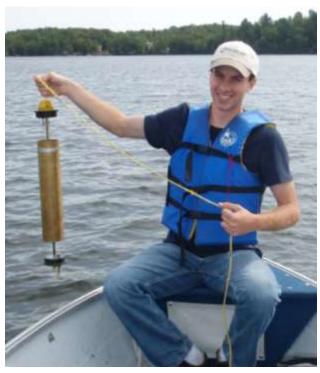
A Kremmerer Bottle (pictured to the right) is used to sample water at specific depths. The bottle is lowered to the required depth with both ends open. A weight on the rope is dropped. When the weight hits the bottle it causes both ends to close, sealing the sample water in the bottle.

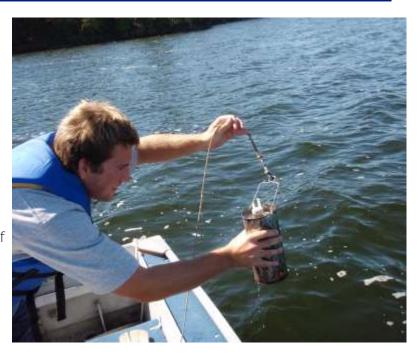
A Composite Sampler (pictured above) is used by dropping the tin container into the water. When it reaches the required depth it is slowly pulled back to the surface. The tin is filled as water enters one tube and air escapes the other. Some air remains in the tin to ensure collection throughout the haul to the surface.

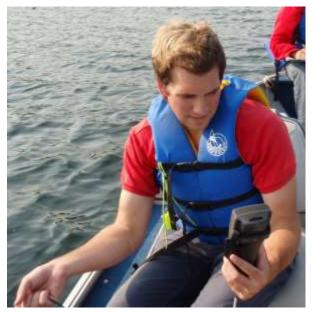
The Dissolved Oxygen Metre is used to gather DO and temperature readings. The probe is lowered into the lake and readings are taken at every metre from the hand-held screen.
