GEOTECHNICAL INVESTIGATION AND DESIGN REPORT KASHWAKAMAK LAKE DAM REPLACEMENT, TOWNSHIP OF NORTH FRONTENAC, ONTARIO

Project No.: CCO-23-3603

Mississippi Valley Conservation Authority
10970 Highway 7
Carleton Place, ON K7C 3P1

Revision 1 - January 2023

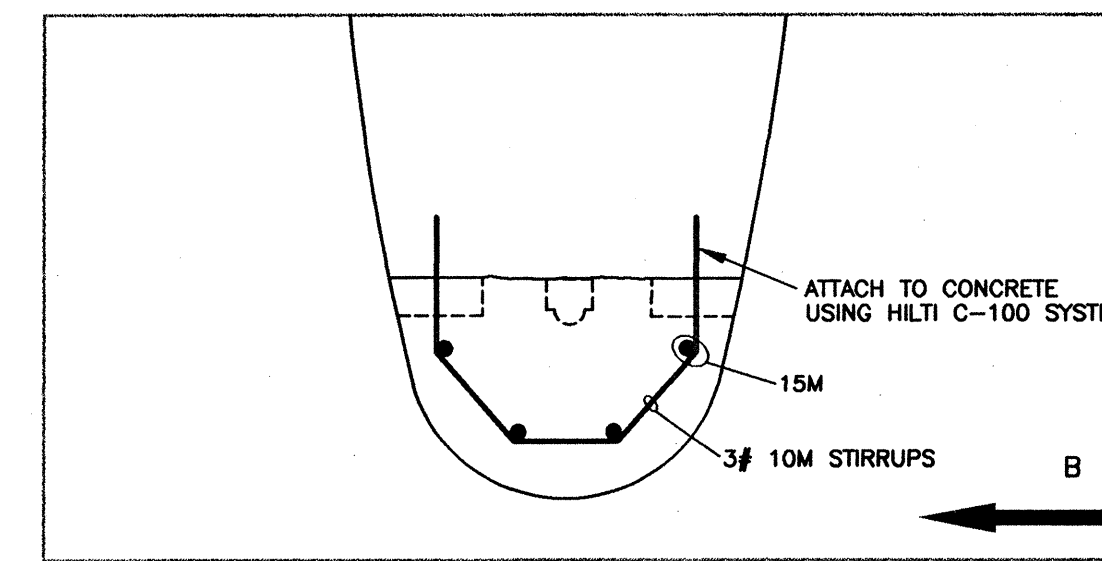
PLAN VIEW

DOWNSTREAM NORTH PIER SEVERE STRUCTURAL CRACK

DOWNSTREAM CENTRE PIER SEVERE STRUCTURAL CRACK

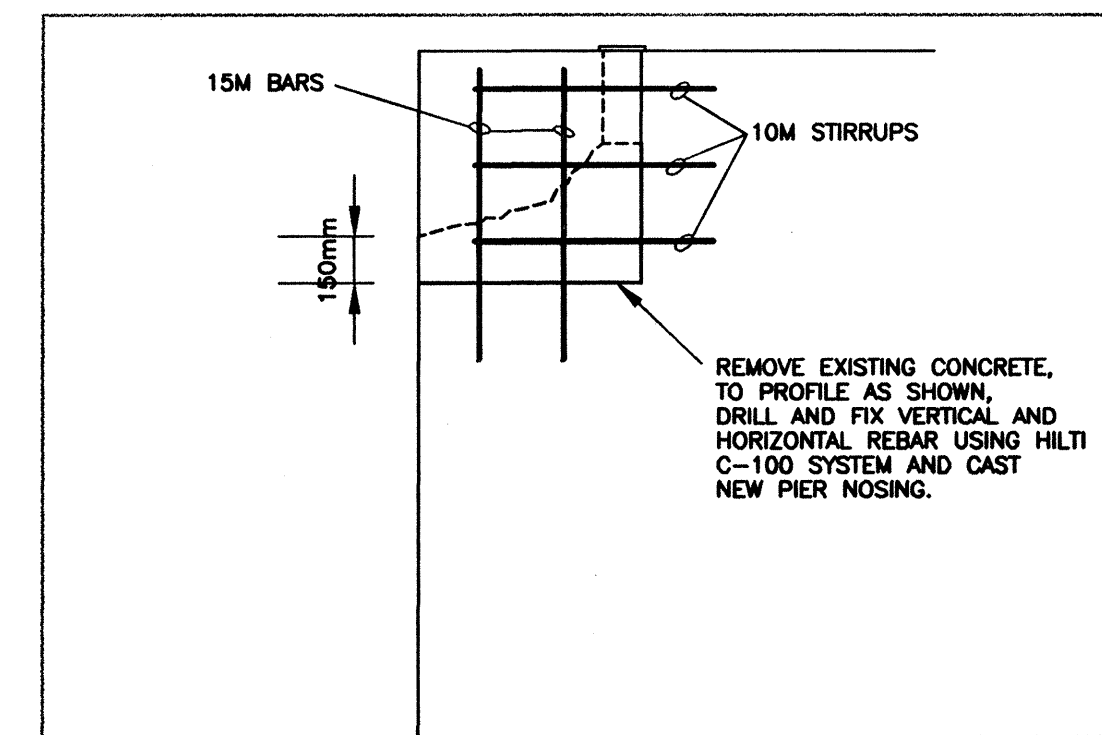
ELEVATION B

NORTH PIER - DOWNSTREAM SIDE
